**RC Application:** – APP042595.01.01

**Applicant:** Glenview Estate Ltd.

## Proposed Purua Rapids Hydroelectric Scheme - Assessment of Ecological Effects

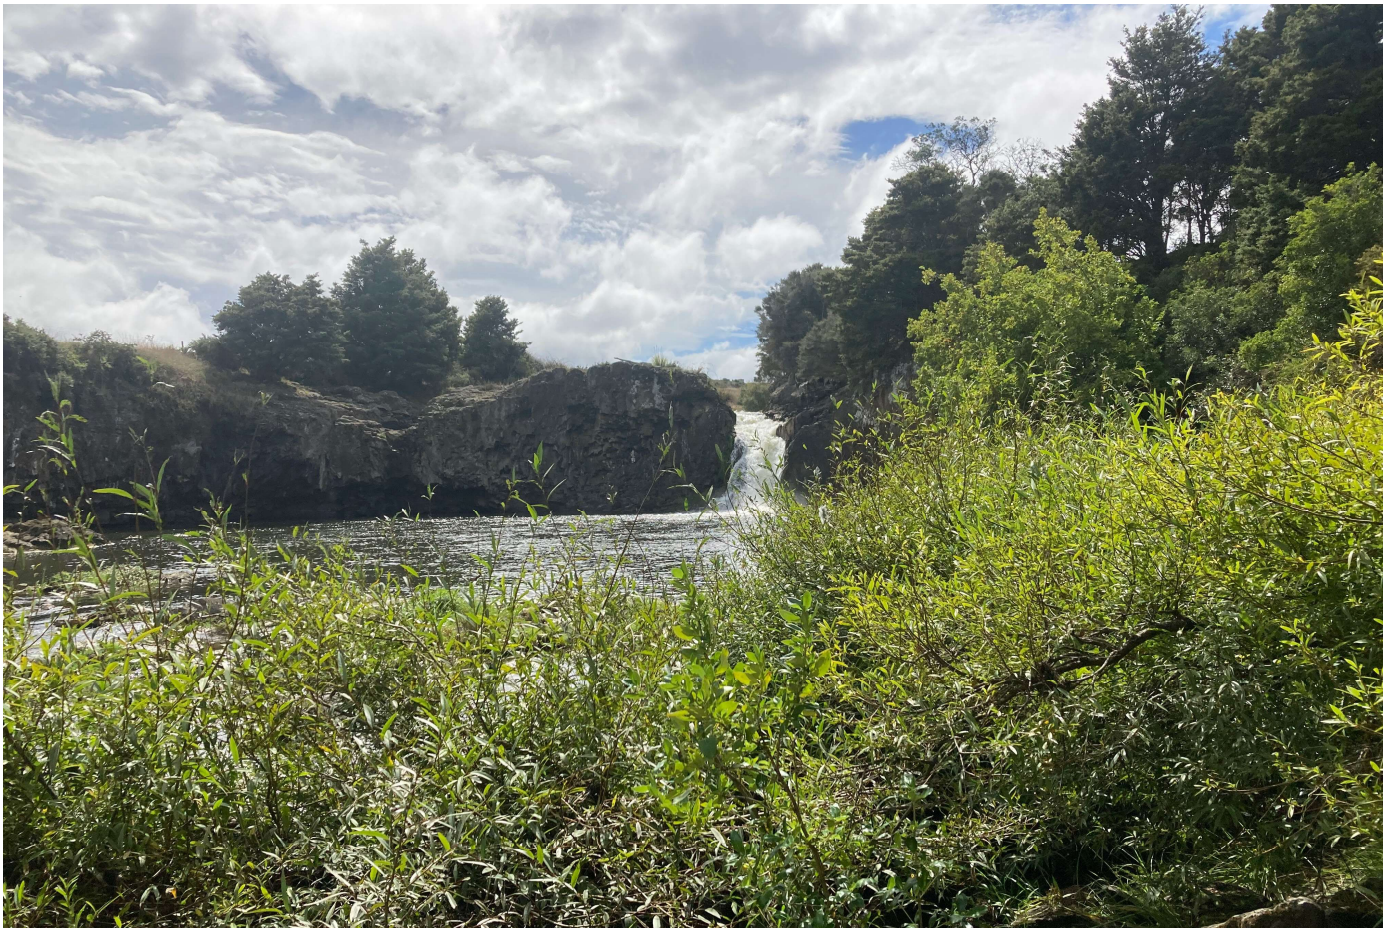
**Figure 1: The Falls.** The unnamed waterfall in the section of the Wairua River affected by the proposed hydroelectric scheme (sometimes described as Purua Falls).

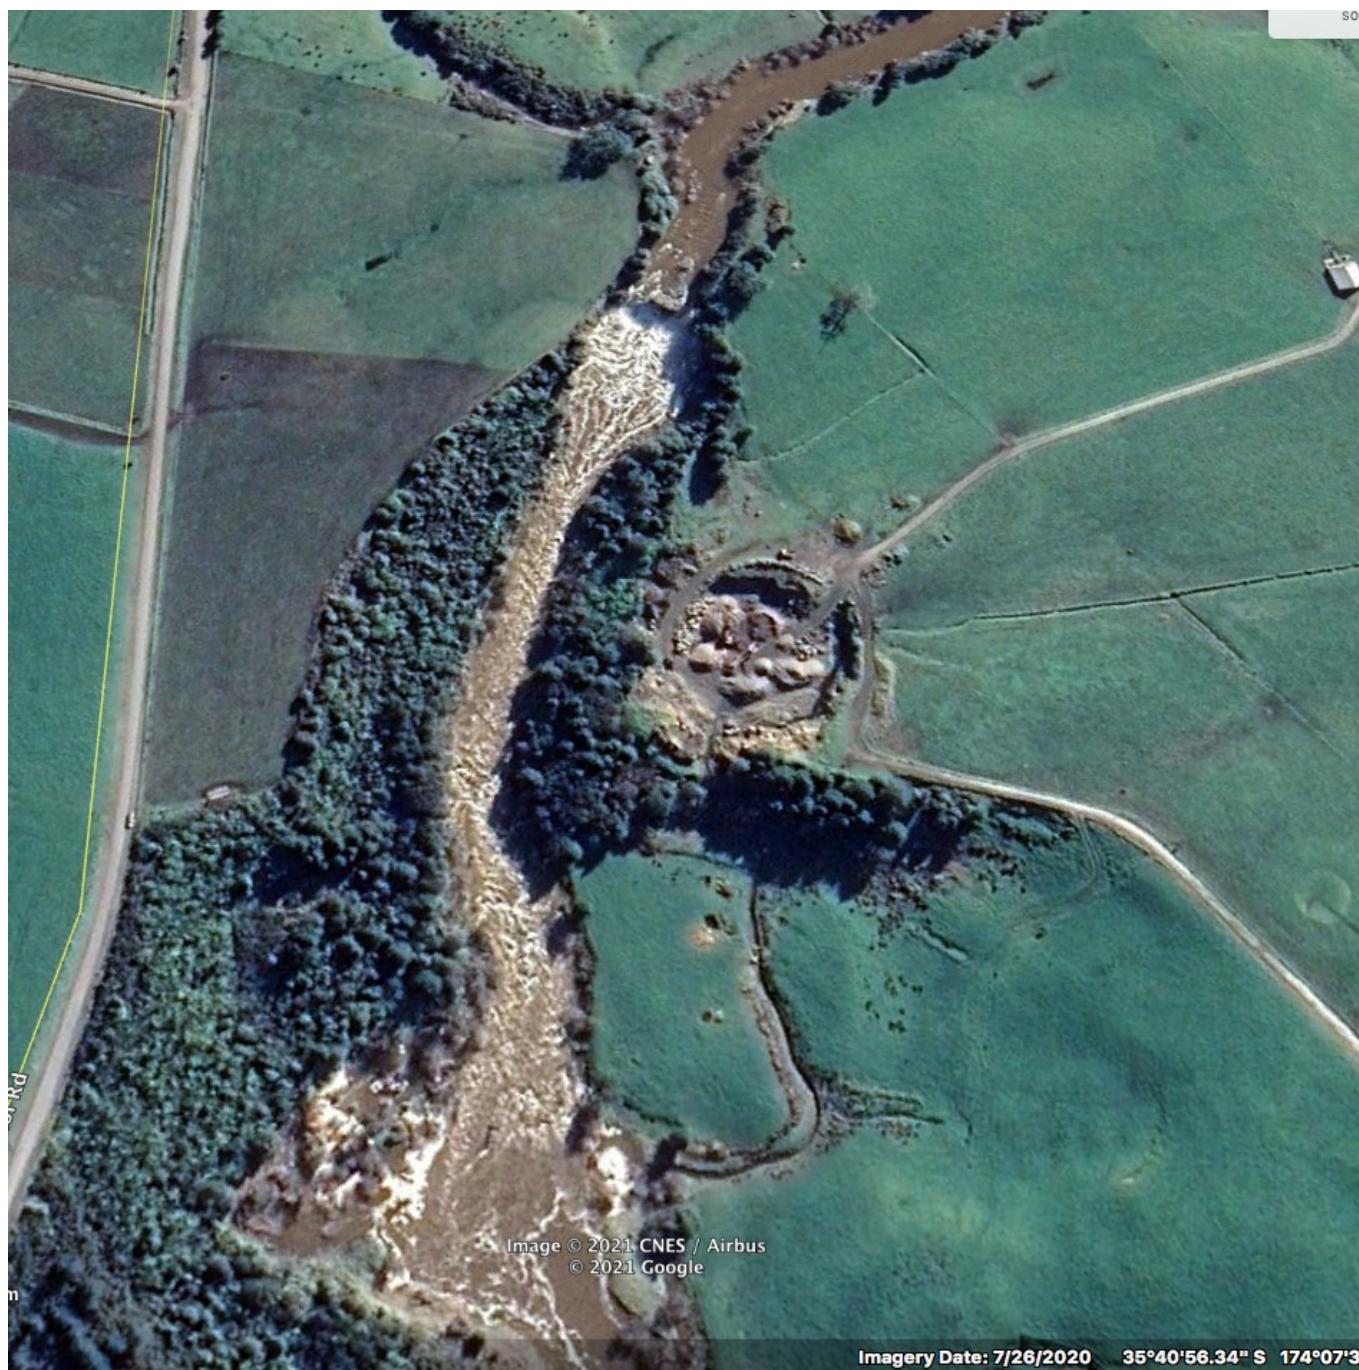
**Figure 3:** Showing the affected section of the Wairua River encompassed by the proposed Purua Falls hydroelectric scheme. On the eastern side of the river, the schemes water intake is around the top of the photo and the outlet back into the river is near the bottom of the photo. The river is shown in high flow following a substantial rainfall event.

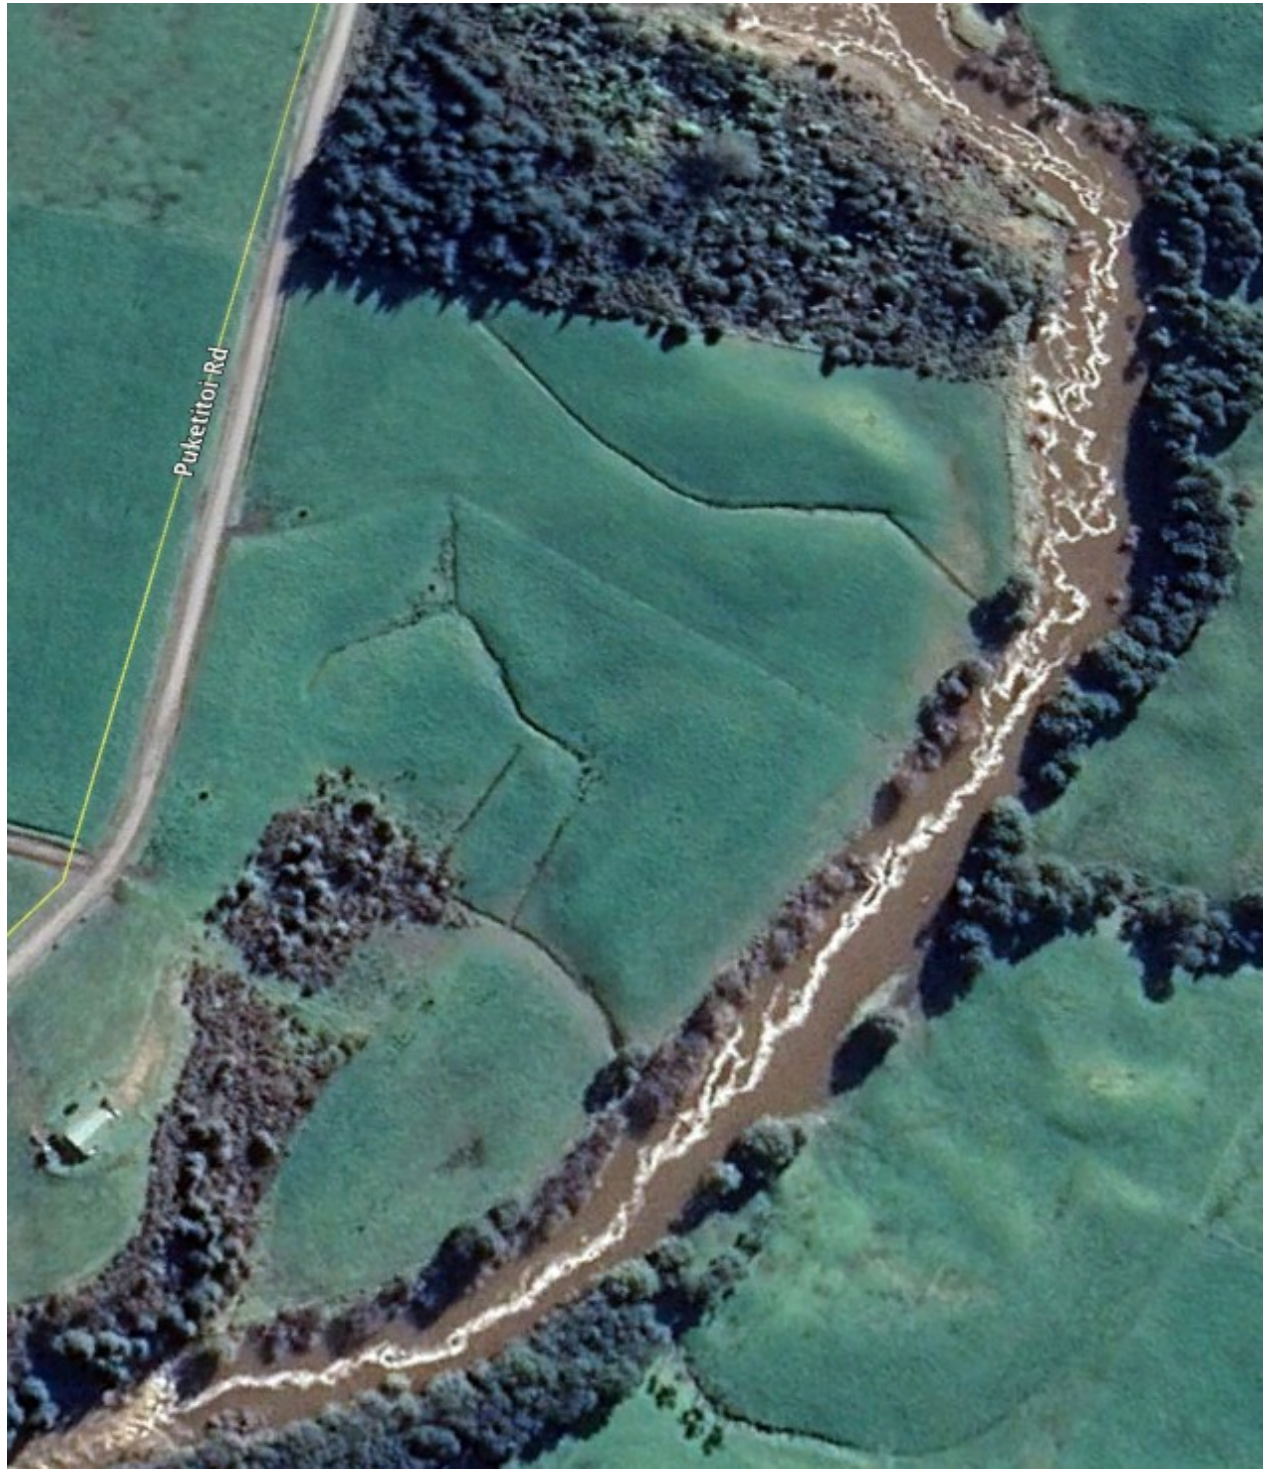
**Figure 4:** Showing the vortex that when functioning:

- Centralizes current flow.
- Guides and supports fish migration.
- Carries the Wairua (life force) upstream.

The Wairua's central vortex collapses. See central vortex in **Figure 4** below.

- Mechanical insertion of oxygen into the spent water flow.
- Passage through a flow form channel to re-establish the Vortex (refer to *Figure 4*).
- Cooling of the water through the buried intake pipes.
- Establishing a fish ladder for elver passage.
- Strategic placement of the outlet into the discharge pool.

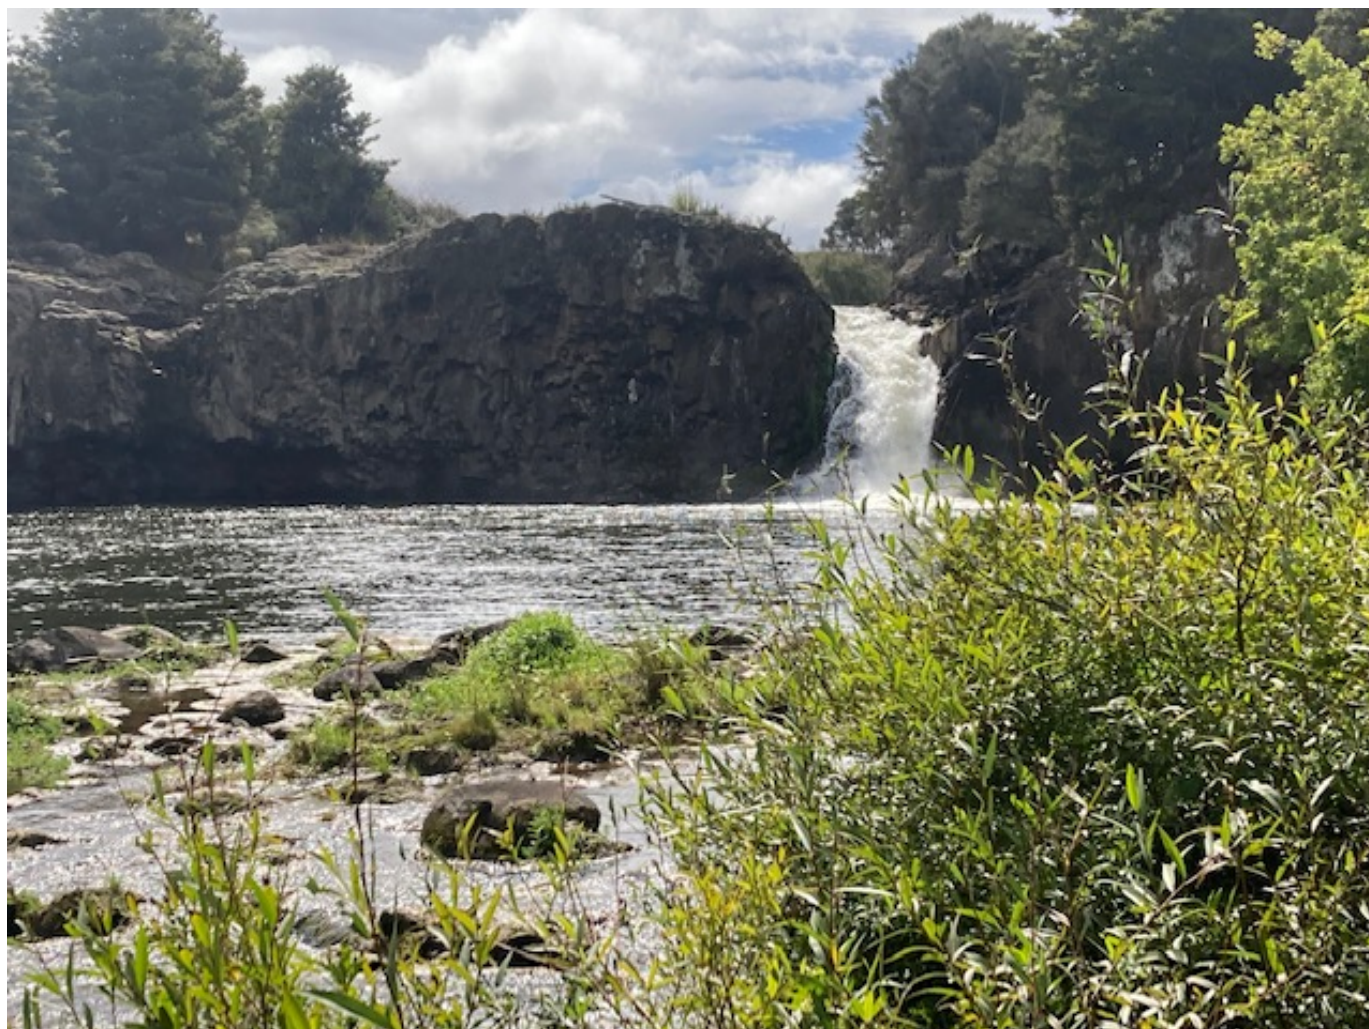
**Figure 5: The Falls.** The unnamed waterfall in the section of the Wairua River affected by the proposed hydroelectric scheme (sometimes described as Purua Falls). During median annual flows the falls channel water at 1300-1500 litres per second over a 5m drop into a 9m deep scour hole / pool below. The channel at the right of the rock formation was blasted during the drainage works for the Hikurangi Swamp. During flood events the flow can increase dramatically, covering the entire rock wall and transporting vast amounts of sediment downstream.

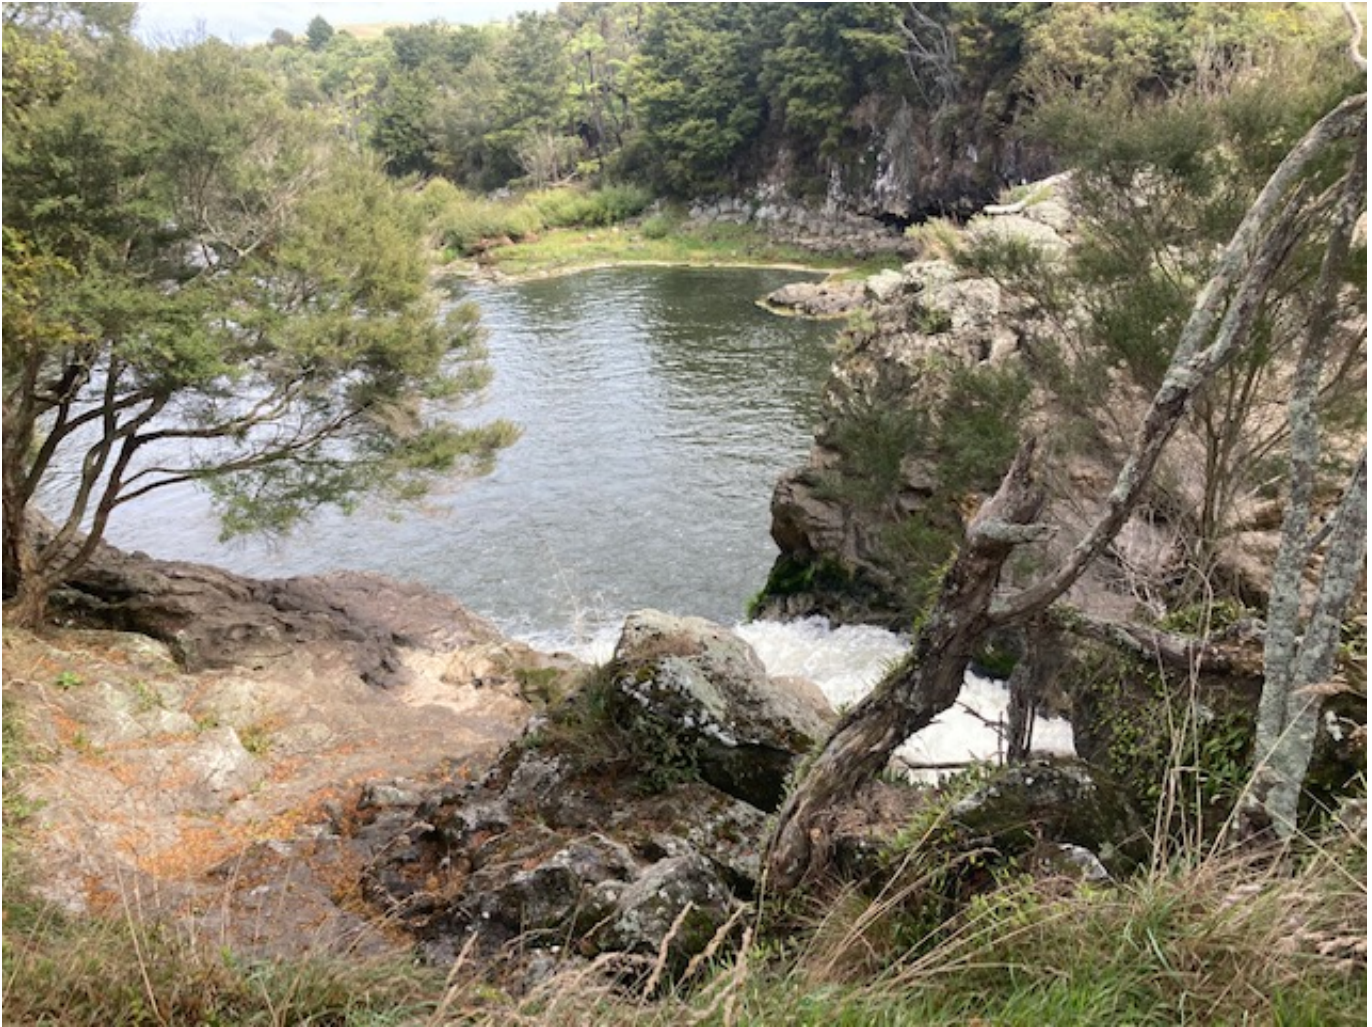
**Figure 6:** Another view of the wide, deep pool below the falls.

After a period of warming over sunlit rapids, the river water plunges over the falls into the pool below, where it is cooled and circulated through a downward vortex to the bottom of the pool. The water in this pool is highly dynamic and it is regarded as a dangerous section to enter.

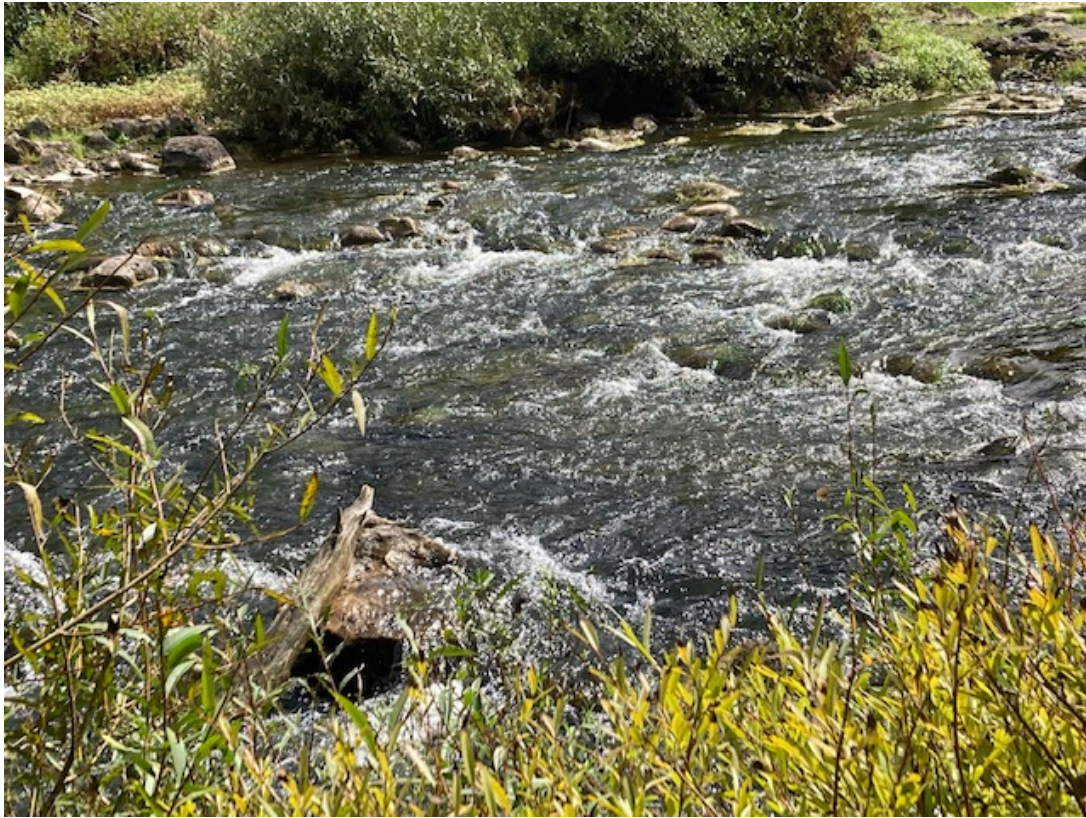
**Figure 7:** The Rapids between the two wide pools.

Rapids are stretches within a river where the riverbed has a relatively steep gradient, resulting in an increase in velocity and turbulence.

The flow into this pool is regulated by the section of shallow rapids (**Figure 7**). The river deposits silt here and water clarity at the surface improves.

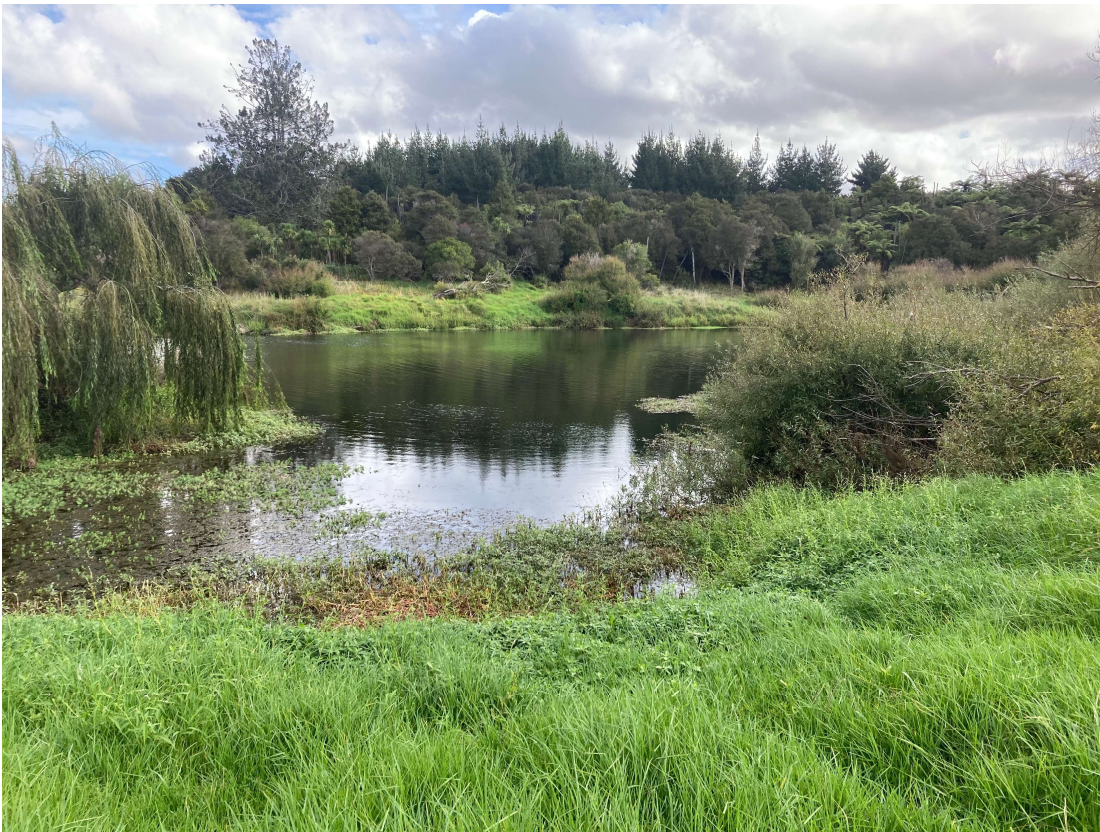
**Figure 9:** Around 100m downstream from the 9m deep scour hole below the falls, this scour hole forms a large pool. Screened, oxygenated water from the hydroelectric scheme would be discharged into this pool.

The downstream scour hole forms a large pool 100m further downstream (the pool designated for the water discharge from the scheme) - **Figure 9**. It is deep and wide and stabilizes the velocity of flow within a circular current.

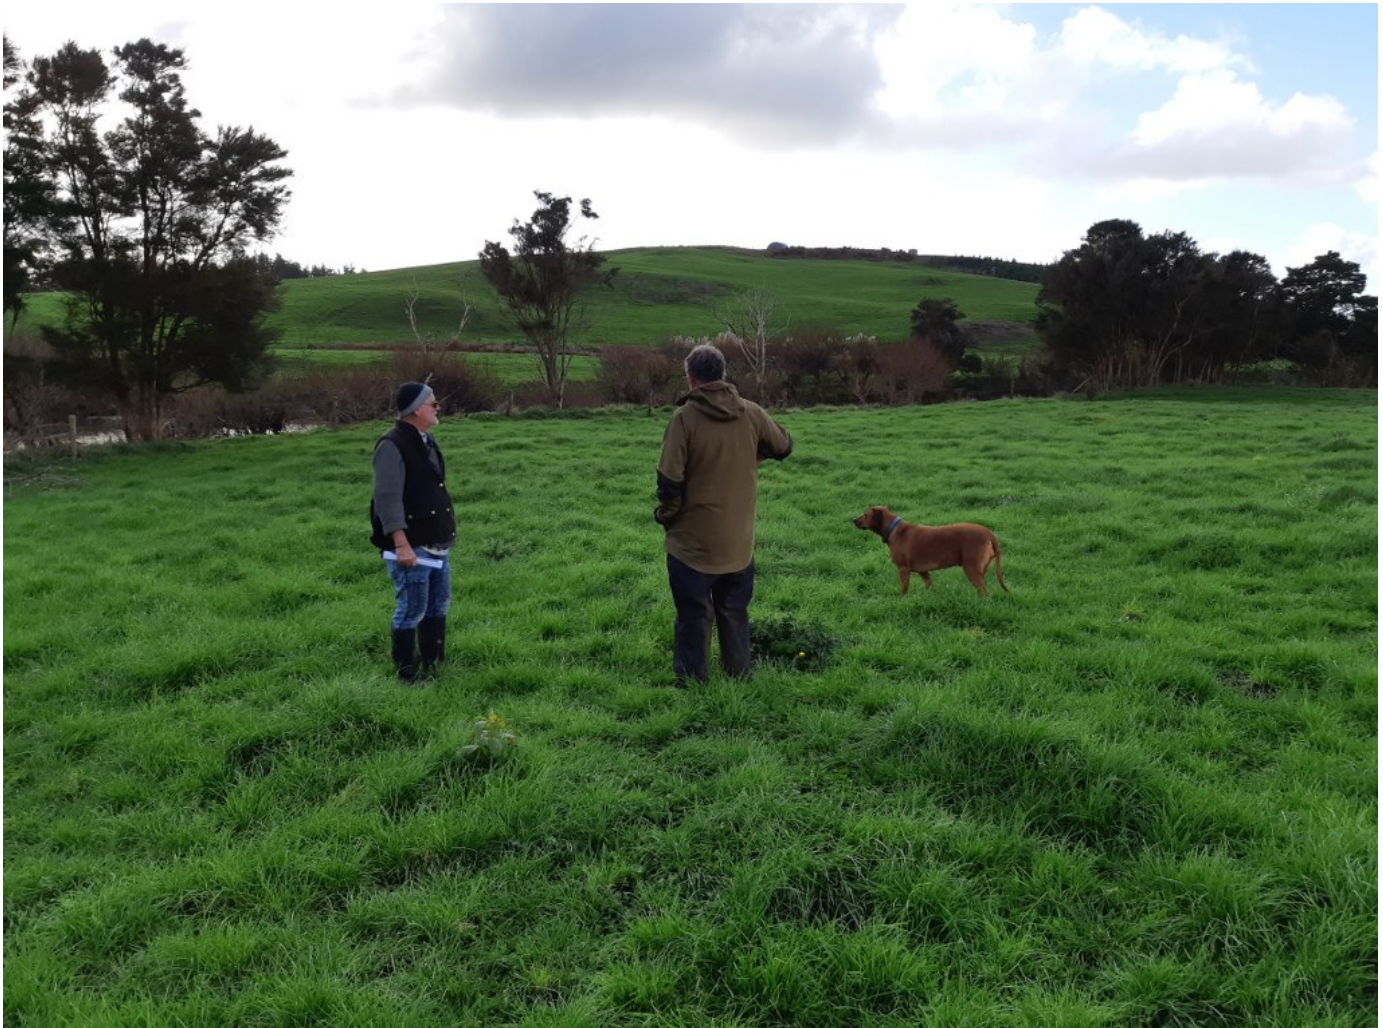
**Figure 10:** Looking North towards the river. Terry Kennedy (ecologist) to the left & Neil Lewis (landowner) to the right. Near the river edge, intake area excavation is to be carried out in a manner that will direct river water flow to the “screened pipeline intake” (refer to **Figure 8** for the layout). It is proposed that excavation for the intake area is located between the two tall Kanukas’ on the river’s edge (the larger tree being at the top left of the photo & the other being to the right a little further along the river bank).

Refer to **Figure 7**, “Proposed Purua Rapids Hydroelectric Scheme – Concept (provisional)” for the conceptual layout of the hydroelectric scheme intake and outlet areas. Both of the riparian areas that intake and outlet areas will traverse are currently almost entirely devoid of indigenous vegetation (refer to the four photos that follow immediately below (**Figures 10 -13**).

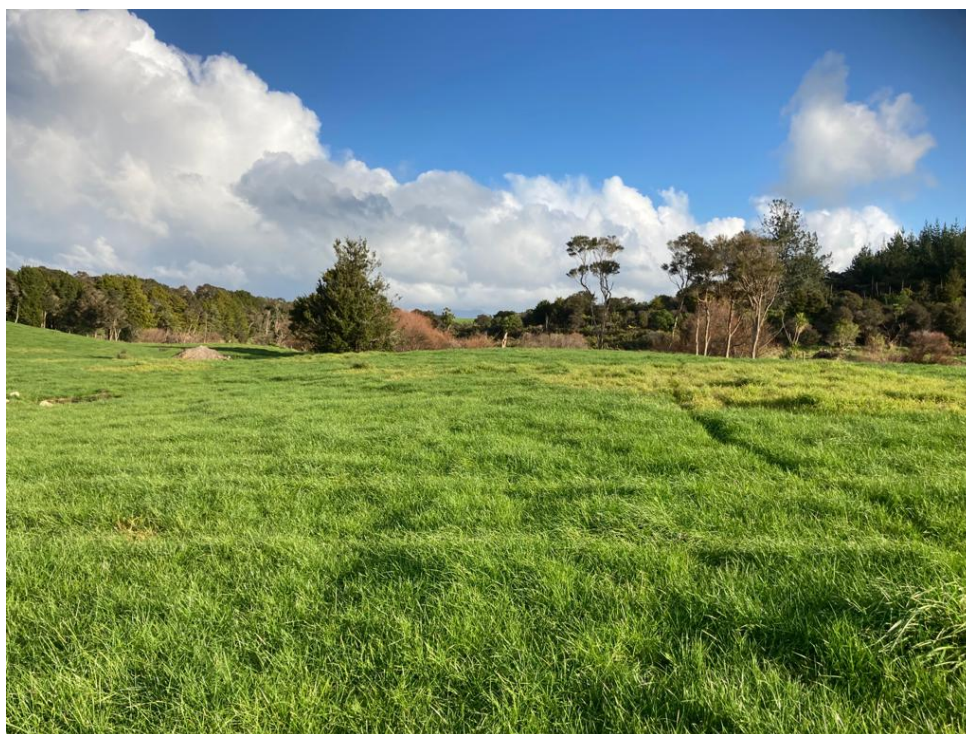
**Figure 11:** Looking South towards the river edge, across land where the tailrace is to be formed. It is proposed that the tailrace is located between the Totara just to the left of centre and the tall Kanuka Kanuka to the right. **Figures 12 & 13** are close up views of these two trees. The tailrace discharges to the river at that point (the “outlet area”).

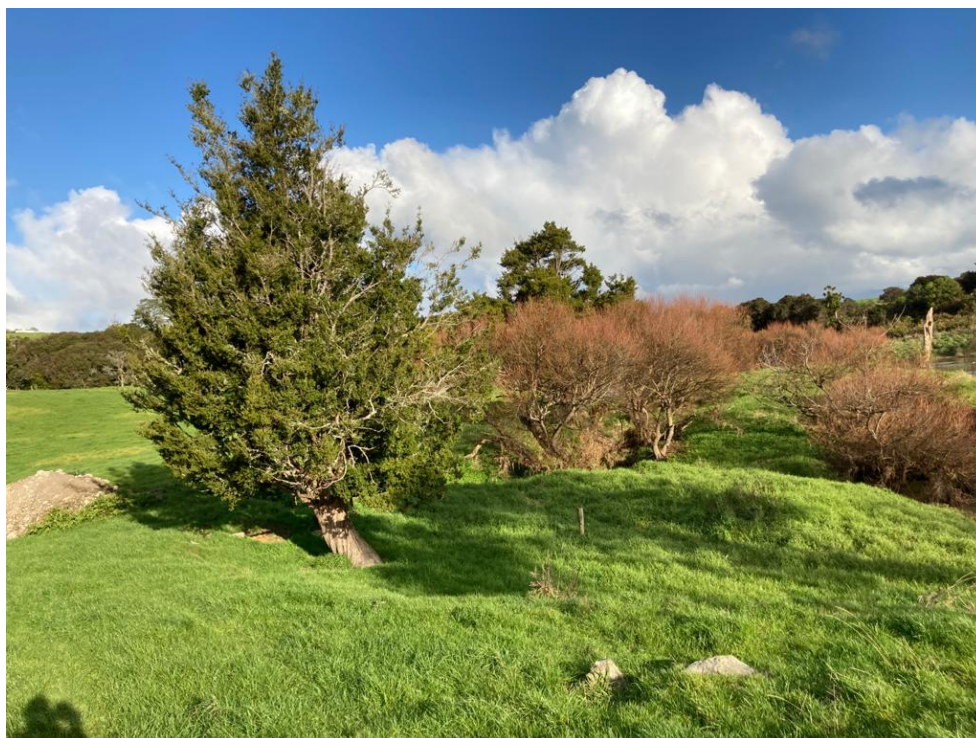
**Figure 12:** Close up view of the Totara labelled in **Figure 11**. The proposed location of the tailrace outlet is to the right of this tree. As shown in this photo, other vegetation established in this riparian area is predominantly Willow.

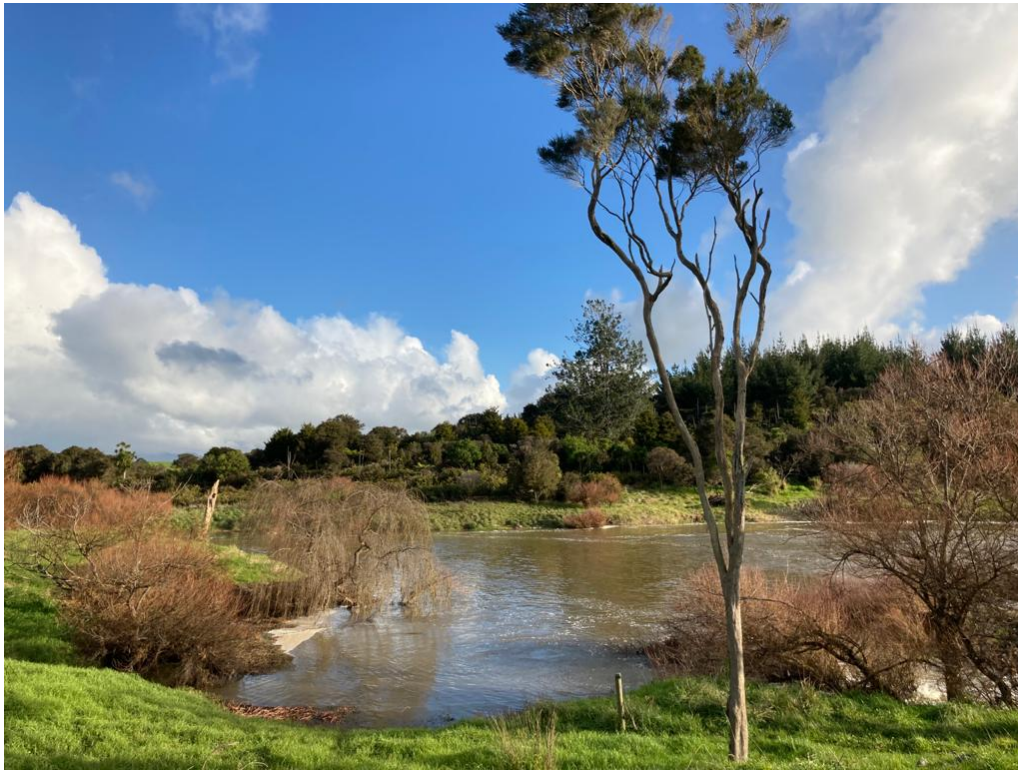
**Figure 13:** Close up view of the Kanuka referred to in **Figure 11**. The proposed location of the tailrace outlet to this scour hole / pond in the river, is to the left of this tree. As shown in this photo, other vegetation established in this riparian area is predominantly Willow.

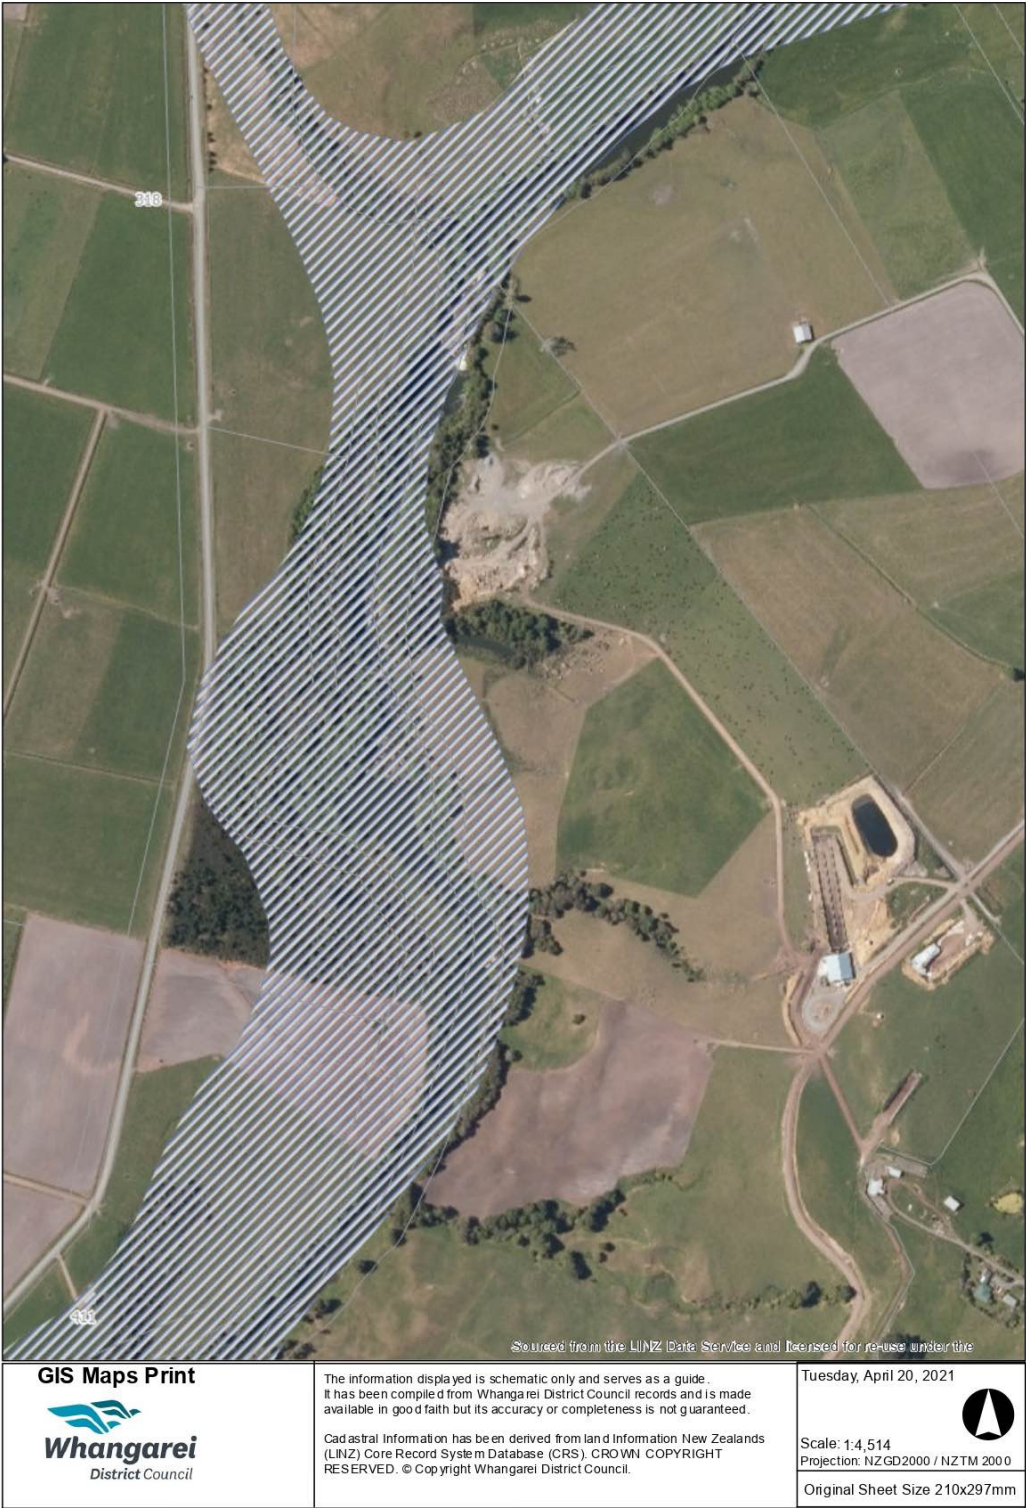
**Appendix 1:** Area affected by the hydro scheme currently documented as being prone to flooding. The hydro scheme as proposed will withstand such flooding.
