Document Ref: AKL2021-0210AB Rev 0

RE: GEOTECHNICAL EXPERT INPUT
201 – 203 BROWNS BAY ROAD, BROWNS BAY

CMW has been engaged by Matvin Group to provide expert input for the proposed apartment development at 201 – 203 Browns Bay Road Browns Bay.

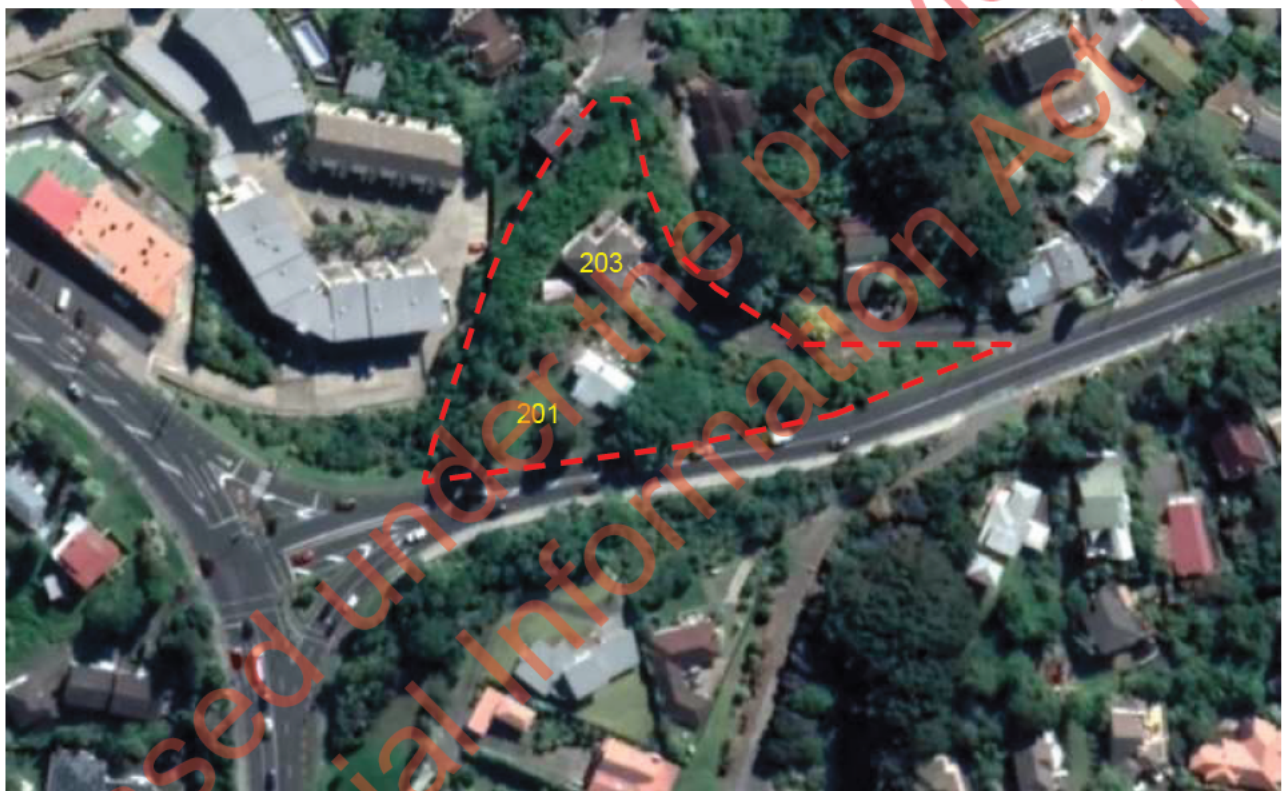
Both properties are currently occupied by residential dwellings. The site is steeply sloping on the southern side with gradients of up to 2H :1V with two level platforms present on the site where the residential dwellings are located. The site location is shown on the aerial on Figure 1 below.

Figure 1: Aerial photograph of site with site boundary shown in red

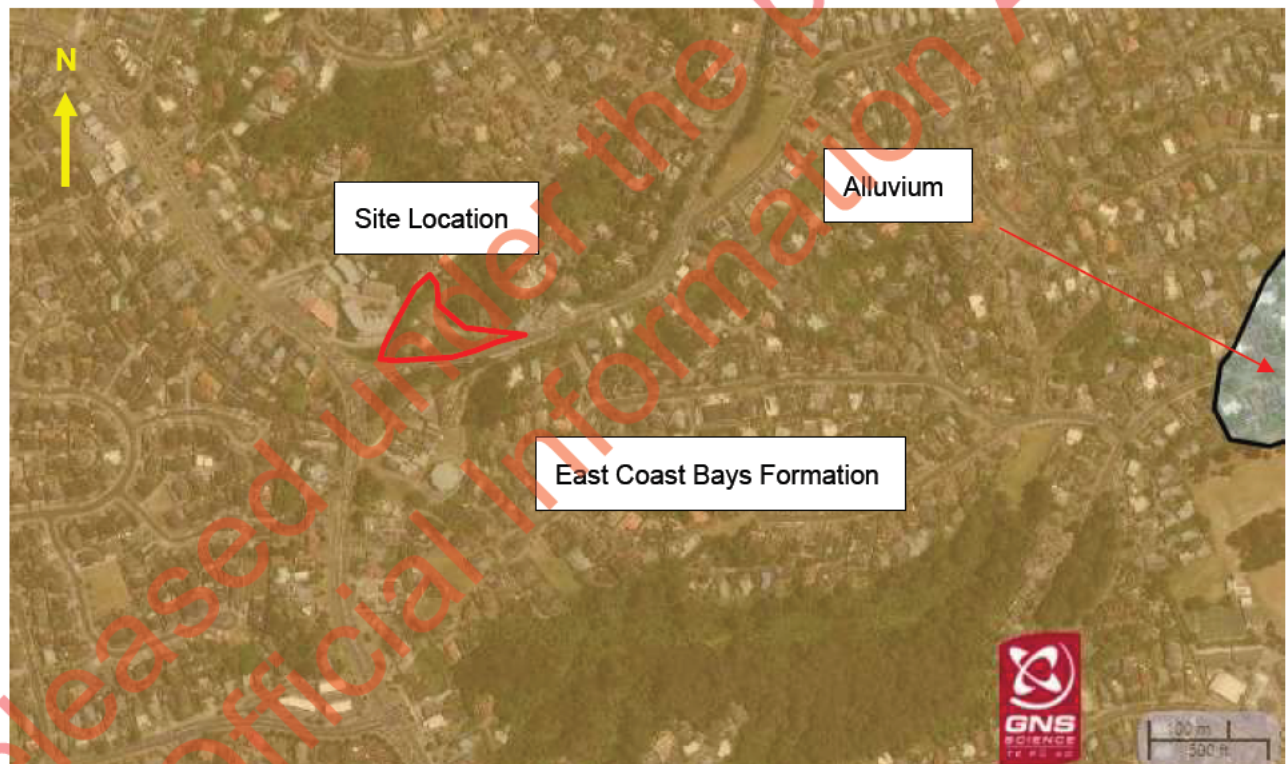
Published geological maps suggest that the site is underlain by East Coast Bays Formation alternating sandstone and siltstone (with variable volcanic content and interbedded pebble and boulder sized clasts). It is anticipated that the near surface material will be comprised of a residually weathered soil derived from the East Coast Bays Formation rock. Figure 2 below shows the geology in the area local to the site.

Figure 2 Geology map, Source: GNS Web Viewer

East Coast bays Formation (ECBF) deposits of Waitemata group are evident along much of the eastern coastline of the Auckland Area. Formed during the Early Miocene in the submarine fan and basin floor depositional environments and typically consists of thickly bedded sandstone and interbedded laminated mudstones/siltstones. Residual soils formed by weathering and alteration of the parent sedimentary formation typically form silts and clays or mixtures of the two depending on groundwater conditions, faulting and land gradients.
