## Due Diligence Geotechnical Investigation

224 Great South Road  
Remuera  
Auckland

Submitted to:  
Laura Fergusson Trust  
224 Great South Road  
Remuera  
Auckland 1546

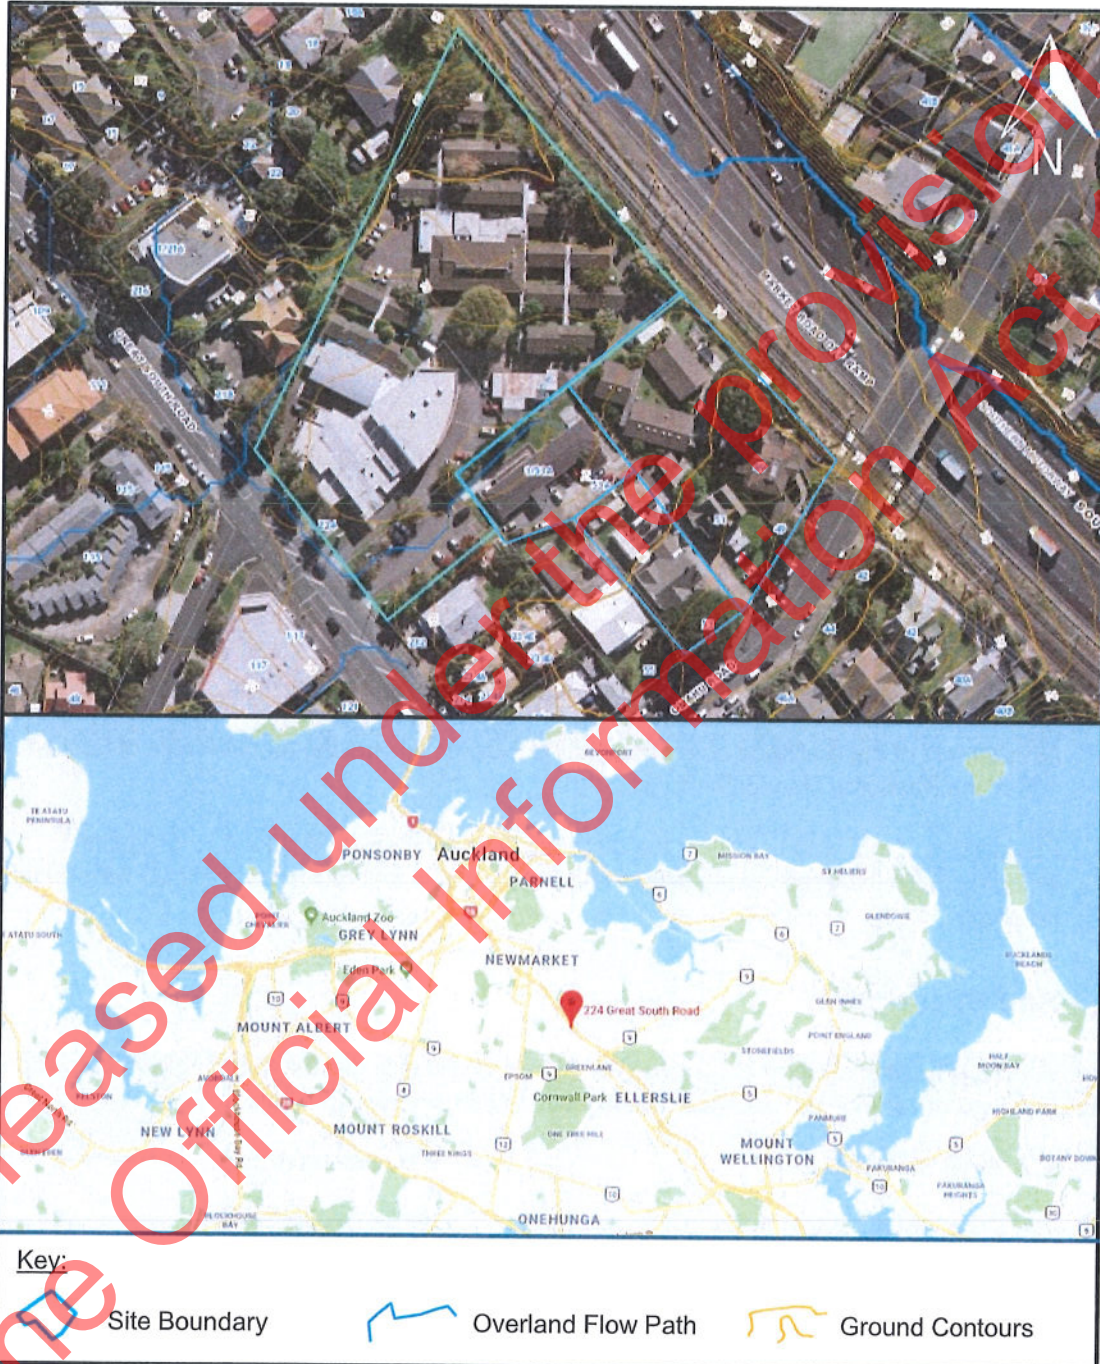
Figure 1: Site Location

Images sourced from Auckland Council GeoMaps and Google Maps. Not to scale.

The project site is located in Remuera-Greenlane, Auckland and includes the following land parcels as shown in Figure 1 and on the attached Investigation Location Plan (Appendix 1):

The site is bound by residential properties to the west, Great South Road to the south, Omaha Road to the east and the North Island Main Trunk Railway and Auckland-Hamilton (Southern) Motorway to the north. Based on our review of the Auckland Council GeoMaps, two isolated overland flow paths are mapped to be present within the site. These flow paths are shown on Figure 1.

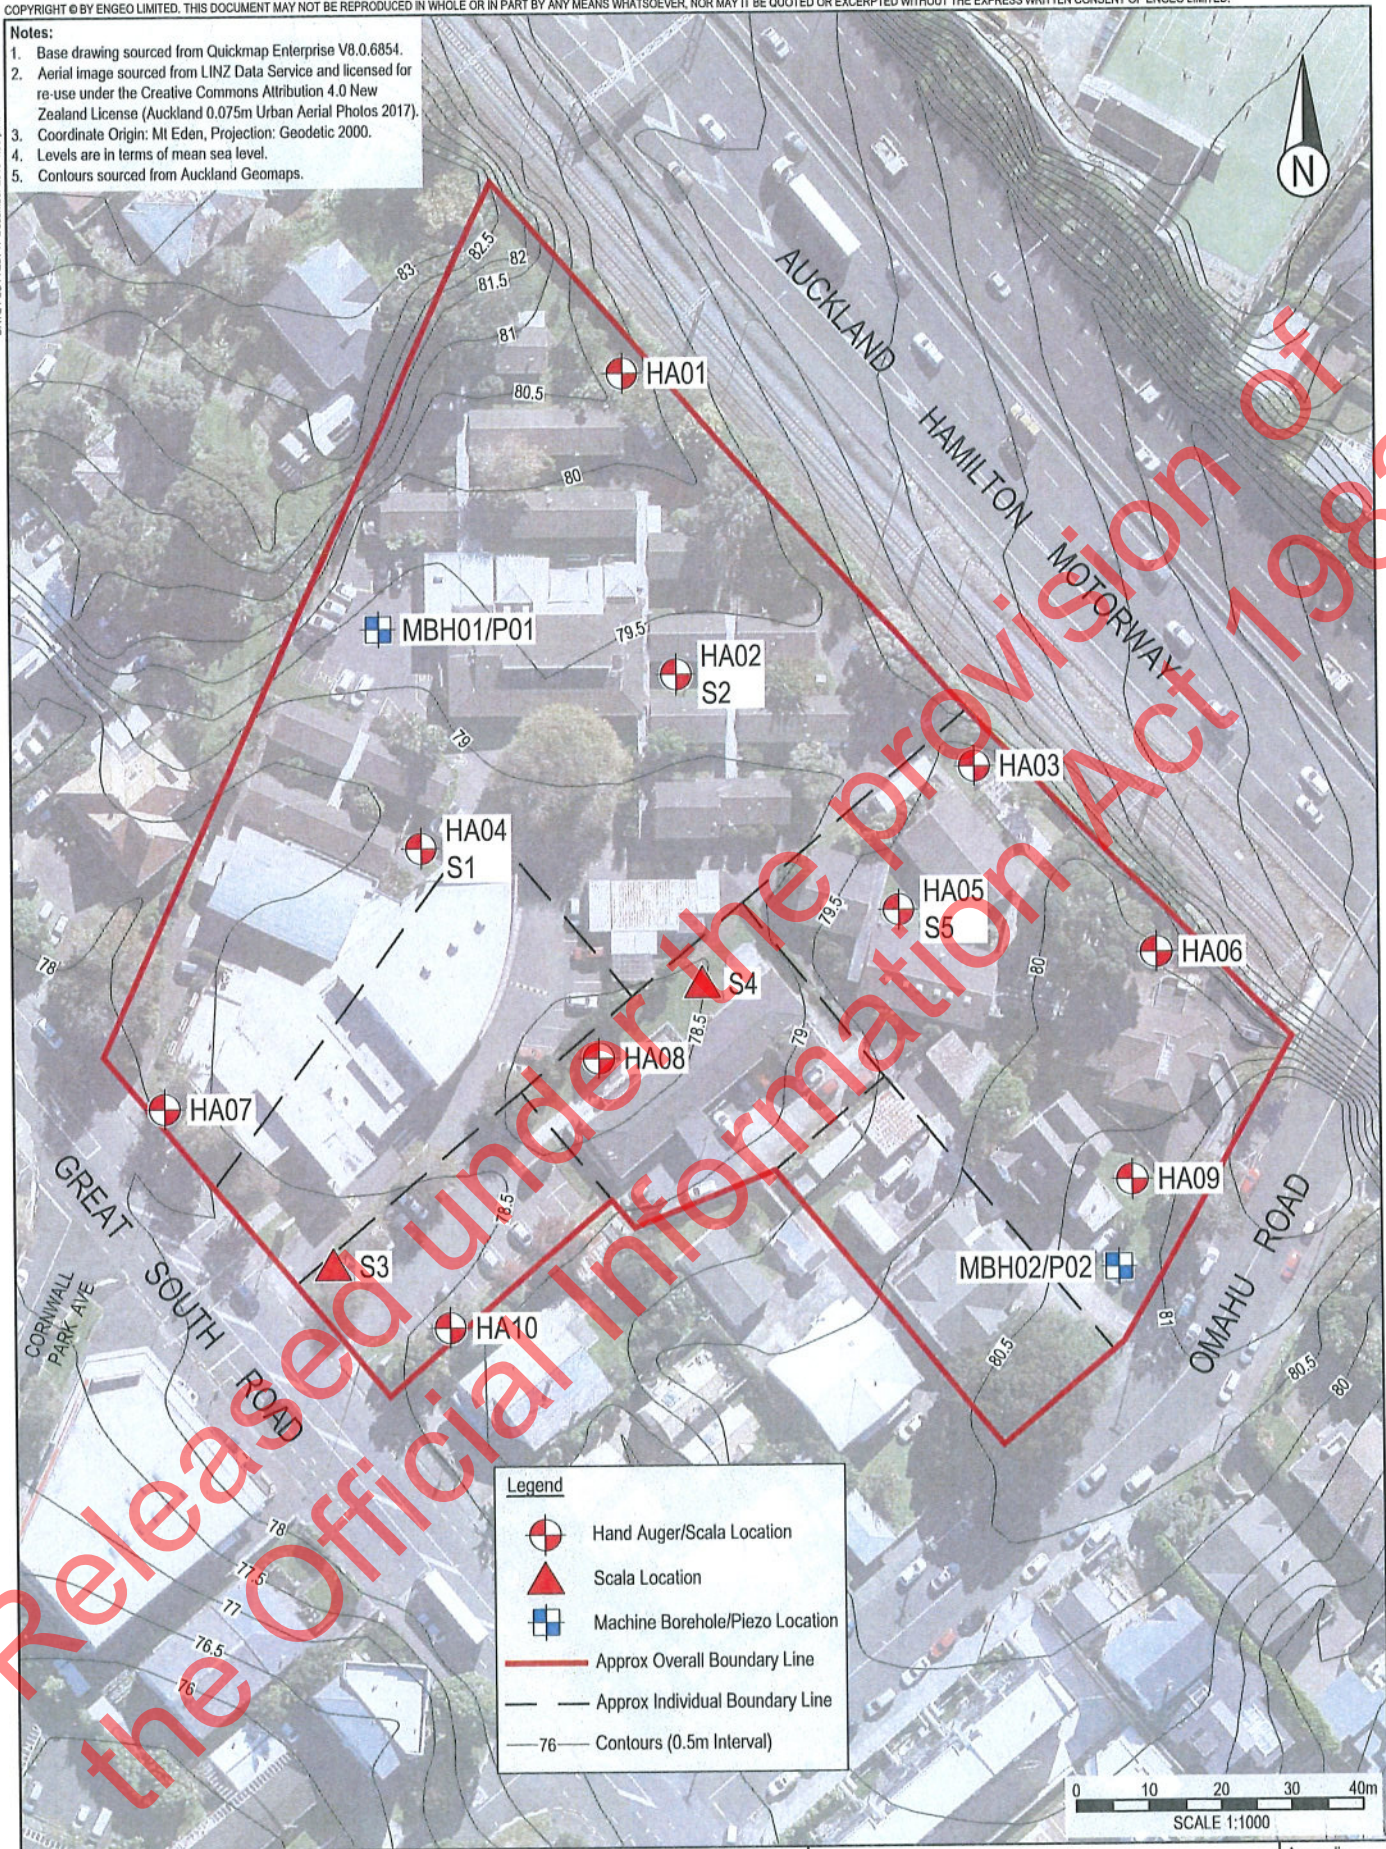
- Notes:**
1. Base drawing sourced from Quickmap Enterprise V8.0.6854.
  2. Aerial image sourced from LINZ Data Service and licensed for re-use under the Creative Commons Attribution 4.0 New Zealand License (Auckland 0.075m Urban Aerial Photos 2017).
  3. Coordinate Origin: MI Eden, Projection: Geodetic 2000.
  4. Levels are in terms of mean sea level.
  5. Contours sourced from Auckland Geomaps.

| <div><p>— Expect Excellence —</p><p><b>Auckland Office</b><br/>8 Greydene Place, Takapuna 0622, Auckland<br/>Tel: 09 972 2205, <a href="http://www.engeo.co.nz">www.engeo.co.nz</a></p></div> | <p>Title:</p> <p><b>INVESTIGATION<br/>LOCATION PLAN</b></p> | Client: Laura Ferguson Trust | | Appendix: | |
