Document Ref: AKL2021-0056AD Rev 1

**RE: GEOTECHNICAL EXPERT INPUT**

**1092 COATESVILLE-RIVERHEAD HIGHWAY, RIVERHEAD**

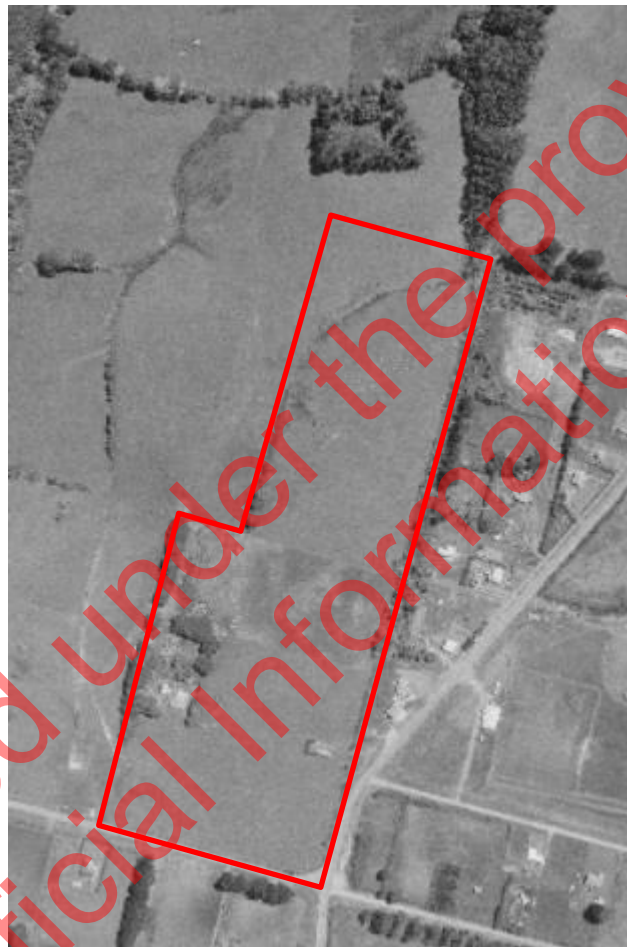
Historic aerial photography viewed on the Auckland GIS viewer<sup>1</sup> and from the Retrolens<sup>2</sup> website indicates the site was in pasture in 1940 with a shallow broad gully running generally south to north through the northern half of the site. This gully appears to originate abruptly within the site, and it is not certain if the gully head was filled in prior to available aerial photos records. The gully exits the site in the approximate location of the modern-day intersection of Queen Street and Cambridge Road. A small farmhouse and associated infrastructure was located near the south western corner of the site, accessed via Riverhead Road.

**Figure 1: 1957 Aerial photo with subject site outlined in red.**

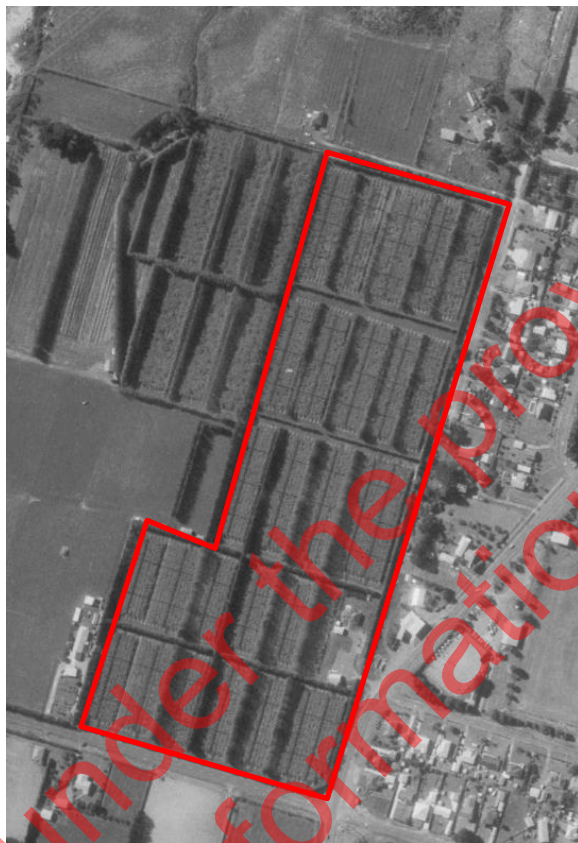
By 1988 the site had developed into how it is currently. The gully appears to have been filled in and a number of shelter belts have grown across the site. The current residential dwelling on the site was constructed between 1981 and 1988.

**Figure 2: 1988 Aerial photo with subject site outlined in red.**

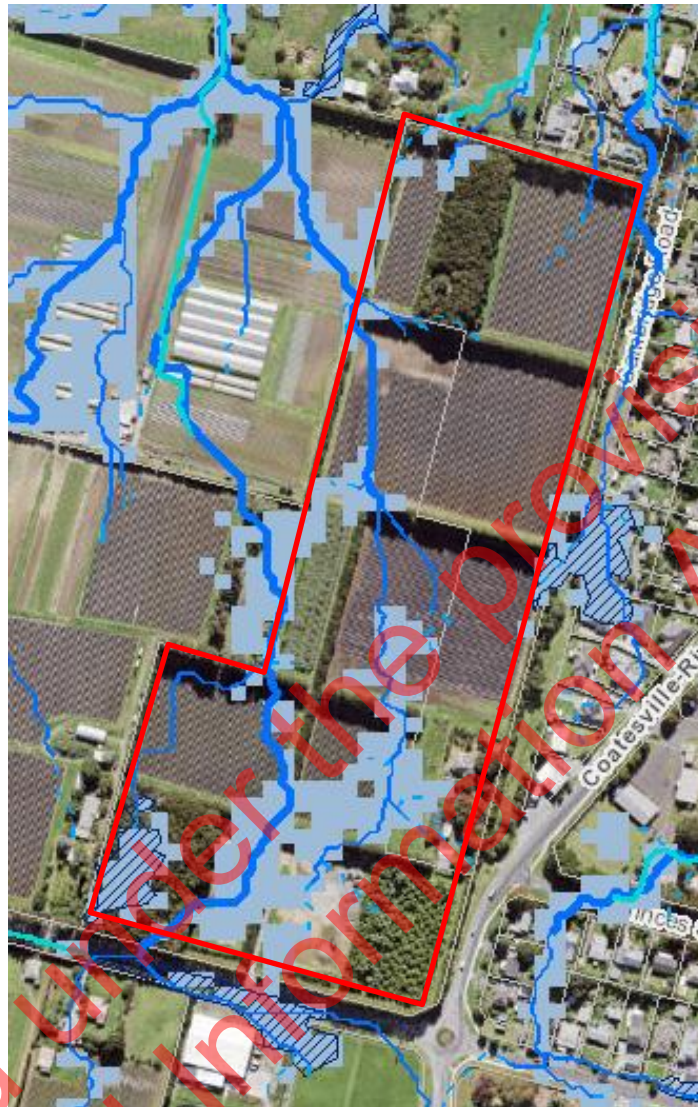
A review of the Auckland Council GIS shows a series of overland flow paths and flood plains are located across the site.

**Figure 3: Map showing Overland Flow Paths (Dark Blue) and Flood Plains (Light Blue) with subject site outlined in red. Source: Retrolens**

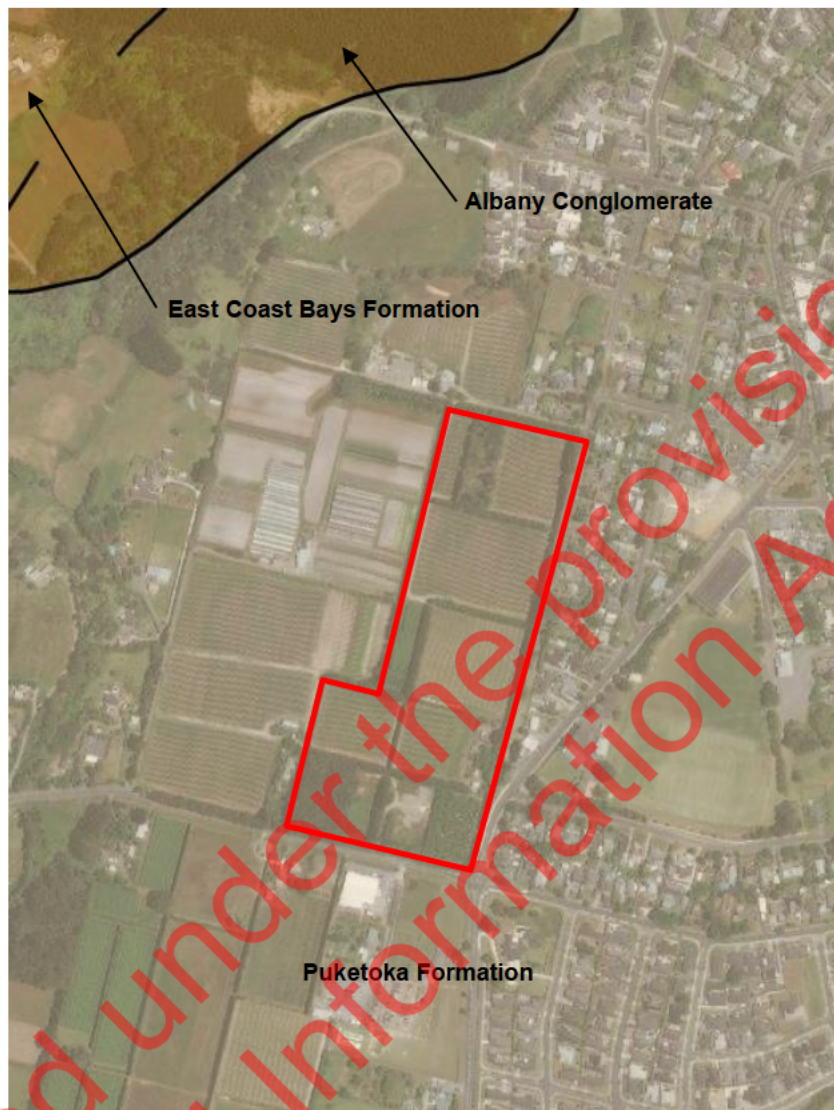
Published Geological Maps<sup>3</sup> suggest the site is underlain by alluvial deposits of Puketoka Formation (Tauranga Group) overlying alternating sandstone and siltstone (with variable volcanic content and interbedded pebbles and boulder sized clasts) of the East Coast Bays Formation and Albany Conglomerate (Waitemata Group)

**Figure 4: Geology map, site is highlighted in red. Source: GNS Web viewer**

Tauranga Group alluvial deposits comprise Pliocene aged, or later, deposits including silts, clays and sands with possible peat or organic rich clay soils, and carbonaceous deposits. Some volcanic deposits are also often encountered. Accordingly, these deposits can be quite varied in their properties and may include soft and /or organic layers or deposits of soils that are sensitive to disturbance.

East Coasts Bays Formation (ECBF) deposits of the Waitemata Group are evident along much of the eastern coastline of the Auckland area, formed during the Early Miocene in the submarine fan and basin floor depositional environments and typically consist of thickly bedded sandstone and interbedded laminated mudstones/siltstones. Residual soils formed by weathering and alteration of the parent sedimentary formation typically form silts and clays or mixtures of the two depending on groundwater conditions, faulting and land gradients

Albany Conglomerate of the Waitemata Group is similar to the ECBF but consists of thick bedded sandstone and interbedded laminated mudstones/siltstone with dioritic and andesitic pebble to boulder sized clasts.

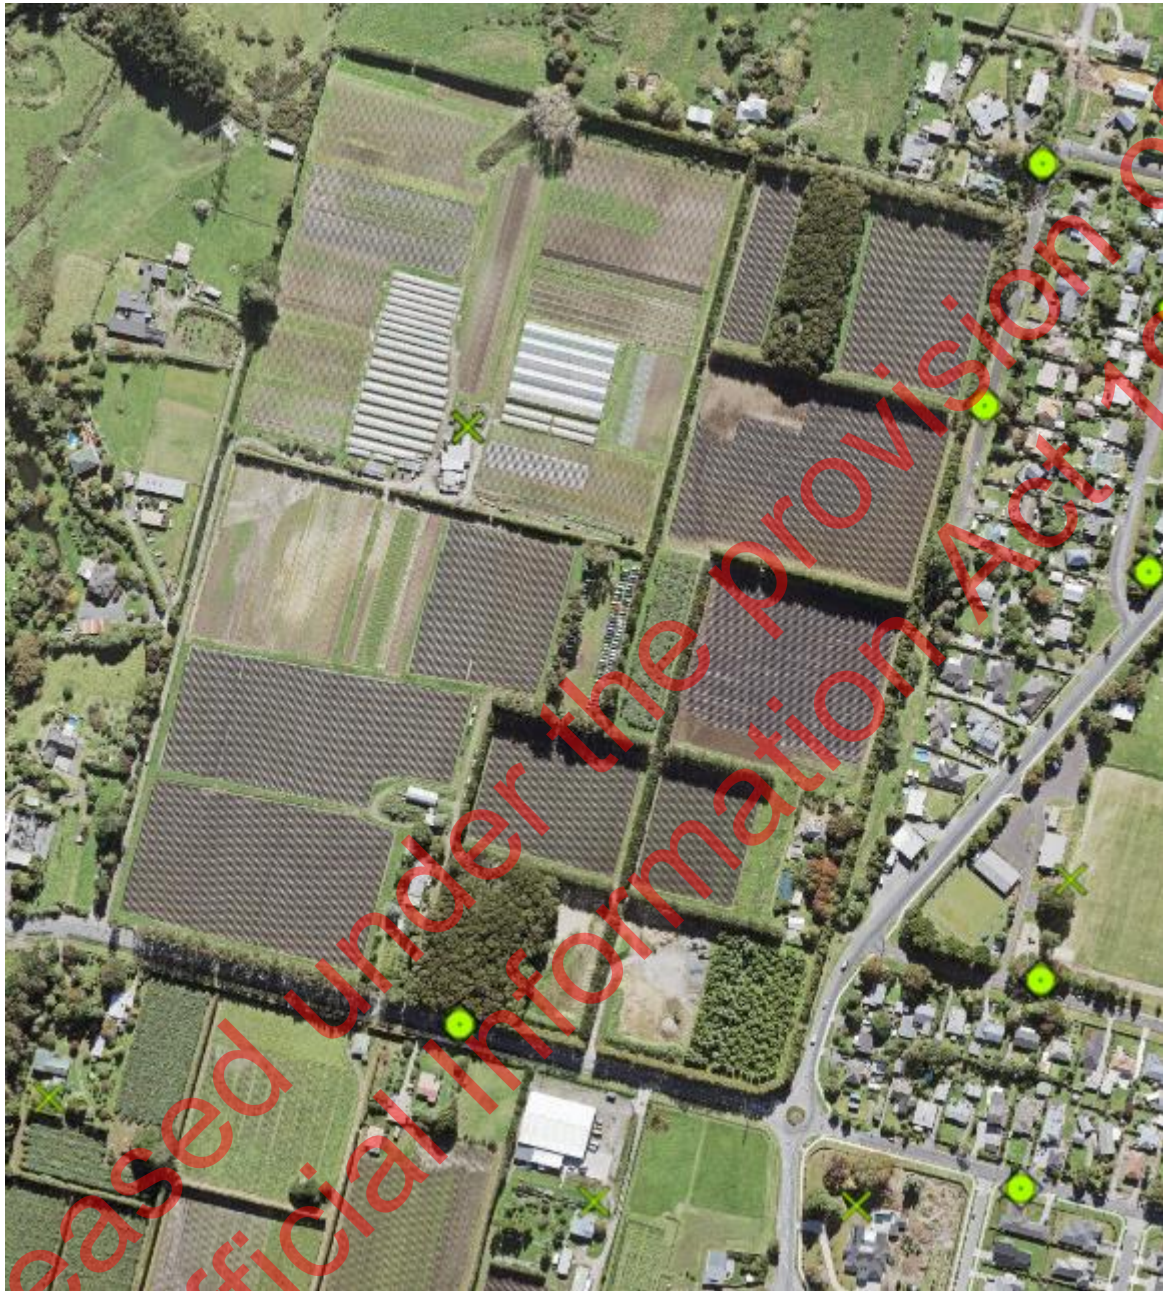
Figure 5: Map of existing geological information. Source: NZGD Web Viewer

A search of the New Zealand Geotechnical Database<sup>4</sup> (NZGD) was undertaken to gather nearby existing ground information. No existing information was located within the subject site.

Three groundwater bore drillers logs are located approximately 100m to the south, east and west of the subject site. The western borehole, located within the neighbouring horticultural property, logged clays to 2m depth, above fine sands to 3m depth. Alternating sandstone and mudstone was logged from 3m to the base of the borehole at 217m. The eastern borehole, located near the Riverhead Bowling Club, logged a mixture of brown and grey silts and clays to 19m depth. Alternating sandstone and mudstone was logged from 19m to the base of the borehole at 252m. No indications of soil or rock strength were included in the logs. The southern borehole, located south of the Zaberri World warehouse, logged clays with 'timber' inclusions to 7m depth. Mudstone and sandstone was logged from 7m to 21m. Hard sandstone with some gravels was logged to the base of the borehole at 303m. It is not certain if the 'timber' encountered was natural wood associated with alluvial deposits or manmade timber associated with uncertified filling.

A number of other groundwater bore drillers logs are located around the subject site, and these follow the general trend of the depth to rock increasing towards the east.
