# ECOLOGICAL ASSESSMENT Whirinaki Drain Whirinaki

PROJECT NO. EAM2282 REP- 01

EVANS FAMILY TRUST

MAY 2022

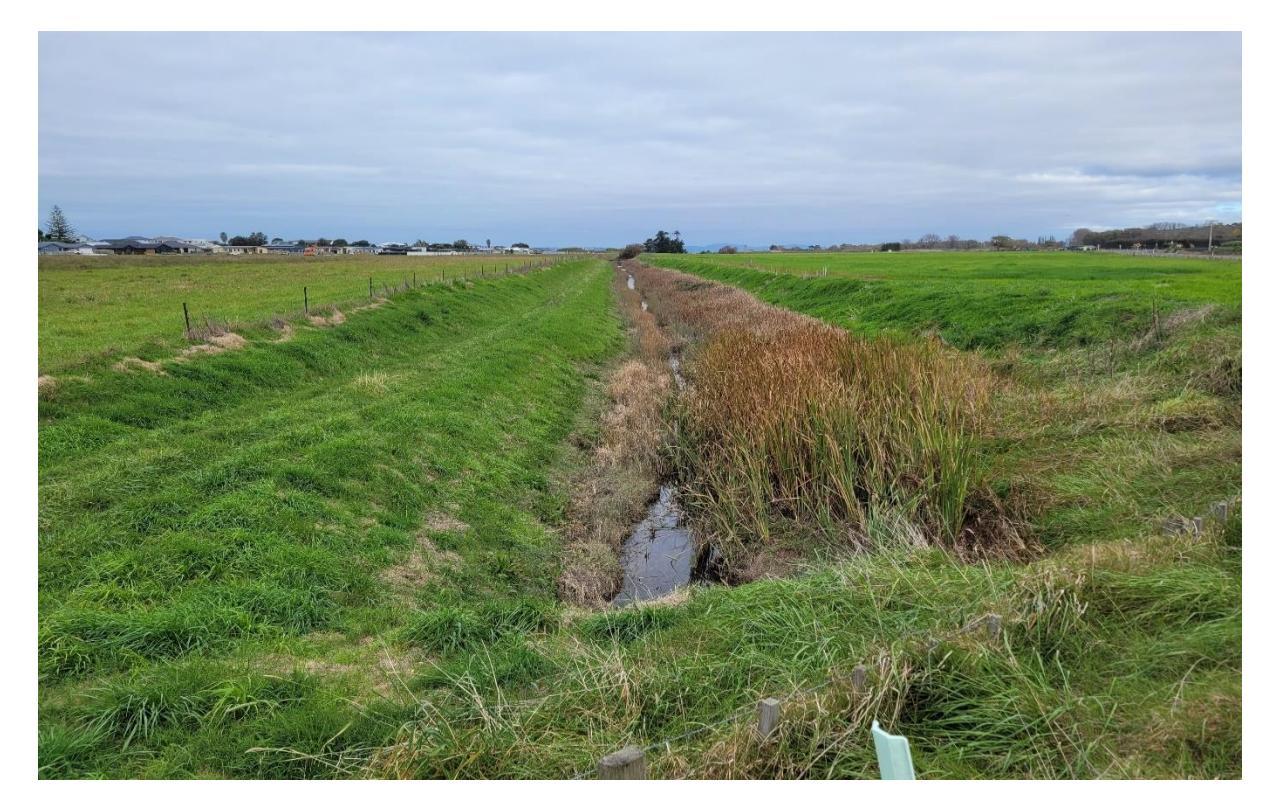
View downstream from the SH2 culvert. Raupo in the foreground true right is replaced by more salt tolerant species after approximately 20m

No woody indigenous species of not were recorded at the site. The sedges and rushes such as *Bolboschoenus medianus*, *Schoenoplectus pungens* and, *Schoenoplectus tabernaemontani* where they are free from mechanical control extend into the wetted margin along the length of the reach giving away to Raupo, *Typha orientalis* where the saltwater influence is reduced. This is approximately 20m downstream of where the reach passes into the culvert beneath SH2

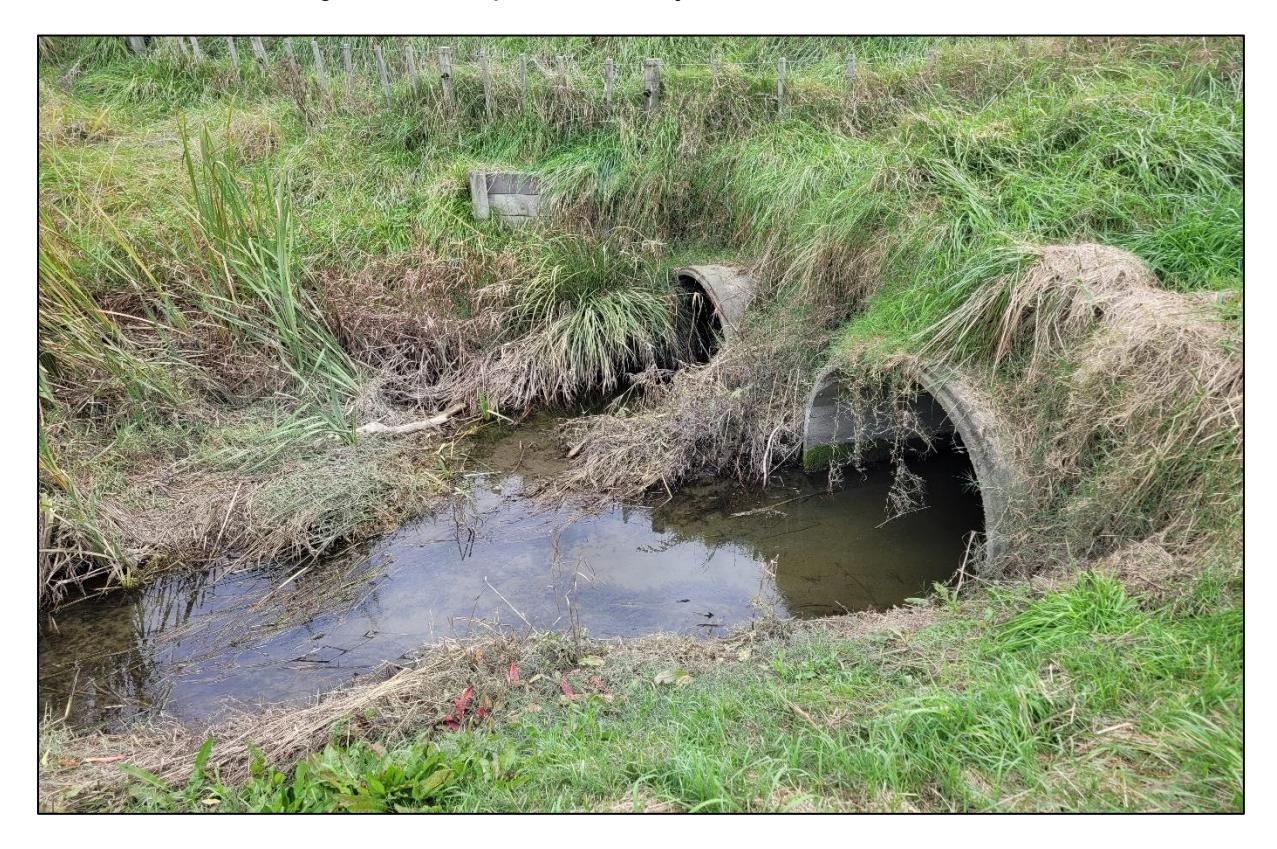
SH2 culvert and small growth of Raupo. This is likely to be the limit of the tidal influence

There is evidence of tidal influence to almost the SH2 culvert but a pair of ford/weir type structures much closer to the coast limit the movement of estuarine fauna in and out of this reach. This in combination with the frequently closed Esk River mouth restrict the drain's value as part of the estuarine system.

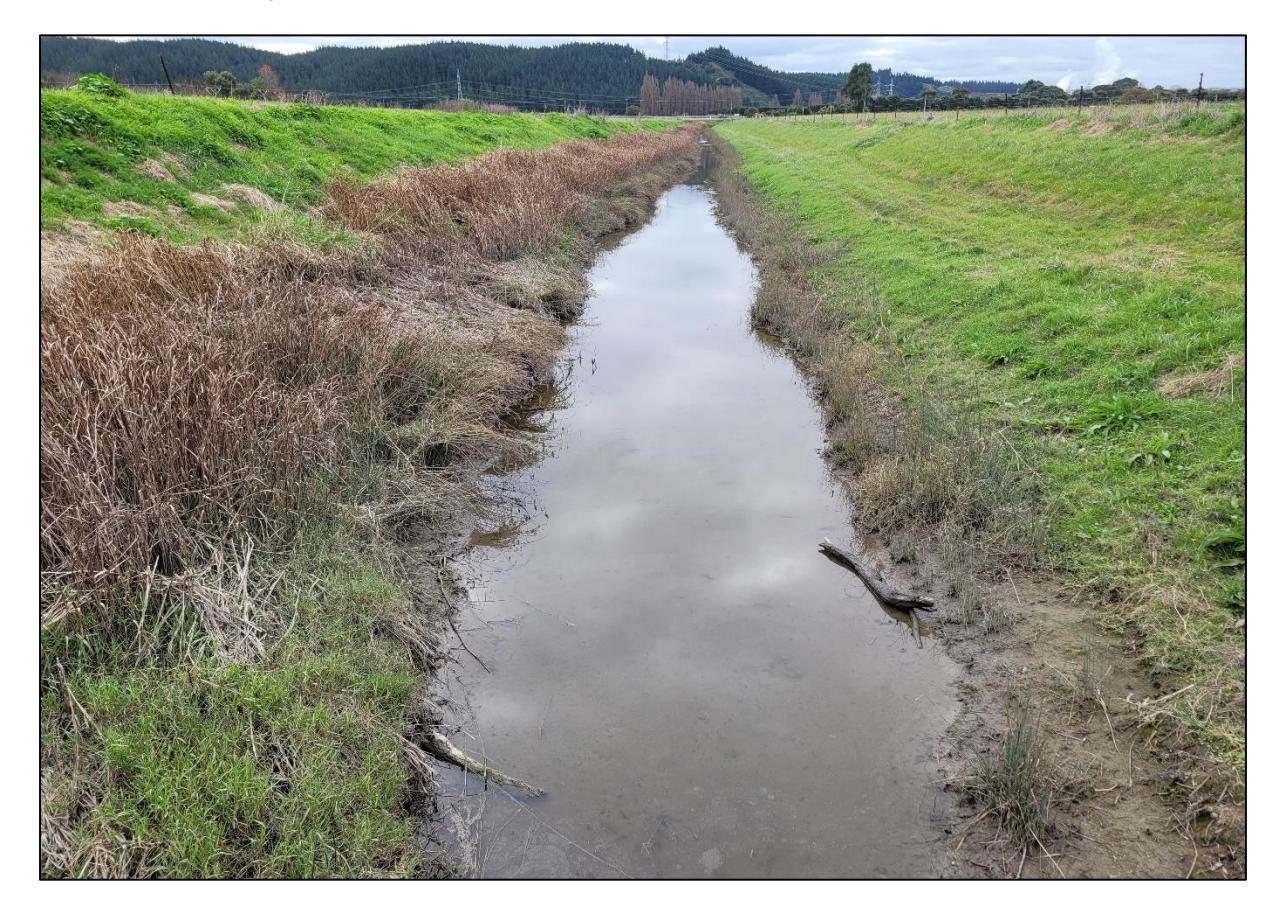
Upstream of the farm bridge the channel is wider with low velocity flows, filled with fine sediments and very little habitat provision

The Whirinaki Drain throughout the site has very poor levels of shade, and minimal overhanging vegetation. It has very low bed and bank roughness providing a minimal range of habitat for aquatic fauna. Terrestrial inputs such as leaves and branches providing both food and cover for the instream life are generally absent. The reach through the site was notable for only one Willow tree extending over the water from the true right bank which provided some habitat through cavities from the root-mat extending across the bed. with a generally uniform bed of soft muds and silts.

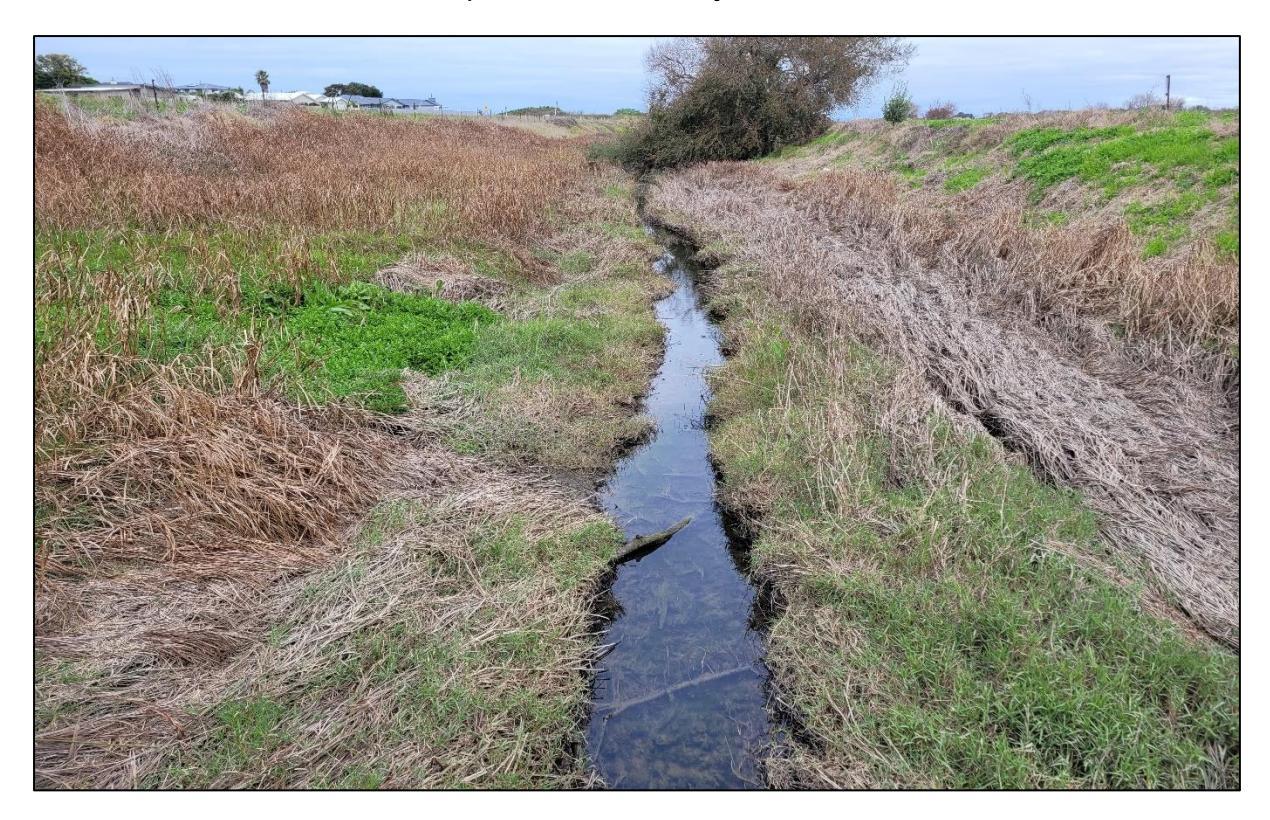
The drain narrows beneath the farm bridge. The increased velocity has flushed some of the fine sediments from this section and exposed coarse woody debris and cobbles.

Where the drain is constrained downstream of the farm bridge the flow is more concentrated a narrowed channel which has increased the velocity of the flow. This increase in velocity has removed much of the fine sediment and enhanced the bed roughness through exposure of coarse woody debris and cobbles. This has improved the instream habitat through this section in contrast the rest of the survey reach

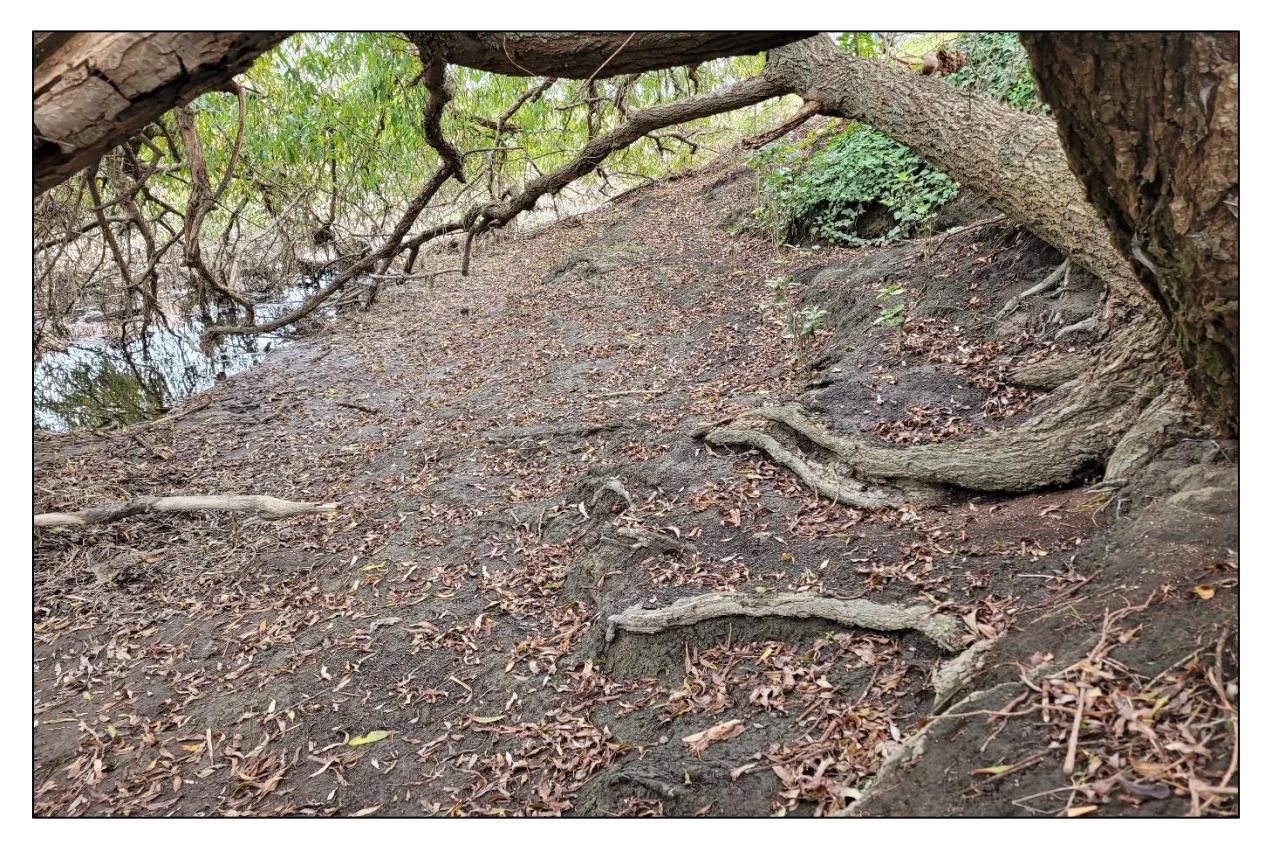
Good riparian cover on the true right of Whirinaki Drain from the lone willow providing shading and instream habitat.

A large Willow *Salix fragilis* is present on the true right of the drain and extends across the entire channel. This is the last remaining tree of several which have been cleared from the drain for the purpose of flood management. The tree is providing habitat for birds as a perch for drinking and roosting. The understory out of the flood zone consists of a variety of indigenous and introduced plant species. Taupata *Coprosma repens*, is common under this tree but unfortunately it is competing with Ivy *Hedera helix* and Chinese Windmill palms *Trachycarpus fortunei* which have also established along with other garden escapees.

Although no specific fish survey was undertaken, no traps were set, or spotlighting or efishing undertaken, the survey reach is largely an area of very poor-quality fish habitat. However, where the large willow provided cover a medium-large eel, visually identified as a longfin eel (*Anguilla dieffenbachii*), was seen utilising the cavities presented by the root mat. It is possible that more eels are in this small section as well as possibly utilising the interstitial spaces of the ford/weir structures. There is also likely to be fish utilising the section between the farm bridge and the willow tree as well due to the bed diversity and cover in the section.

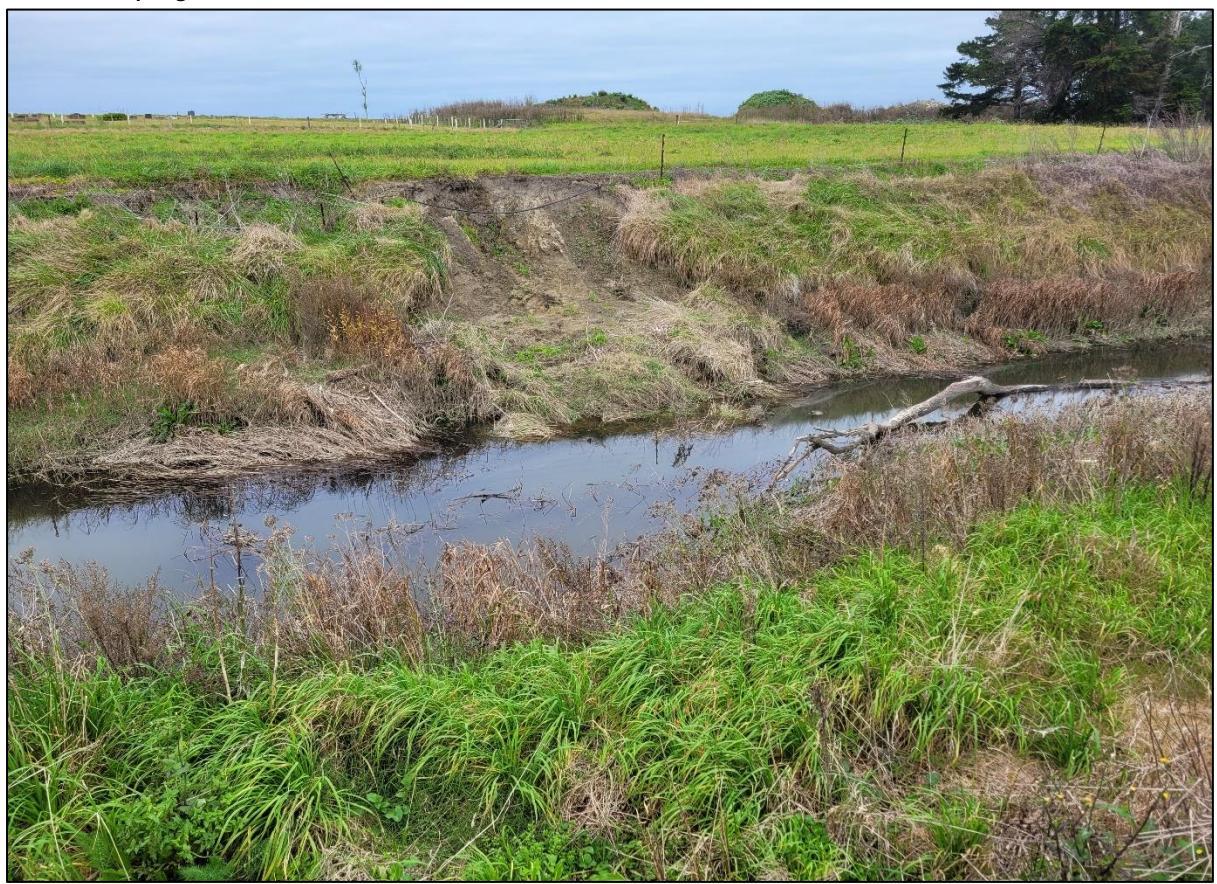
Bank slumping on the true left of the Whirinaki Drain.

The site currently supports very large trees surrounding the Nukurangi Pa archaeological site at the drains discharge location into the Esk estuary, so the restoration recommendation has good potential to succeed based on the health these trees. Forested banks should aid in the management of the currently eroding banks and provide some terrestrial biodiversity values currently lacking. Once established the ford/weir structures which were in part installed to reduce the scour of the bed and banks could be progressively removed as these establish which will improve connectivity especially in relation to the migratory galaxiid species.

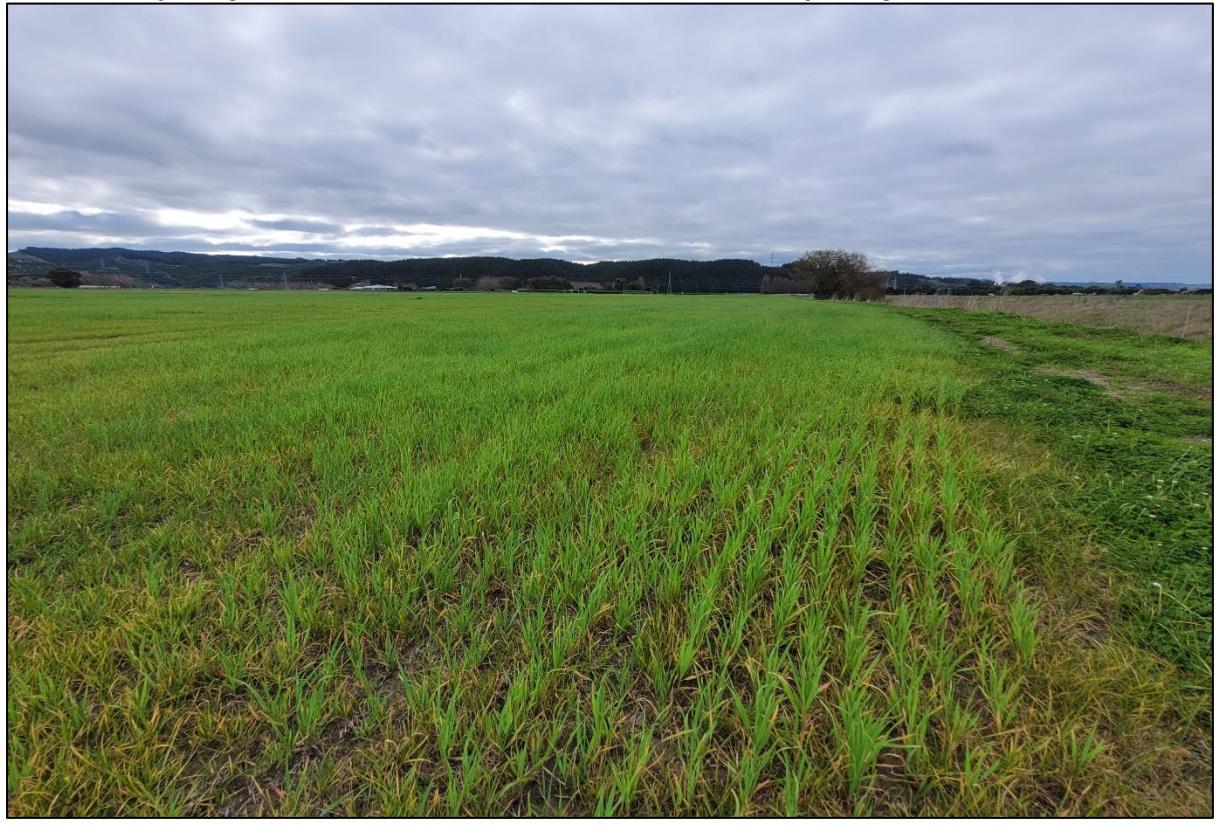
Landuse adjoining the Whirinaki Drain. Note the lack of any indigenous terrestrial habitat

The wider site had no native vegetation reflecting its long history of agricultural use firstly to pasture and more latterly as a cropped area.

There are no evident terrestrial ecological values in the land directly adjoining the Whirinaki Drain due its long-term agricultural use.

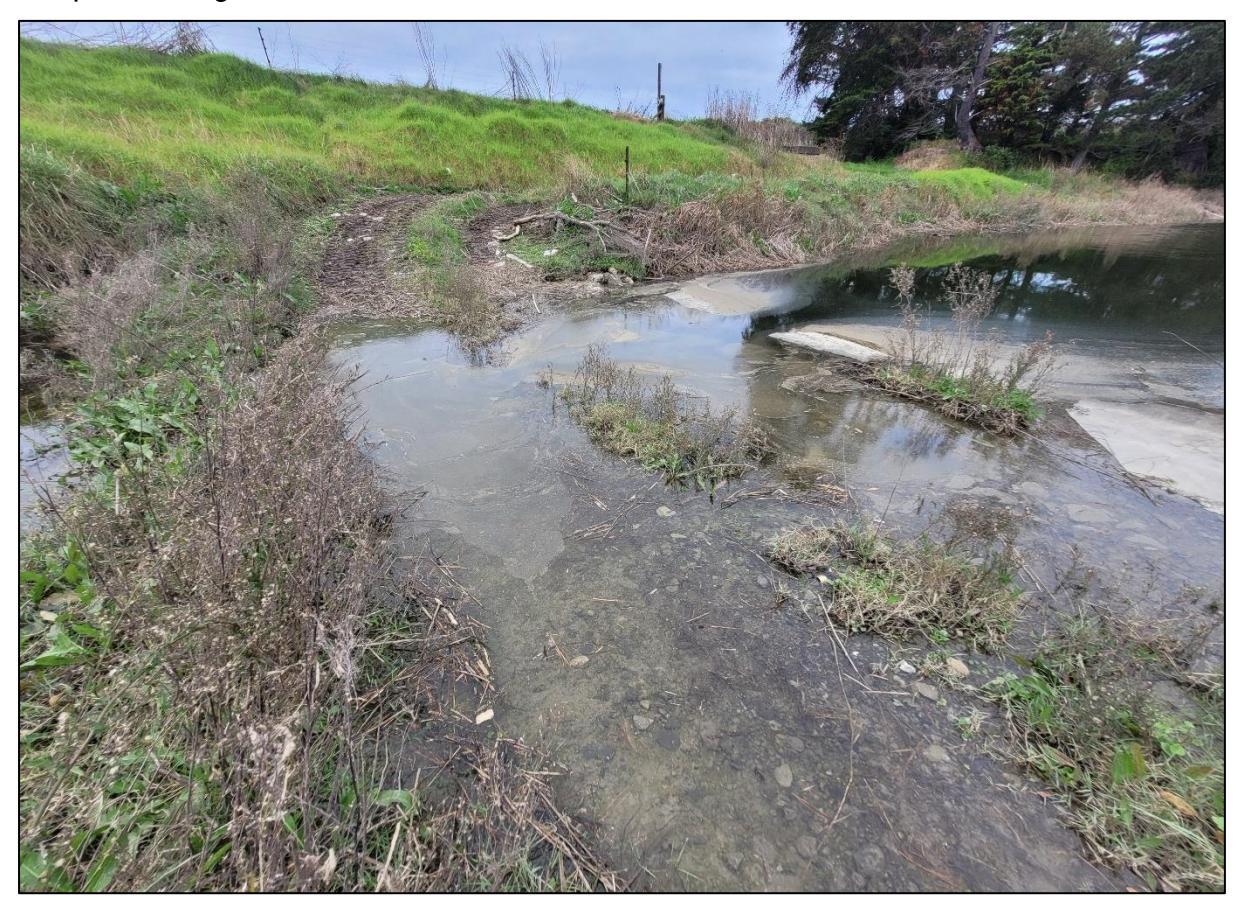
Lower Weir/Ford at full tide. Note the shallow depth of water providing a small window of access for upstream migration

It was not known how significant a barrier the two ford/weir structures are to other species, but the lower ford/weir was observed at the peak of the smallest high tide for the month. During this time there was approximately 0.10 m of depth over the structure. This would be sufficient depth for migratory galaxiids to access the upper reaches of the stream as the culvert beneath SH@ does not present a barrier.

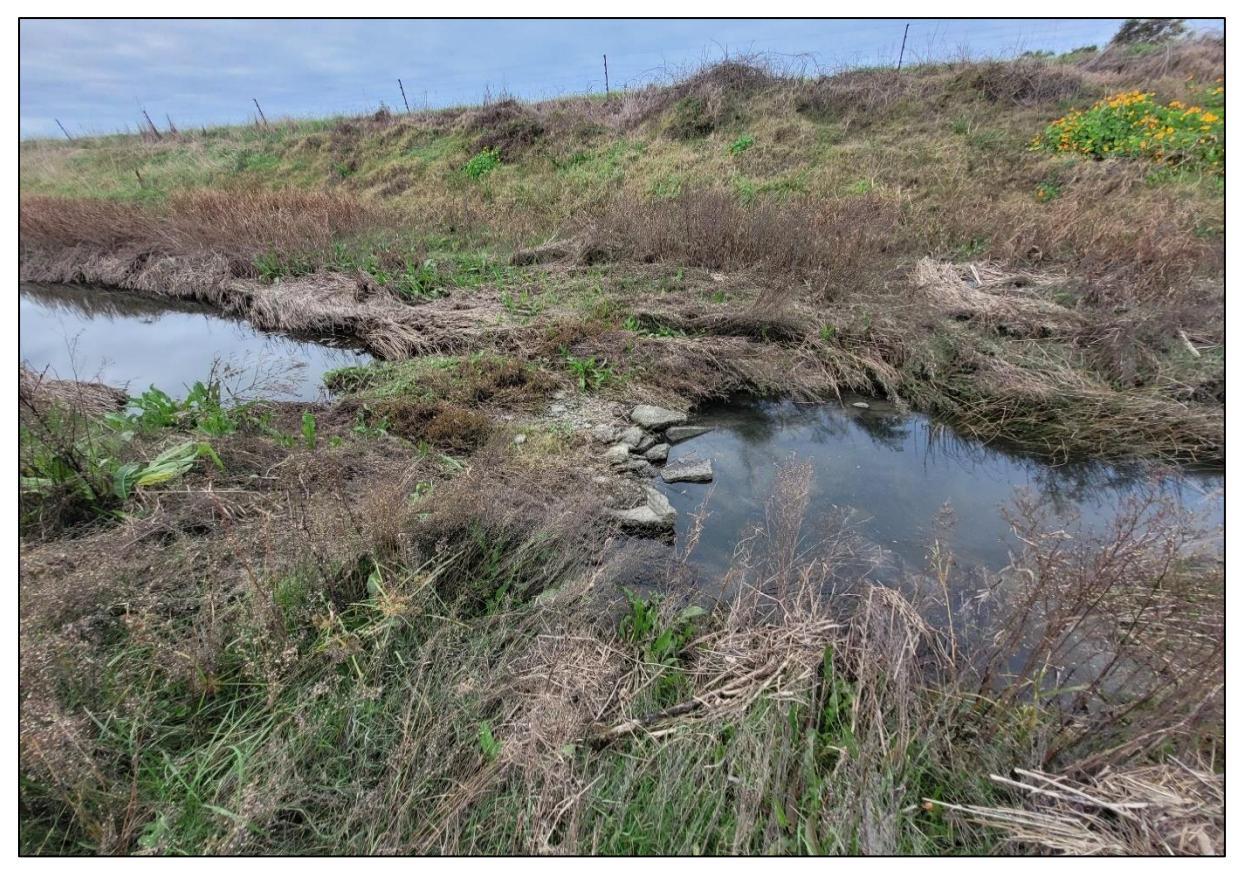
The upper Weir/Ford just prior to high tide. Water is moving through the interstitial space but not over this structure

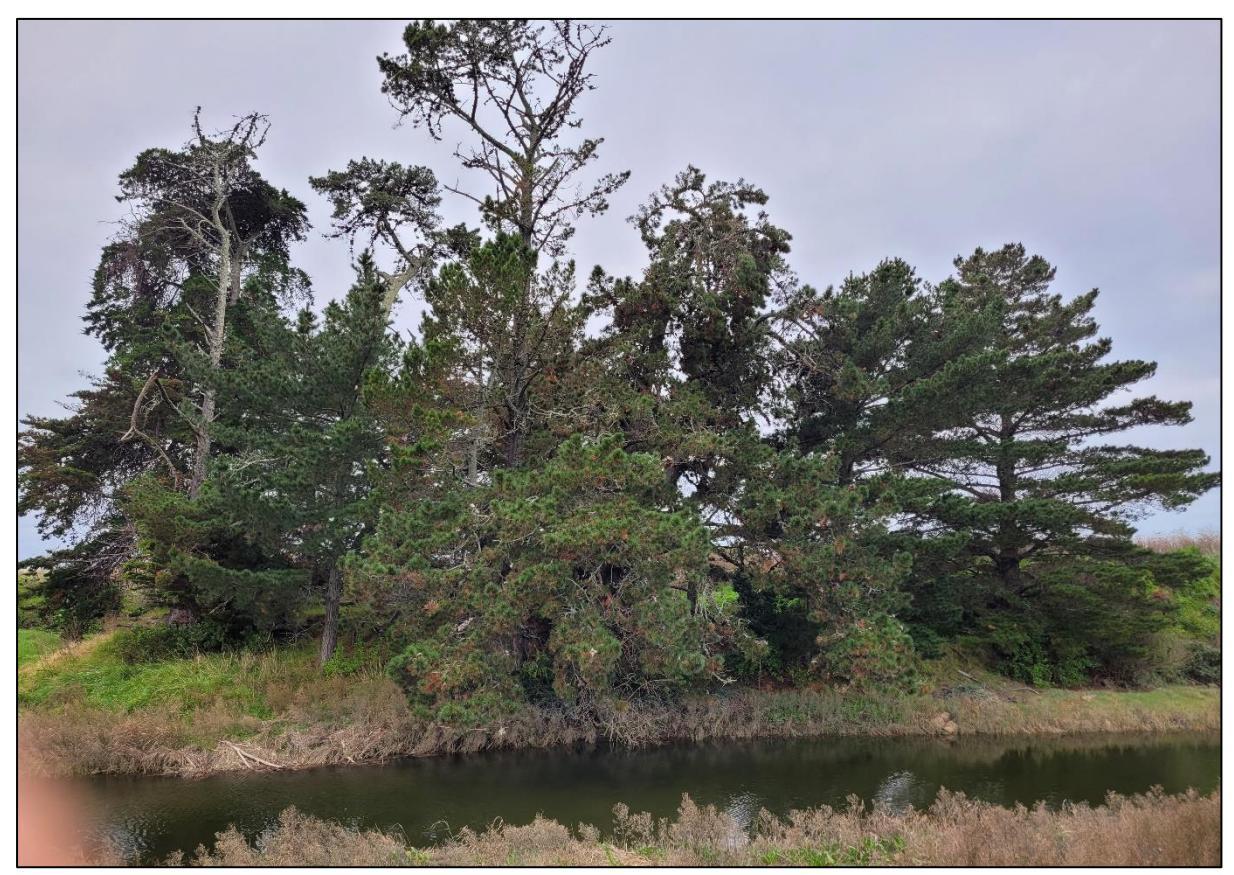
Large exotic trees at the Nukurangi Pa Archaelogical site. Pine and Macrocarpa
