# ASSESSMENT OF ECOLOGICAL EFFECTS FOR THE PROPOSED SUBDIVISION FOR TRADING CORPORATE LIMITED

A Report Prepared for Trading Corporate Ltd

## Poynter & Associates Environmental Ltd

Report prepared June 2007

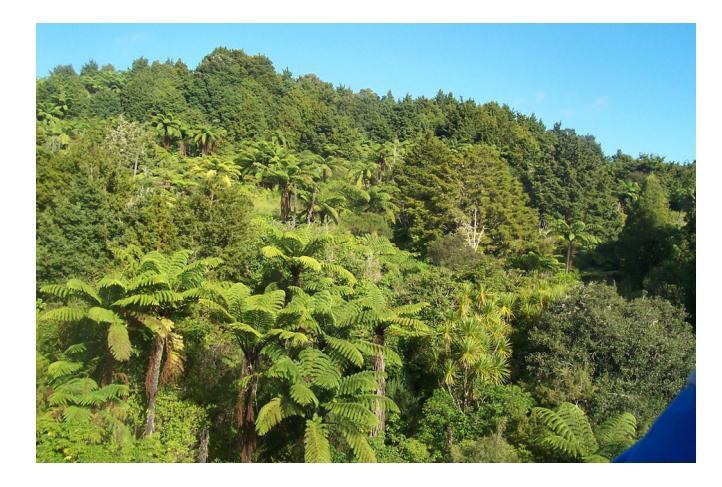
<u>**Photo 1**</u> – Vegetation in Area 1 (western catchment)

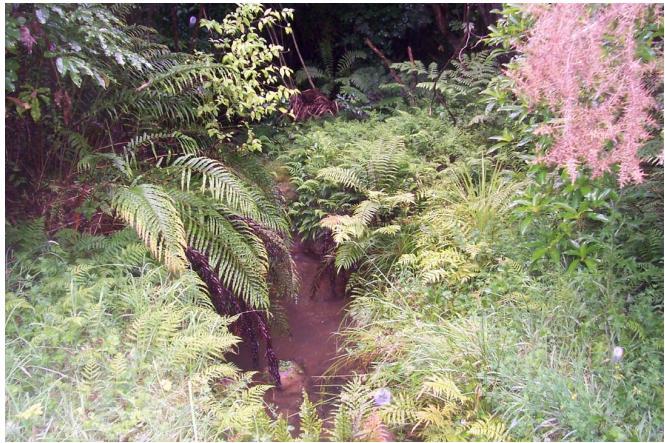
<u>Photo 2</u> – Stream at Site 3 in western catchment.

16% of the sample comprised sensitive EPT taxa. This included 1 Ephemeropteran (*Zephlebia*) and 2 Trichopeterans (*Polyplectropus, Triplectides*). All these taxa were present in good numbers and are indicative of moderate to good water quality conditions in softbottomed streams.

The MCI-sb score of 93 is indicative of probable moderate pollution or environmental perturbation. This is in line with the results of the physical habitat assessment that observed some limitations on riparian vegetation and some evidence of eutrophication and sedimentation.

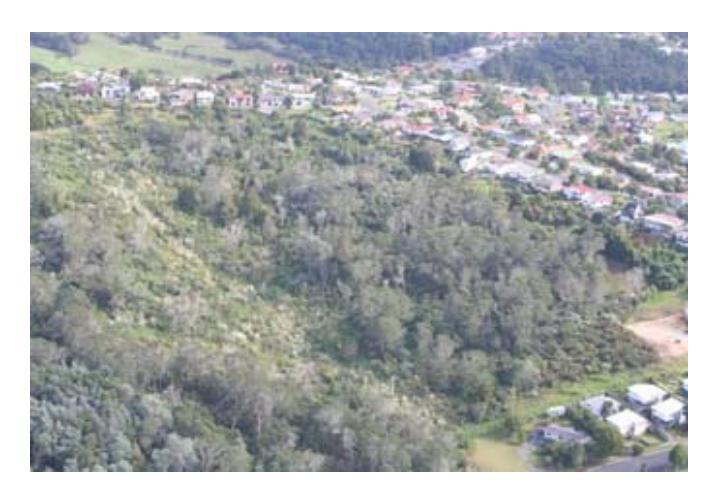
<u>**Photo 3**</u> – Weed field in northern gully, eastern catchment. Proposed soil disposal area.

Clearance for the proposed soil disposal area in the northern gully is unlikely to cause significant botanical or habitat loss due to the highly disturbed vegetation here.

The stream that passes through the proposed soil disposal area of the northern gully is an intermittently flowing watercourse/wetland in the upper part of the gully and a perennial watercourse / weed wetland in the lower gully. The degraded nature of this stream is such that there will be limited loss of quality freshwater habitat if a section of the stream is piped or diverted to allow for a soil disposal area. There will be no significant loss of fish passage because the intermittent flow and lack of continuous channel already limits connectivity. The downstream receiving environment of this tributary is also low quality or piped. If the disposal areas are constructed, stabilised and managed to avoid sedimentation, then any downstream effects should be minor.

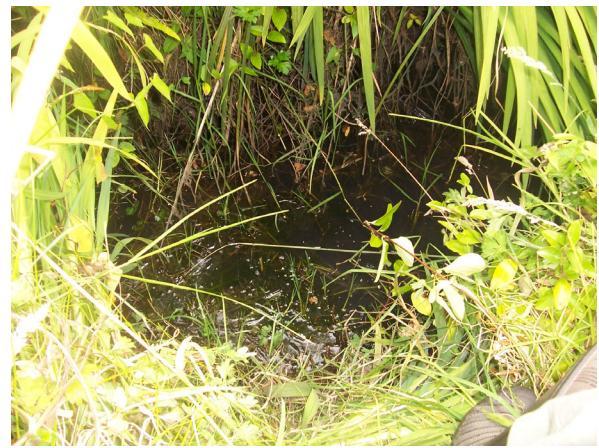
<u>**Photo 4**</u> – Stream Site 1, northern gully, eastern catchment.

The macroinvertebrate community at Site 1 has a relatively low level of taxonomic richness with a total of 12 different taxa recorded. The sample was dominated by a super abundance of freshwater snails (*Potamopyrgus*). Other abundant taxa include waterbugs (*Microvelia*), seed shrimp (Ostracoda) and pea shell mollusc (Sphaeriidae). Worms (Oligochaeta), amphipods and damselfly (*Xanthocnemis*) were all common in the sample. All these species are moderate to low sensitivity taxa when found within soft-bottomed streams.

Only 8% of the sample comprised sensitive EPT taxa and this was attributed to the presence of the Trichopteran, *Triplectides.* This result suggests that instream habitat and/or water quality conditions are poor.

The fish traps set at Site 1 did not return any fish, but one mosquito fish was found in the macroinvertebrate sample. Freshwater shrimp were common. The lack of fish could be attributed to a number of causal factors. It is quite likely that there is a blockage to fish passage in the downstream environment since a large section of the stream is piped under the housing of Hedley Place and Fairburn Street and again under SH1 and to the confluence with the southern tributary beyond.

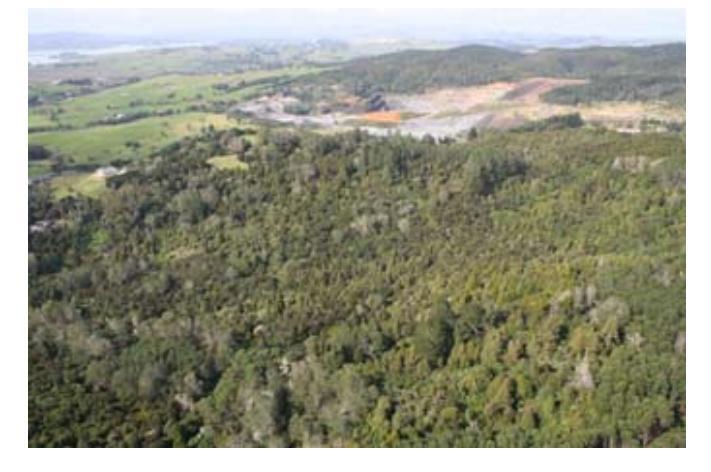
<u>Photo 5</u> – Southern gully, eastern catchment. Part of this area is a proposed reserve.

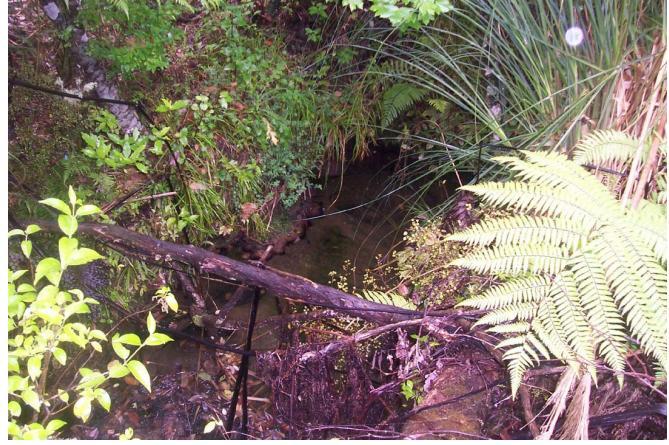
<u>**Photo 6**</u> – Stream Site 2, southern gully, eastern catchment.

The macroinvertebrate community at Site 2 recorded a low level of taxonomic richness with a total of 11 different taxa recorded. Freshwater snails (*Potamopyrgus*) dominated the sample but the mayfly (*Zephlebia*) and amphipods were also abundant. Freshwater shrimp (*Paratya*) and freshwater crayfish (*Parenophrops*) were also common. These taxa have moderate to high levels of sensitivity when found within soft-bottomed streams. A range of other taxa including damselfly, waterbugs, case-less caddisfly, beetles and true flies were also present but in low numbers.

18 % of the sample comprised sensitive EPT taxa. This included the Ephemeropteran larvae (*Zephlebia*) and one Trichopteran larvae (*Polyplectropus*). The presence of these taxa suggests reasonable water quality conditions.

The fish traps set at Site 2 did not return any fish. However, freshwater shrimp were common and two koura were recorded. The koura were medium sized (75mm) and were found in the deeper pools of the sampled section.

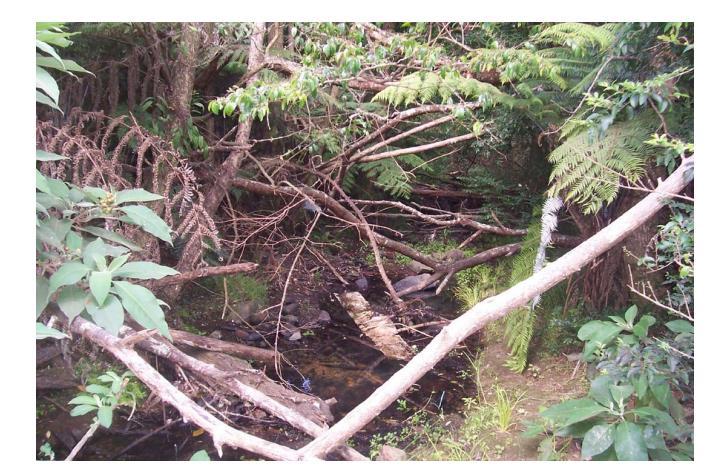
<u>Photo 7</u> – Downstream receiving environment leading to Limeburners Creek.

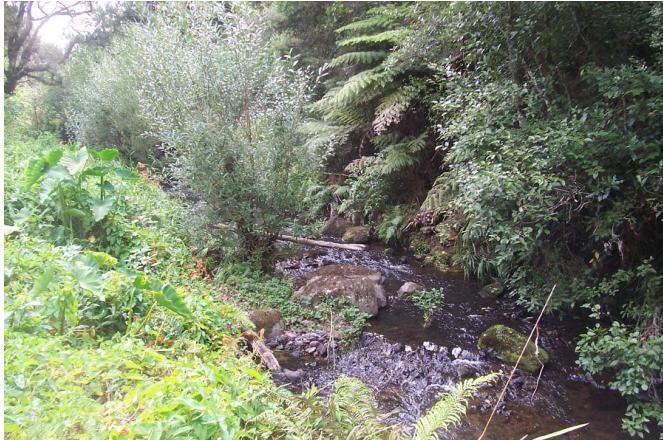
<u>Photo 8</u> – Downstream receiving environment of Raumanga Stream.
