Ecological Impact Assessment – Solar Farm at Upper Kina Road

Report

Prepared for Energy Farms Ltd Prepared by Beca Limited

8 June 2022

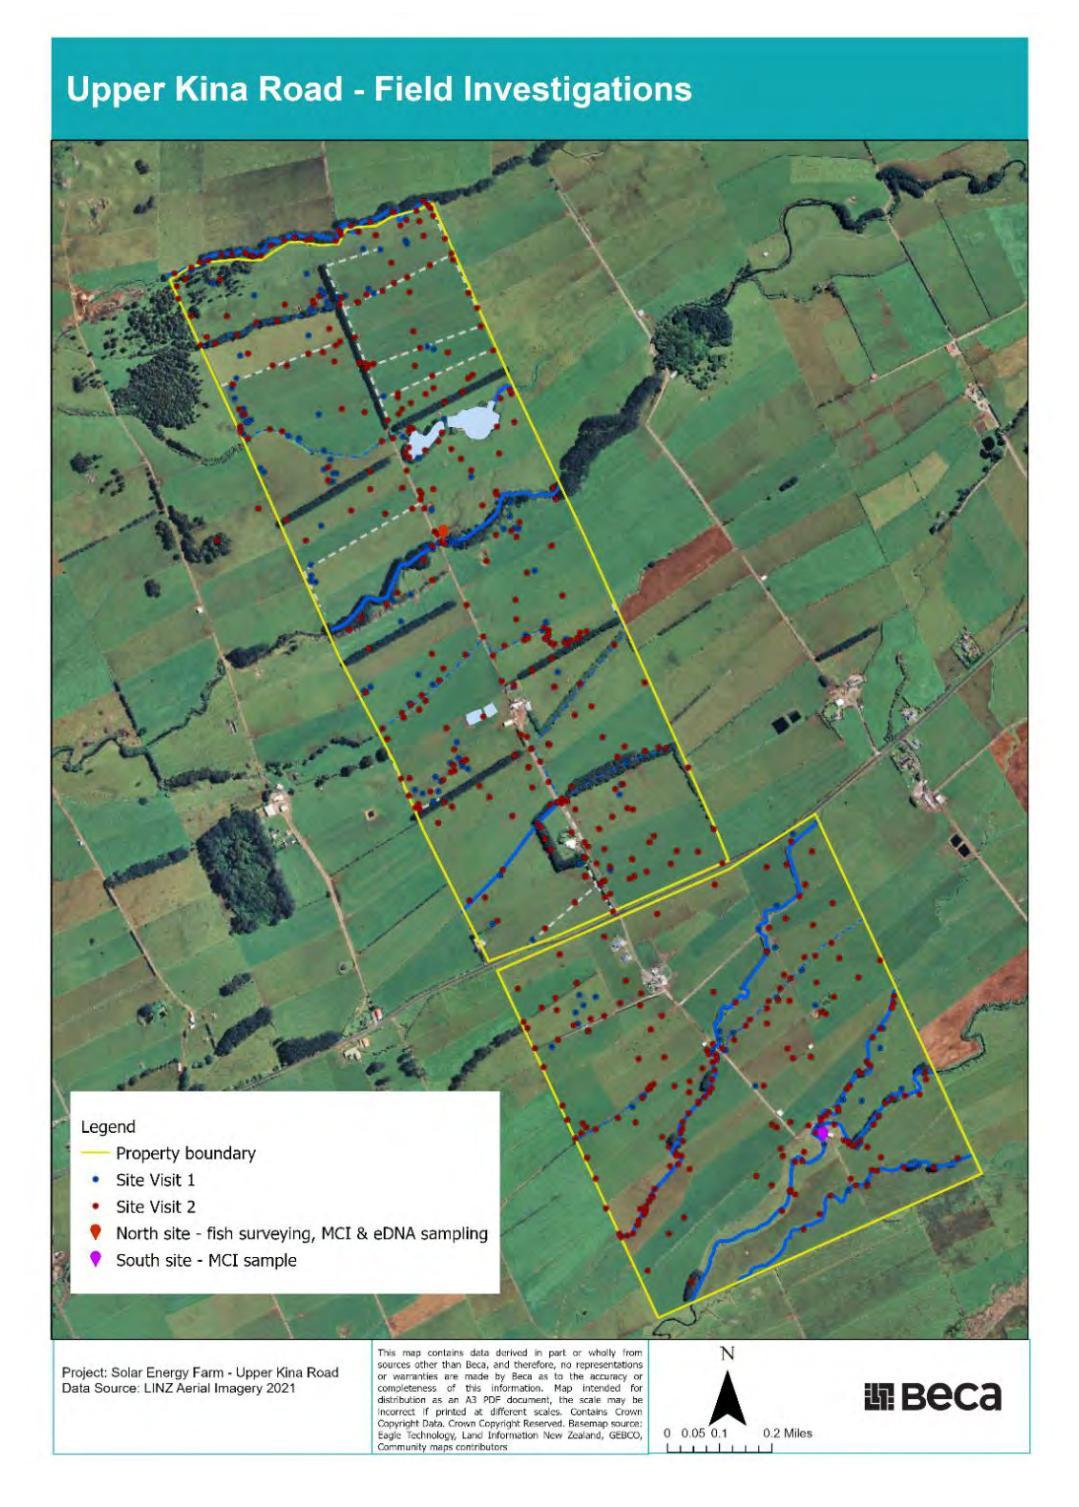
Figure 2: Locations visited during the two site visits.

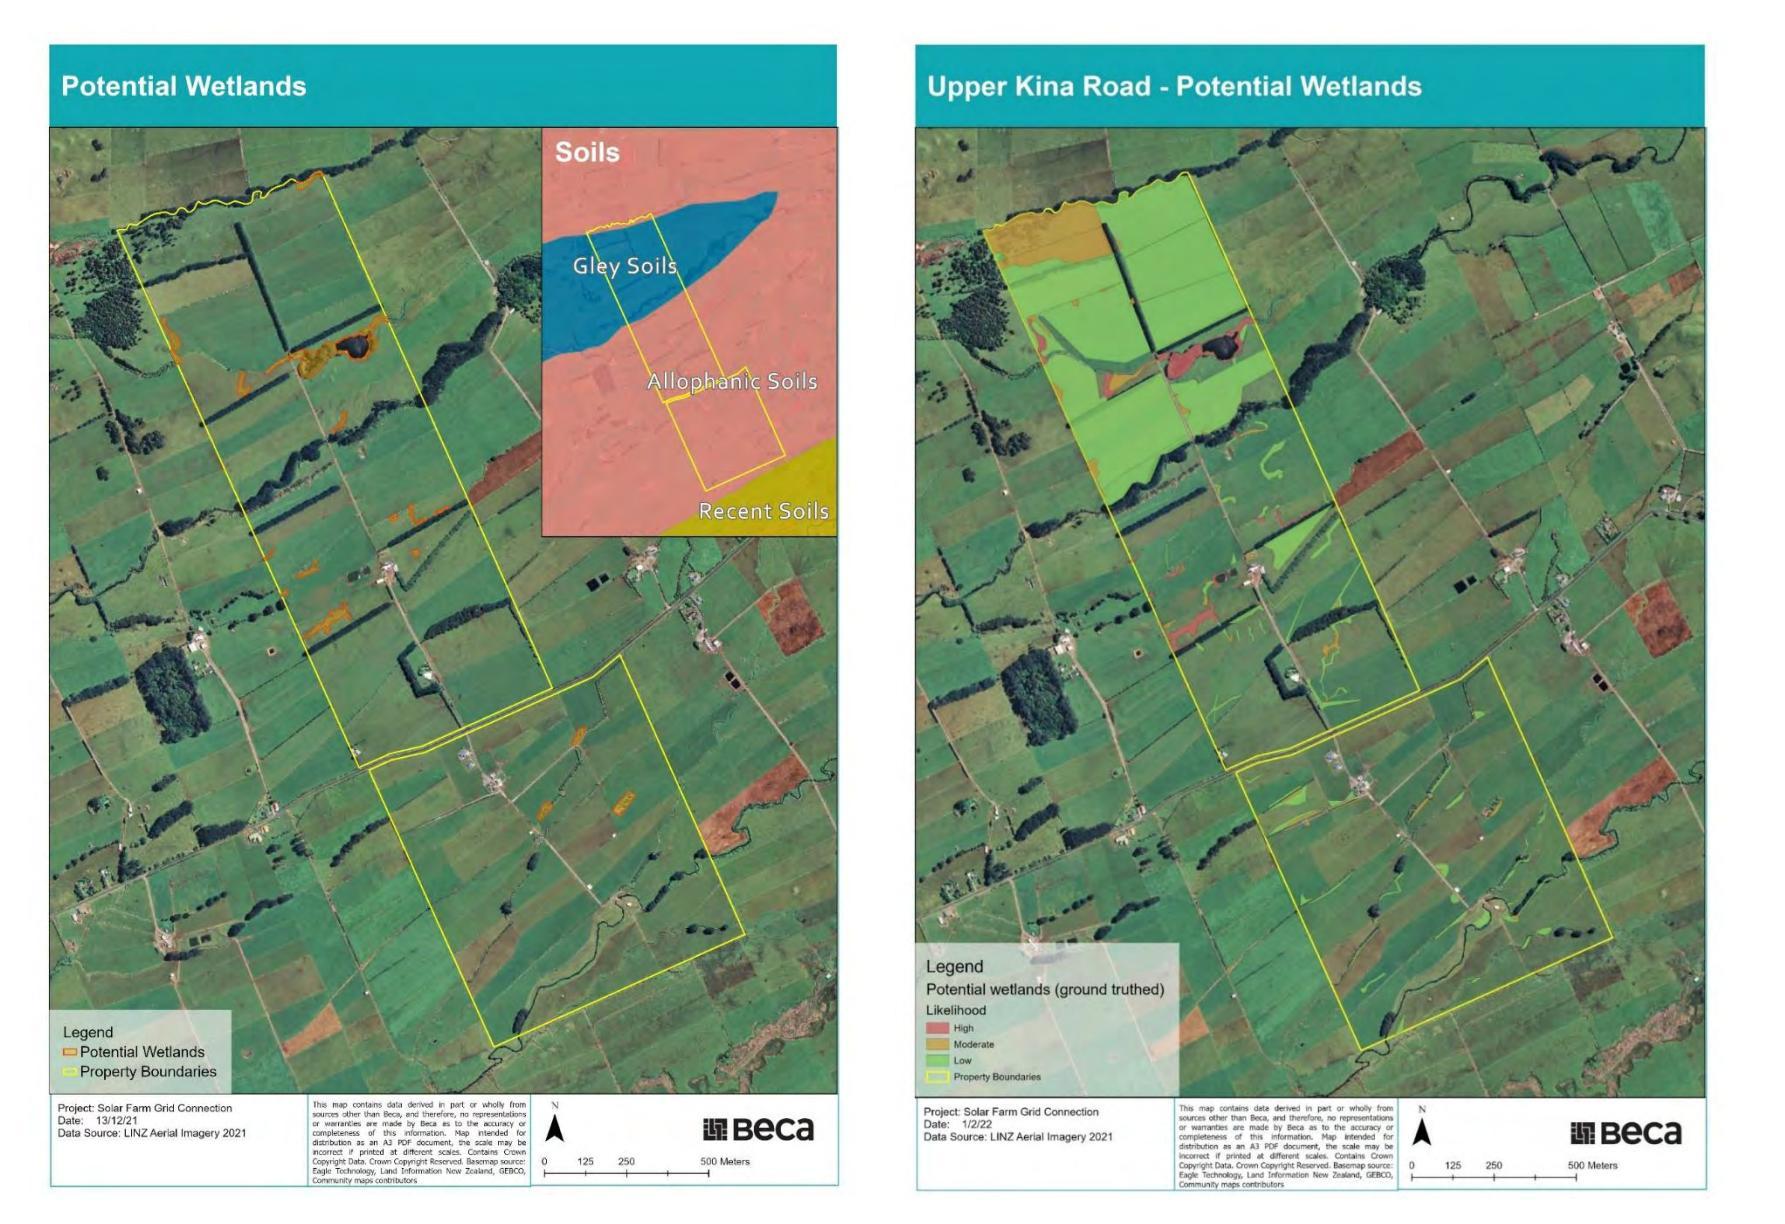
Figure 3: Potential wetlands identified via desktop review, inclusive of soil properties (left) Potential wetland areas assessed within the property and associated likelihood of classification (right).

The majority of the site is mapped as gley soils and allopanic soils (Figure 3), which is likely due to material transfer deposited from Mount Taranaki. Soil investigations within most of the potential wetland extents (as identified in the January screening report) during the March site visit areas found non-hydric soils (high chroma, silt/sand-based soil with some black and orange deposits) typically within pasture-dominated landscapes (Figure 6). A Beca hydrogeologist was consulted for further insights into the soils present onsite. They noted that gley soils are less prone to recharge, they have a higher ability to store water and would more likely support wetland-suitable vegetation types. Allopanic soils, however, are permeable and more prone to recharge, but can allow pockets of permeability where water can be stored at a shallow depth. As such, it was more likely that wetland-suitable vegetation types would be found within the northern end of the north site, which is mapped as consisting of gley.

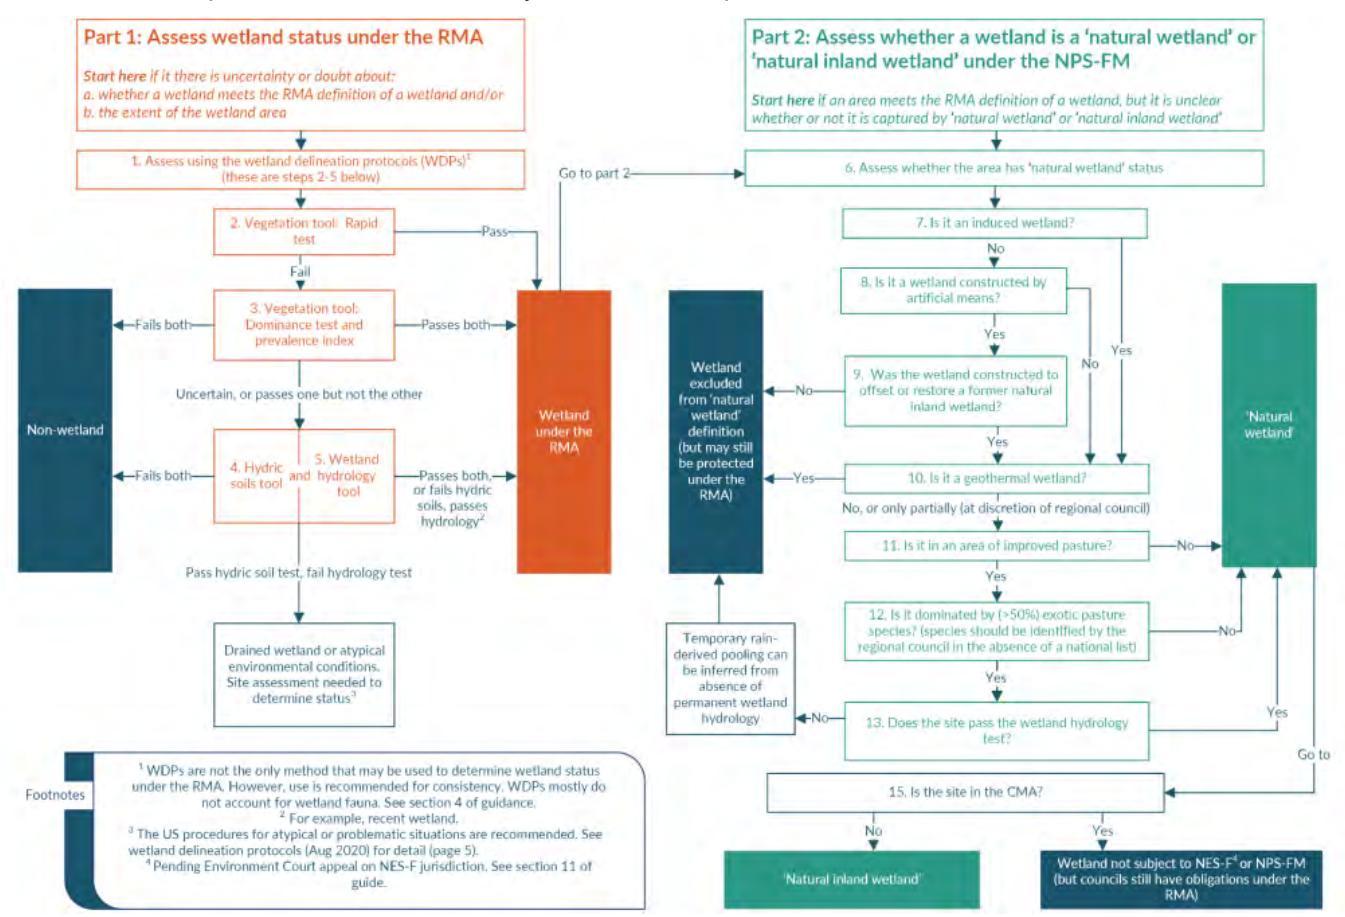
Figure 4: Assessing 'natural wetland' and 'natural inland wetland' status under the NPS-FM (Ministry for the Environment, 2021).

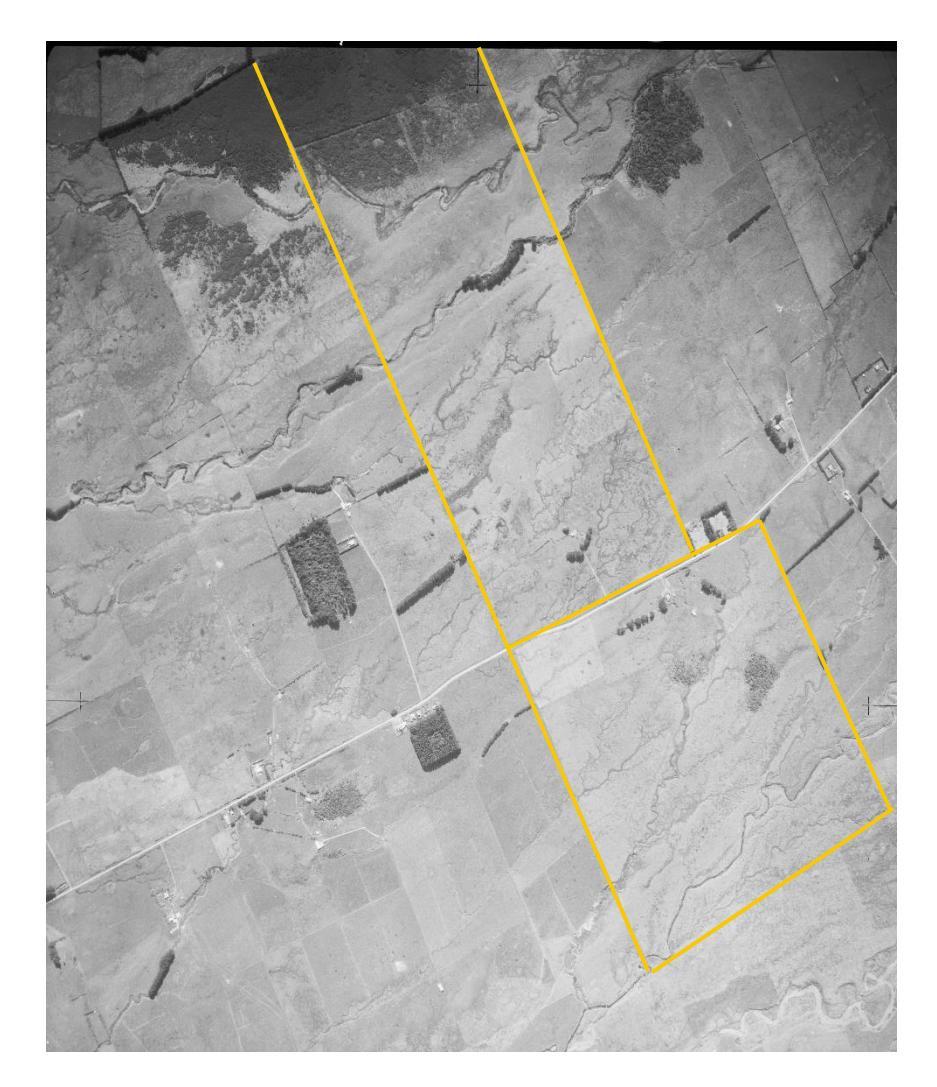
Figure 5: Aerial imagery of the site from the 1950s. Yellow outline is the property boundary (Source: Retrolens).

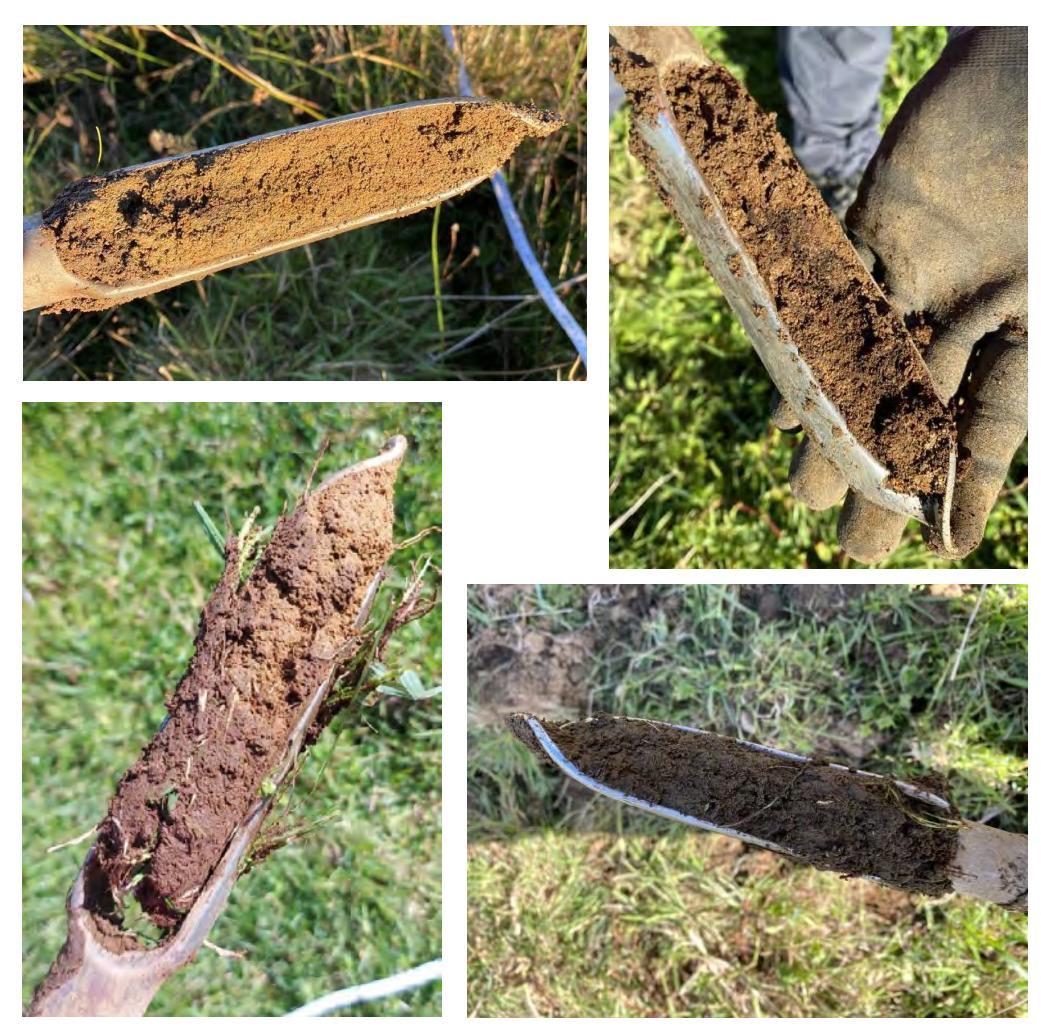
Figure 6: Typical soil auger samples from wetland sites at depths of 30 - 60cm.

Soil investigations during the second field investigation did not uncover any soils that would typically be considered hydric or met the indicators of the WDP Hydric Soil Tool, even at depths of 70cm+. As such, a majority of the putative wetland areas are assessed as not having hydric soils. The confirmed wetland areas (discussed in Section 4.1.5) are typically moist to saturated but did not present other, more typical hydric soil indicators.

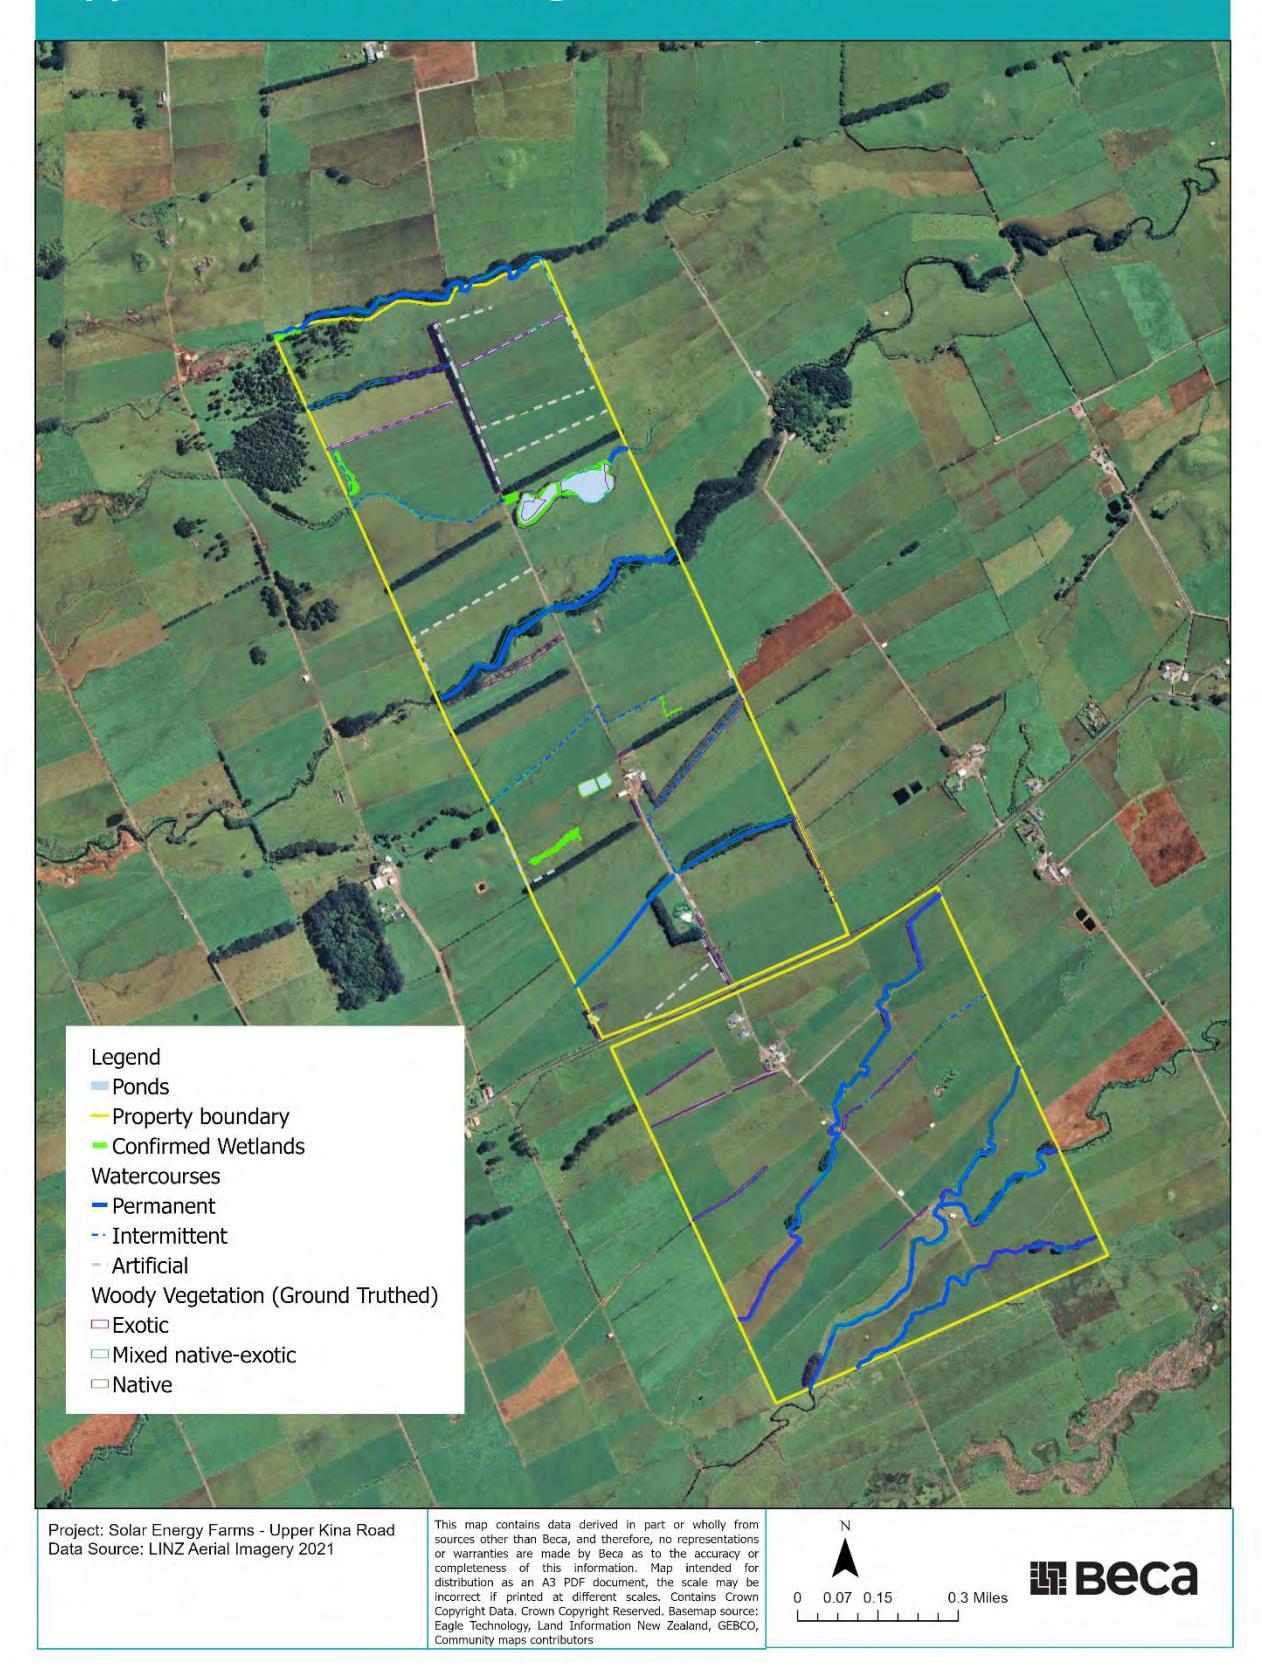
Figure 7: Overview of ecological features mapped within the site following the second site visit.

Given the significant size of the site and number of ecological features of note (Figure 7), a generalised approach to delineation and discussion of those features and their value has been taken, with specific features or values of note explicitly discussed where considered important for context. A large number of site photographs and records have been collected during the ecological surveys undertaken in January and March – individual georeferenced records can be made available for regulatory review if required. Indicative and representative imagery has been provided in the main body of this report to illustrate the features across the site.

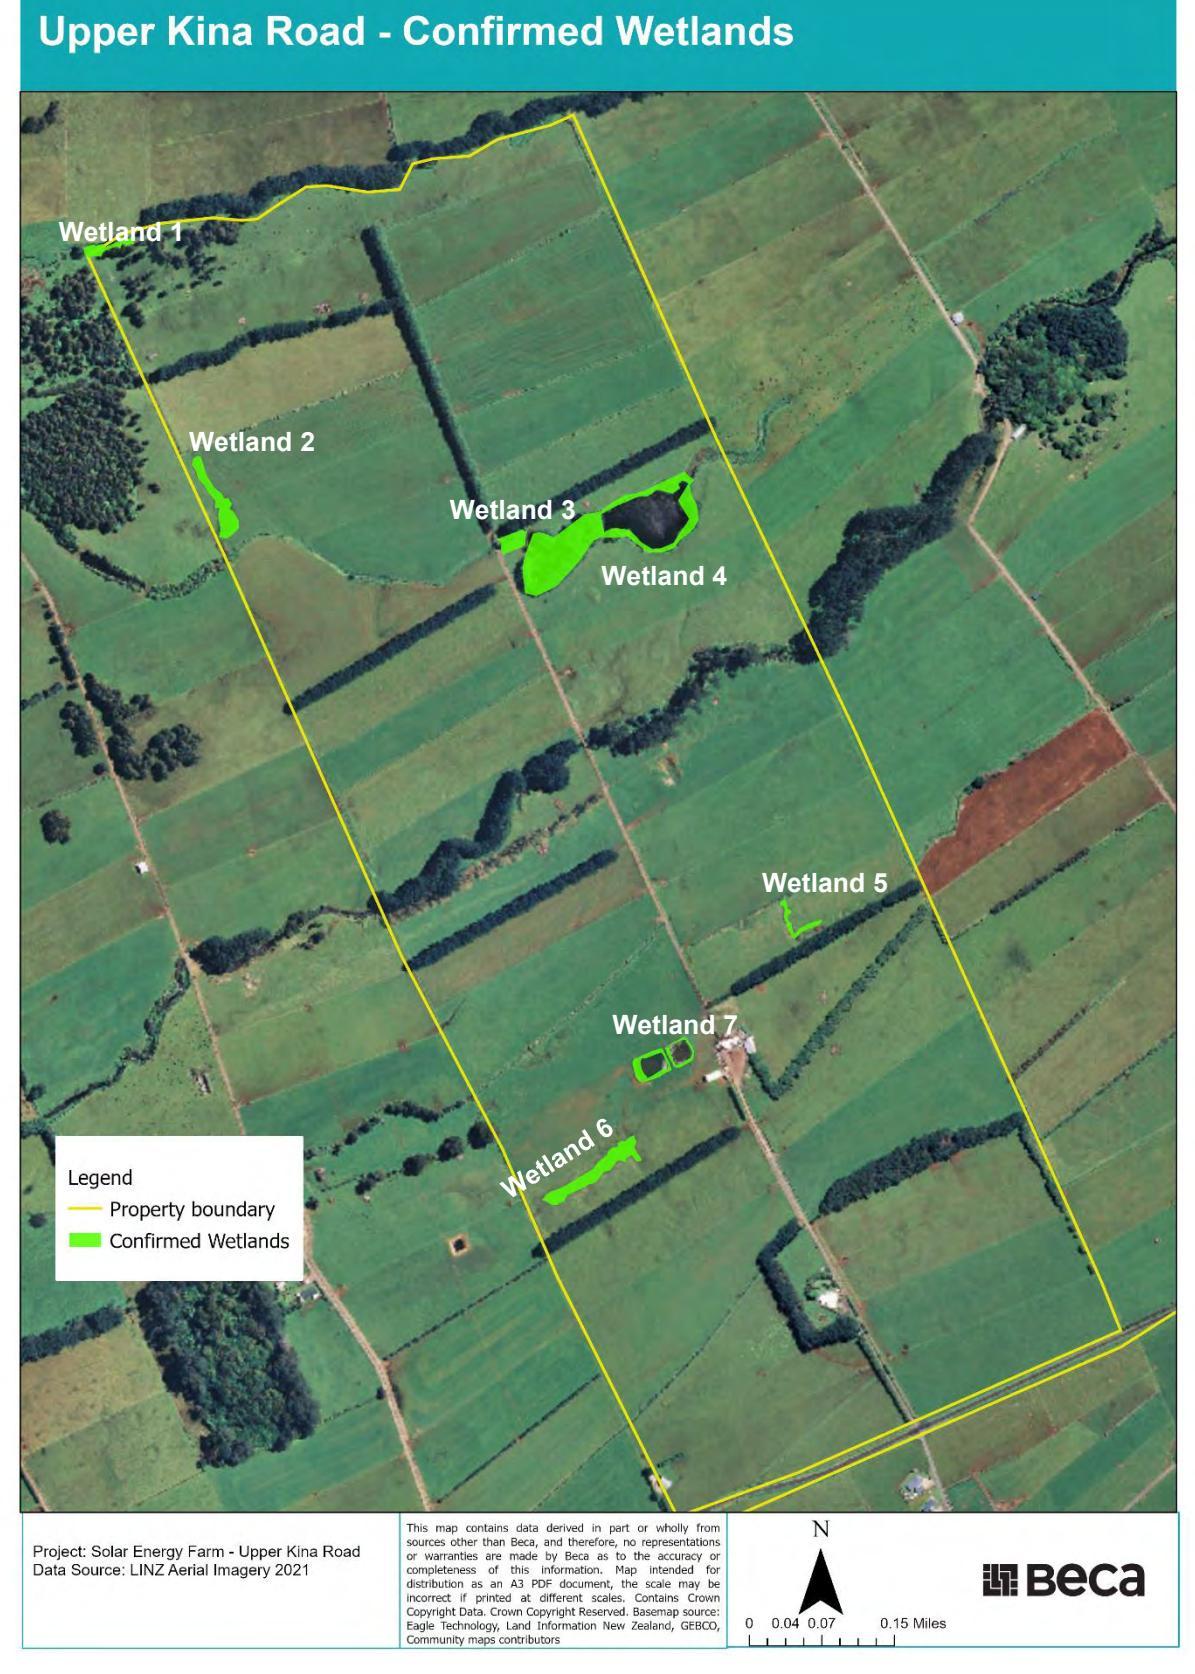
Figure 8: Locations of all confirmed wetlands within the north site

Within the northern property seven wetlands were identified (Figure 8). These wetlands were all located in isolated patches within the pasture fields. Ongoing grazing, stock trampling, and drainage has led to these wetlands being in a significantly degraded state. Nevertheless, they had retained enough characteristics to be classified as 'Natural Wetlands' according to the New Zealand Wetland Delineation Protocols^{17,18} and NPS-FM (2020). No wetlands were identified on the south site.

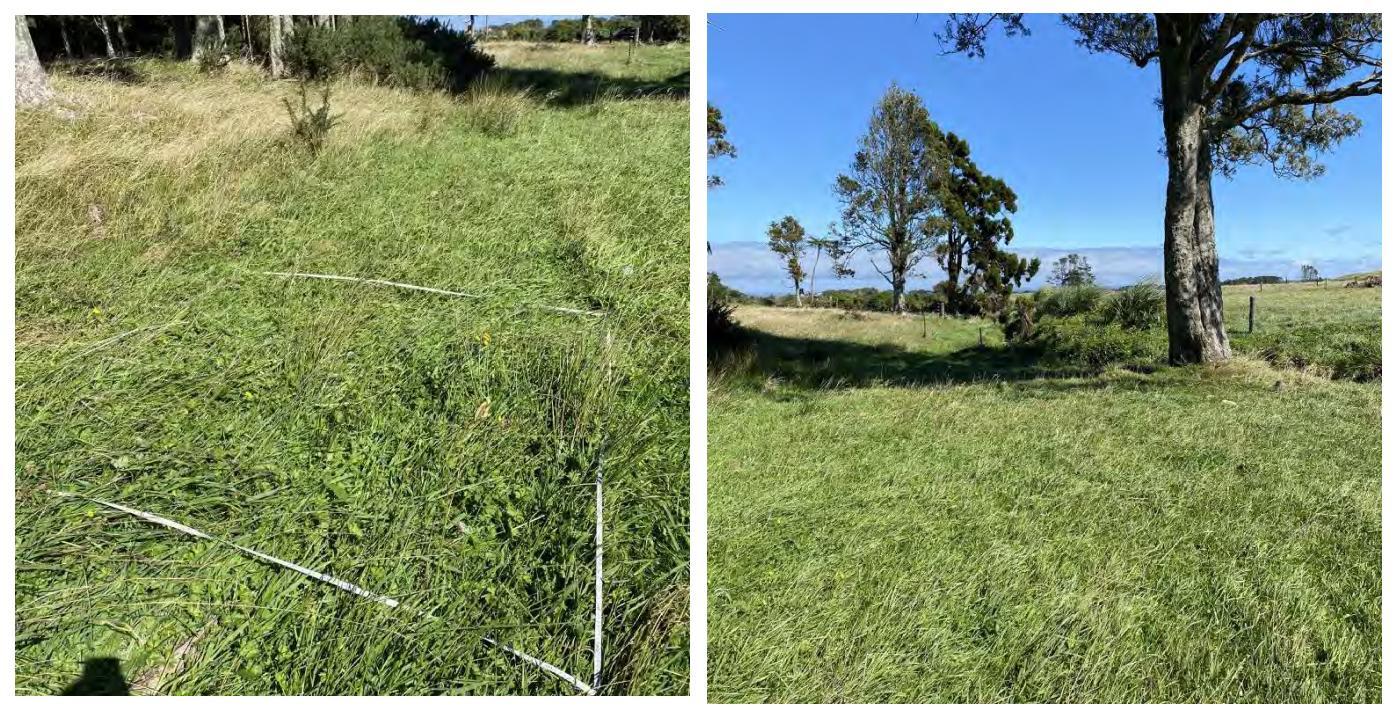
Figure 9: Wetland 1 vegetation plot (left) and surrounding area (right).

There is one riverine wetland within the north site, near the Moutoti Stream (Figure 9). Wetland 1 is associated with the floodplain of the stream, with evidence of drift deposits identified on a waratah and fence wiring within the area. The continually flowing freshwater (the stream) is expected to overtop the stream channel on occasion allowing for the establishment of wetland vegetation¹⁹. Vegetation consisted of *Ranunculus repens, Paspalum distichum, Trifolium pratense, Juncus effusus, and Plantago lanceolata*, of which two are facultative wetland species (FACW). The riverine wetland is approximately 624 m².

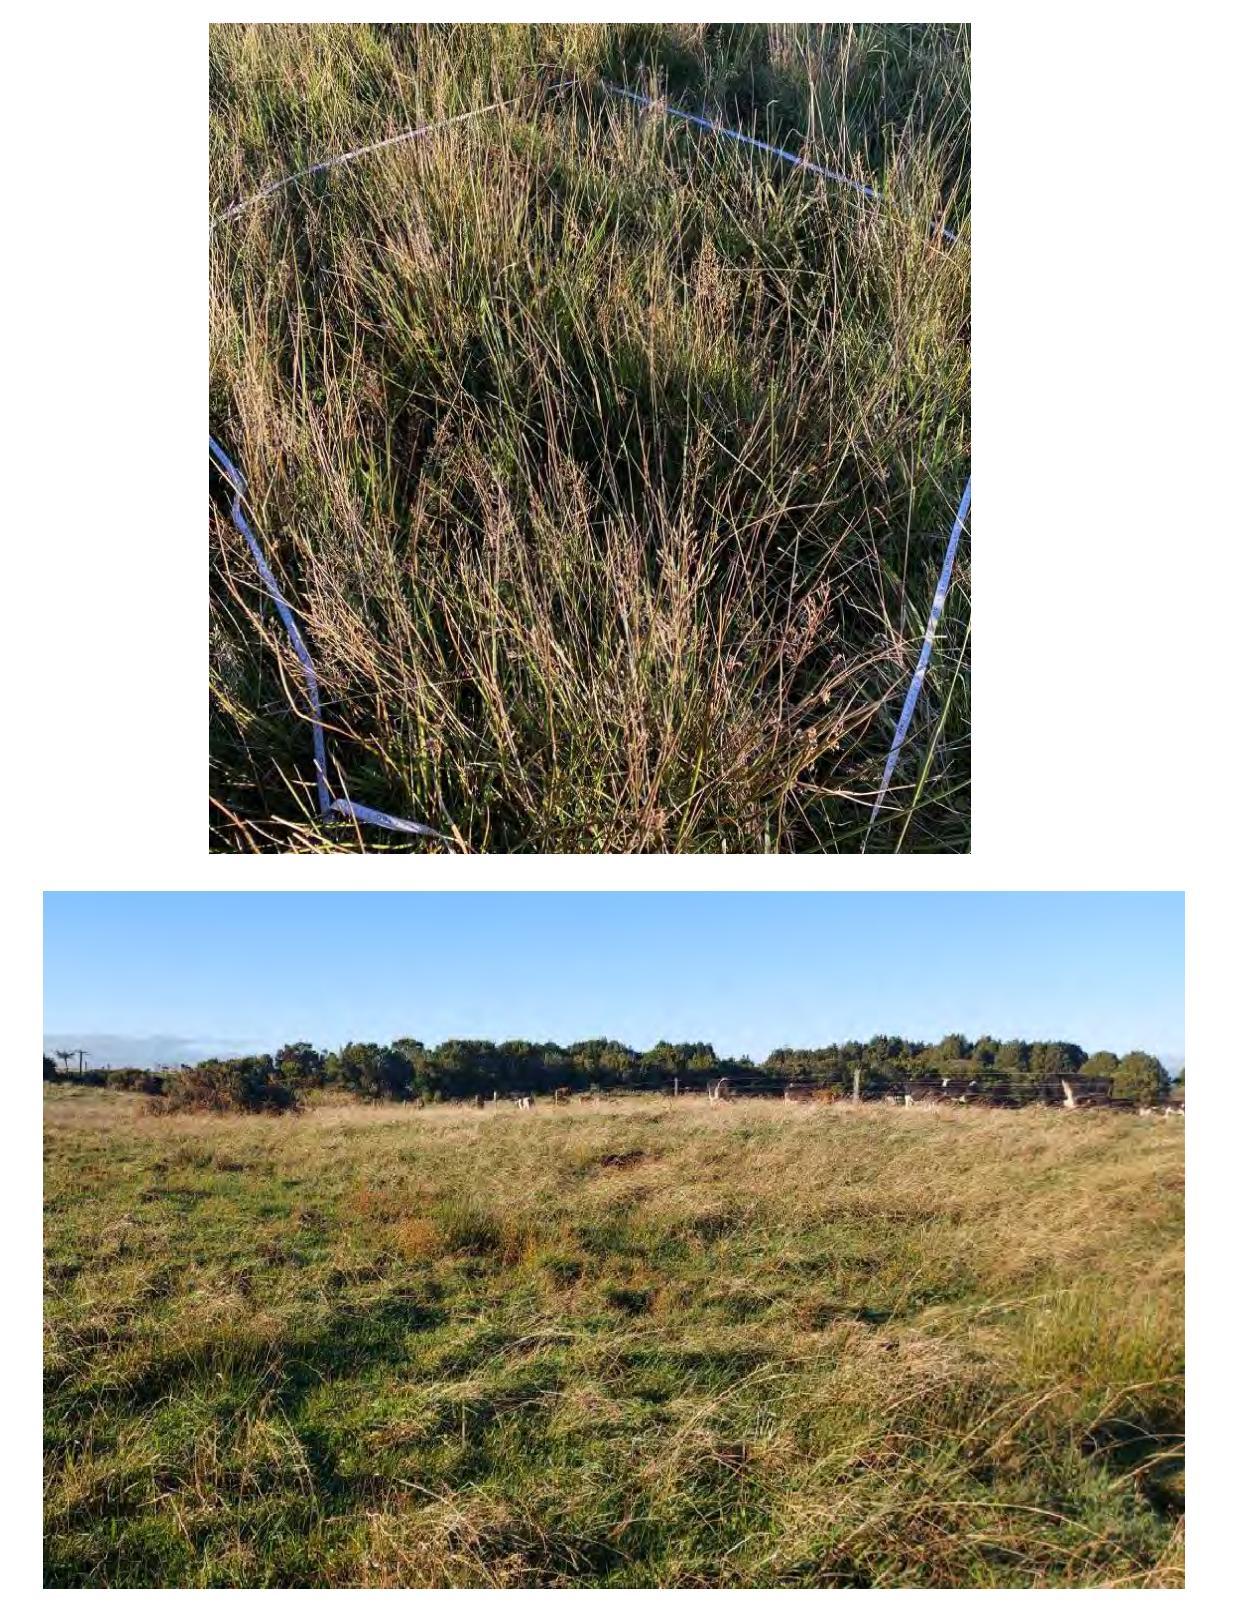
Figure 10: Wetland 2 plot (top) and surrounding environment (bottom) which shows a distinctive pathway of *Juncus* and *Persicaria* moving south.

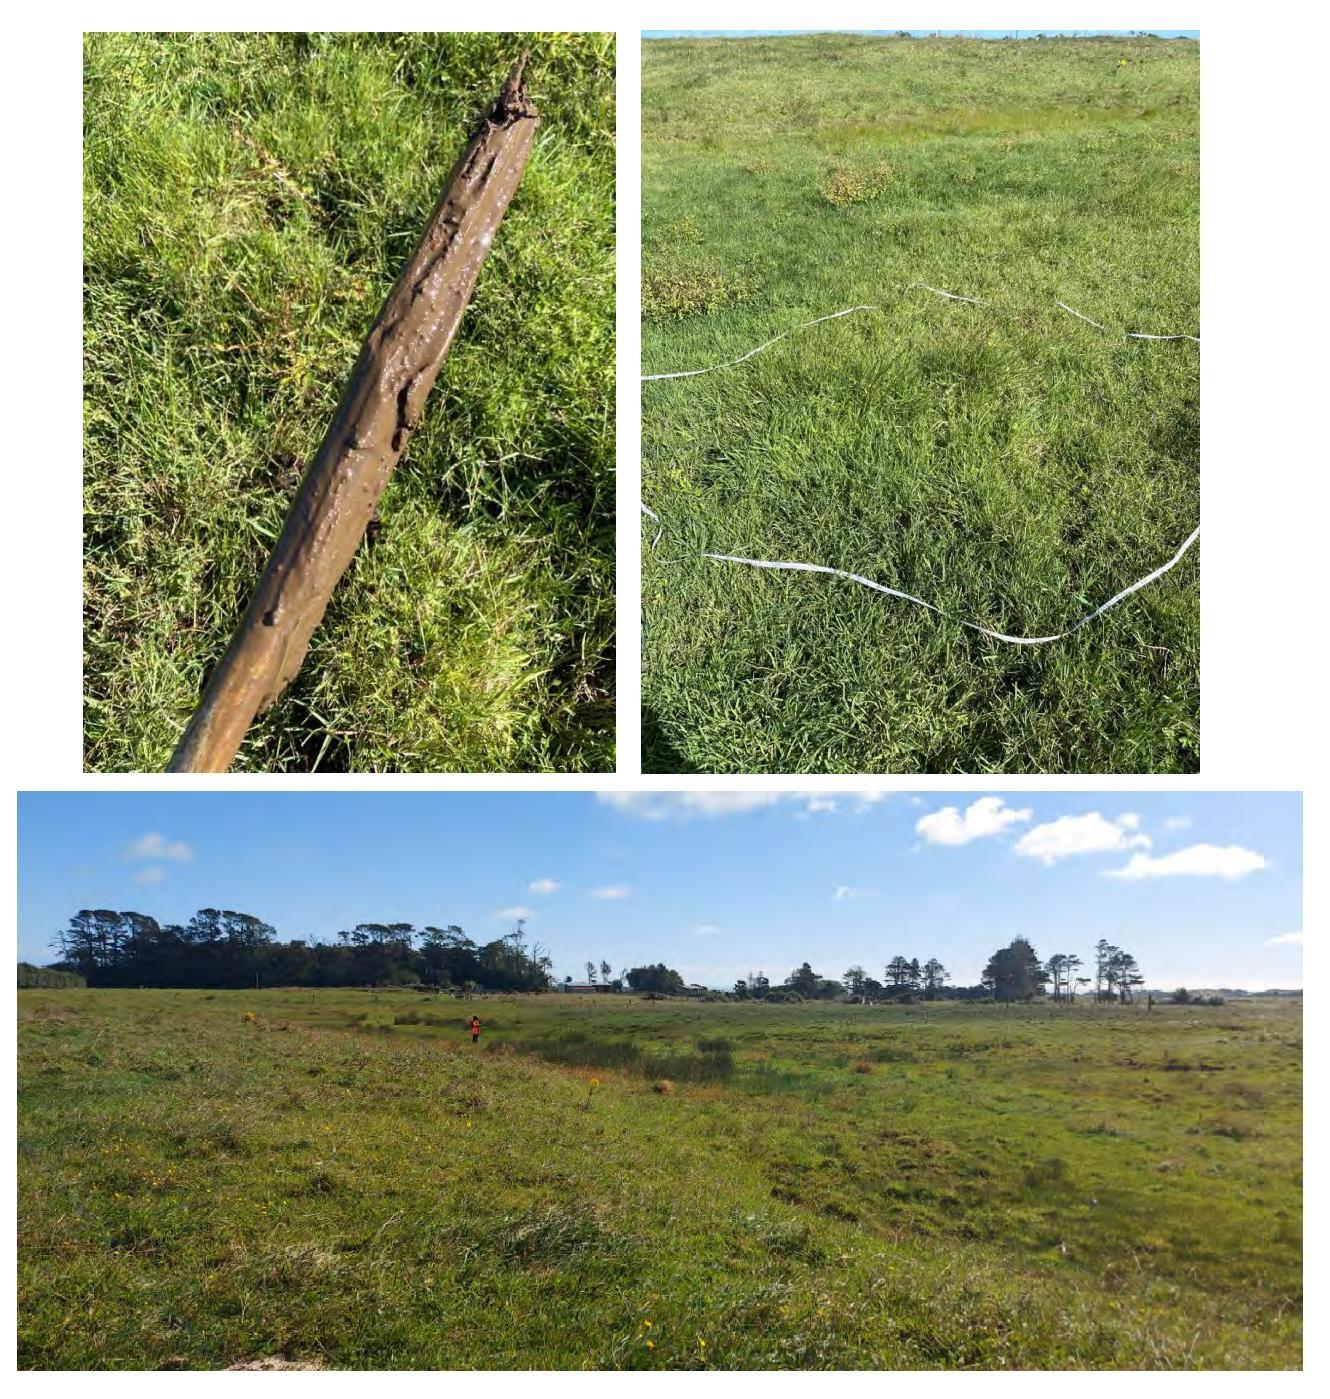
Figure 11: Wetland 6 plot (top right) with very wet soils (top right) and distinctive pathway of *Juncus* sp. and *Persicaria* sp. within a lower lying depression.

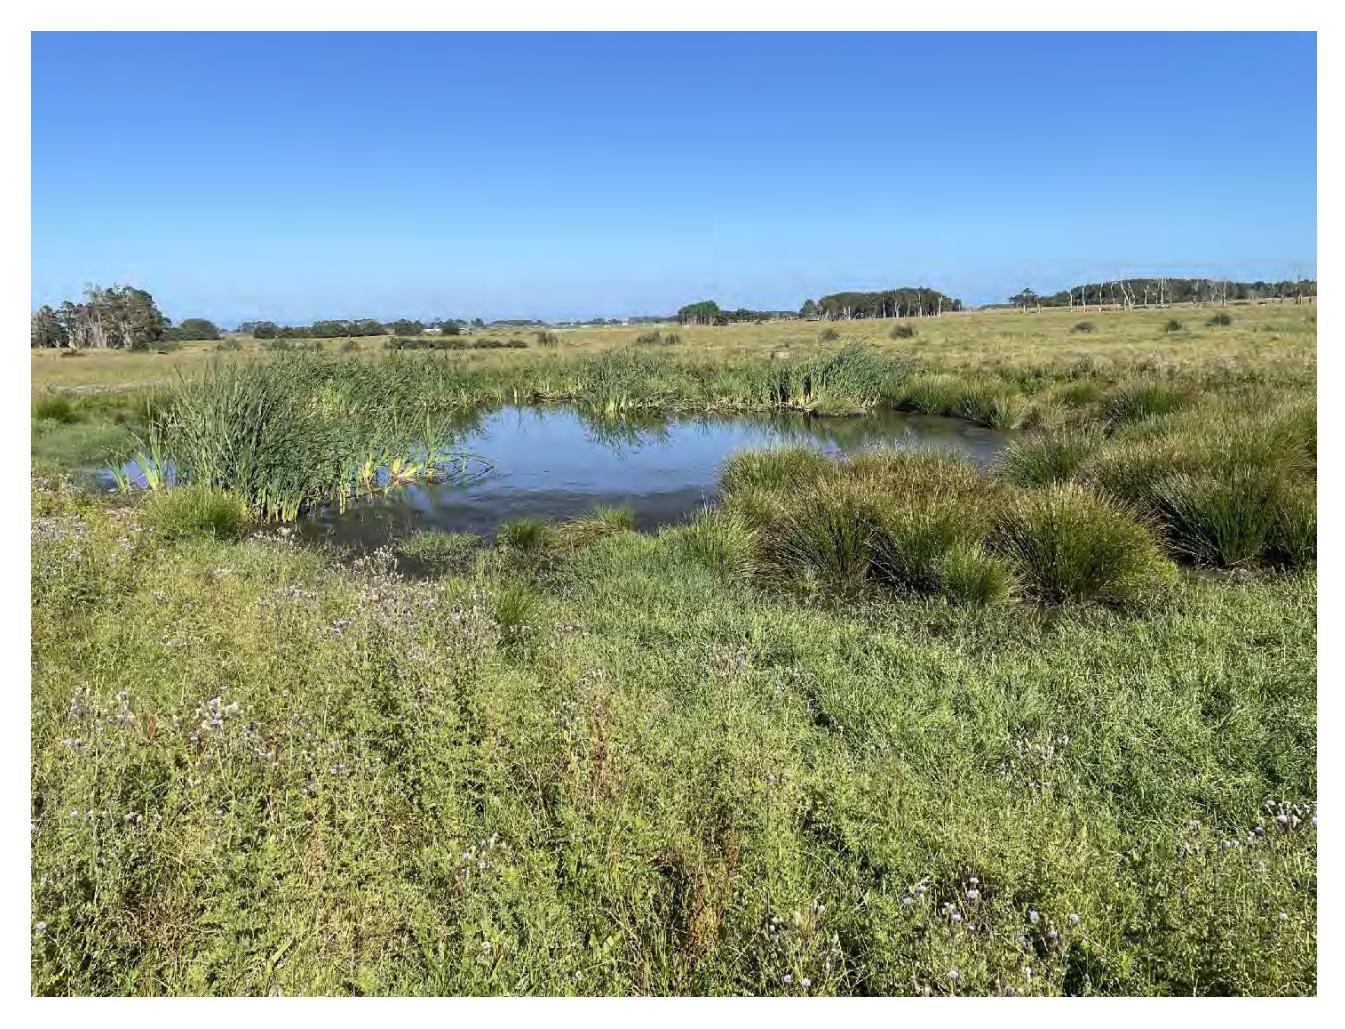
Figure 12: Raupō and Carex sp dominated lacustrine wetland along the pond margin.

The site consists of four highly modified / constructed ponds which have encouraged the development of fringing lacustrine wetland systems that occur within and alongside the ponds that were created on the north site. Vegetation types within the wetland consistent of tall reed-like species including raupō and *Juncus* sp, as well as *Persicaria hydropiper* and *Carex* sp (Figure 12**Error! Reference source not found.**). Lacustrine wetland systems are one type of wetland that occur within or next to lakes, reservoirs, and fresh waterbodies with shallow depth and usually have <30% vegetation cover

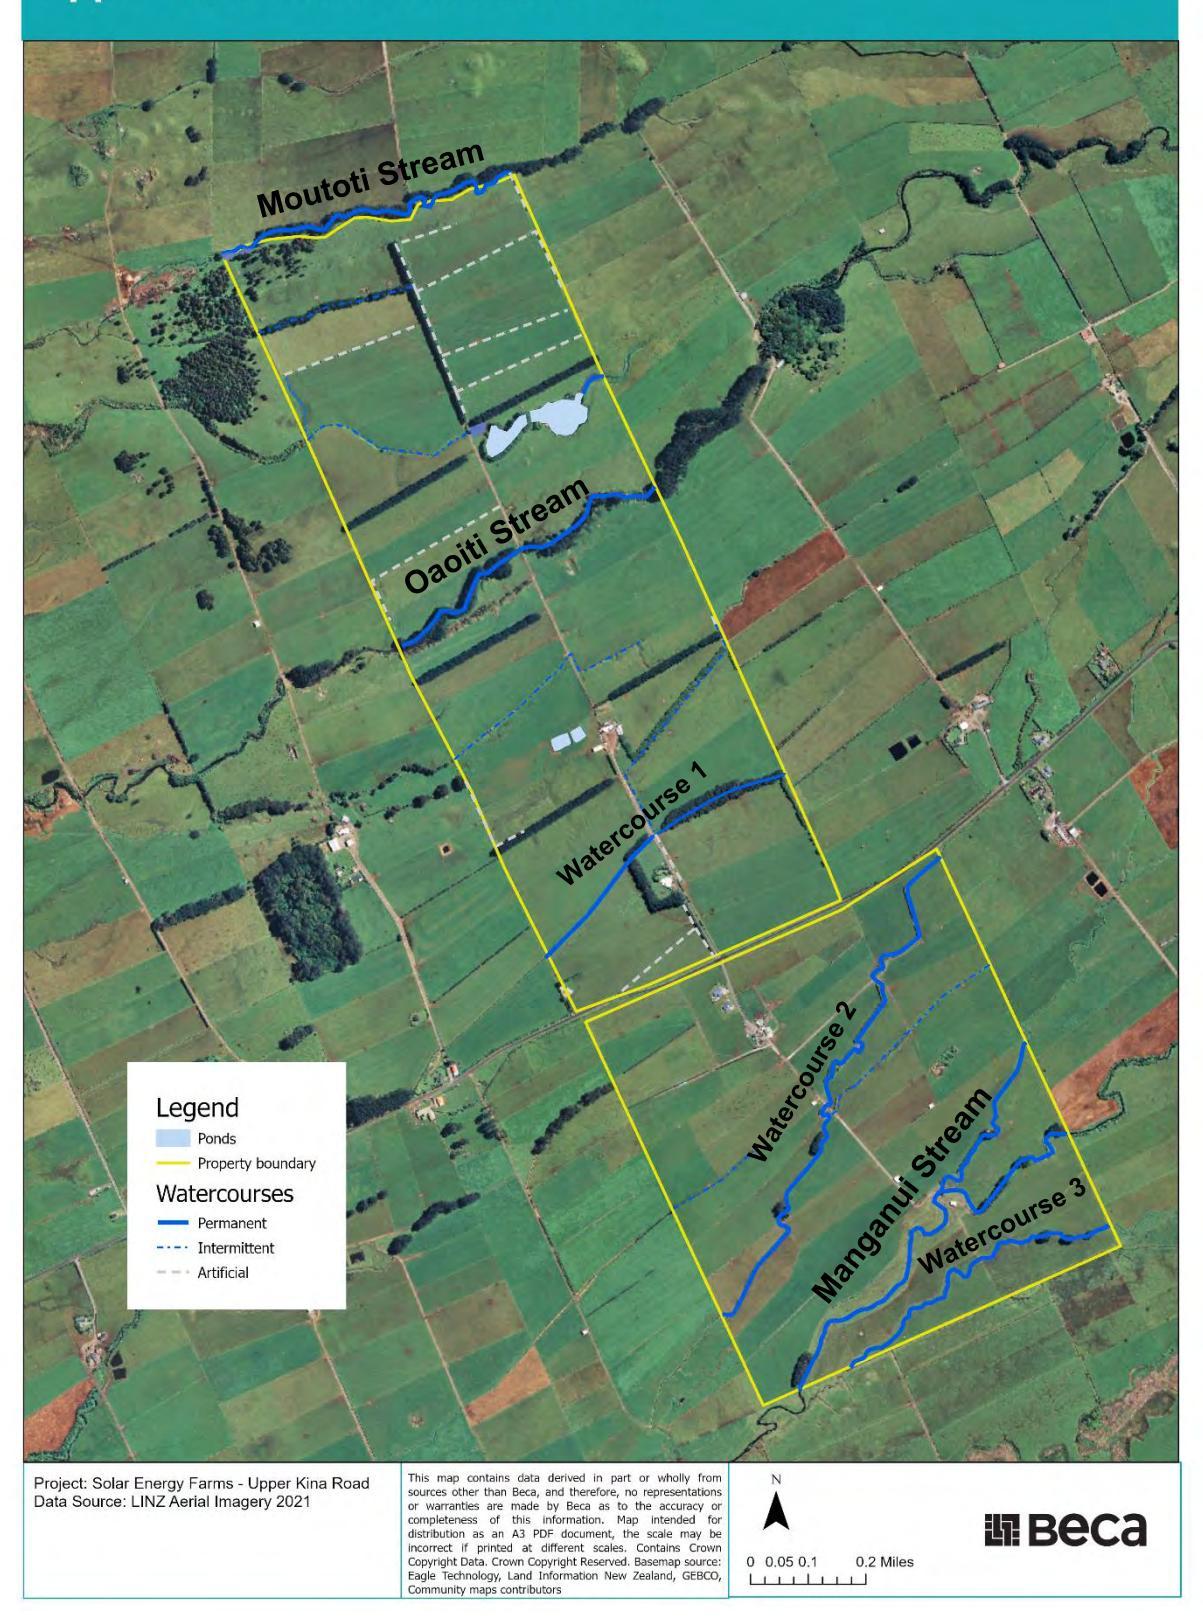
Figure 13: Watercourses within the properties.

Over the two properties there are six identified permanent streams (Figure 13**Error! Reference source not found.**). Watercourse assessments were conducted at all streams and eDNA samples were collected from Oaoiti Stream. MCI samples were collected from both Oaoiti Stream and Manganui Stream.

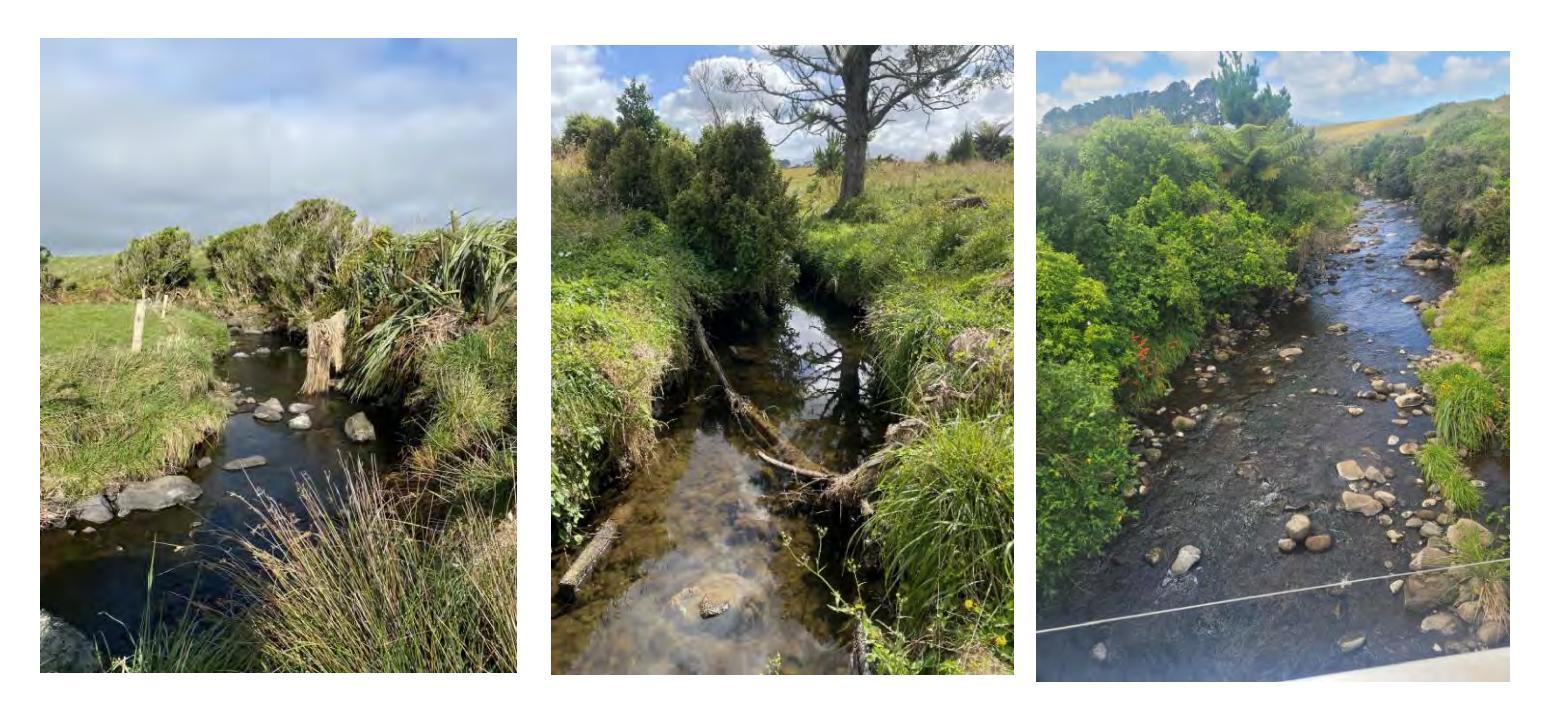
Figure 14: Named permanent streams Manganui stream (left), Moutoti Stream (middle), and Oaoiti Stream (right) (photos taken on 30/03/2022).

Manganui Stream displayed similar characteristics. Some small areas of nuisance macrophyte growth was observed in areas that were unshaded. Manganui Stream was sparsely planted for approximately 50 m downstream and upstream of the access race. Downstream of the race, riparian vegetation included mixed native and exotic species including flax (*Phormium tenax*), karamū, pampas, sedges, and ferns (*Cyathea sp*) (Figure 14). Instream vegetation consisted of watercress and curly leaf pond weed (*Potamogeton crispus*). Upstream riparian vegetation had bamboo shelter belts and also certain patches of mixed native and exotic vegetation of a similar composition to the other unnamed permanent streams on this property.

Generally, limited signs of erosion were observed at the north site permanent streams; although some evidence of mass wasting (likely associated with flood events historically) were present at certain localities along Oaoiti Stream; generally having healed over and vegetated to a certain extent since those events occurred. Extensive erosion was observed within the south site Manganui Stream.
