Ecological Impact Assessment – Solar Farm at Upper Kina Road

Report

Prepared for Energy Farms Ltd Prepared by Beca Limited

8 June 2022

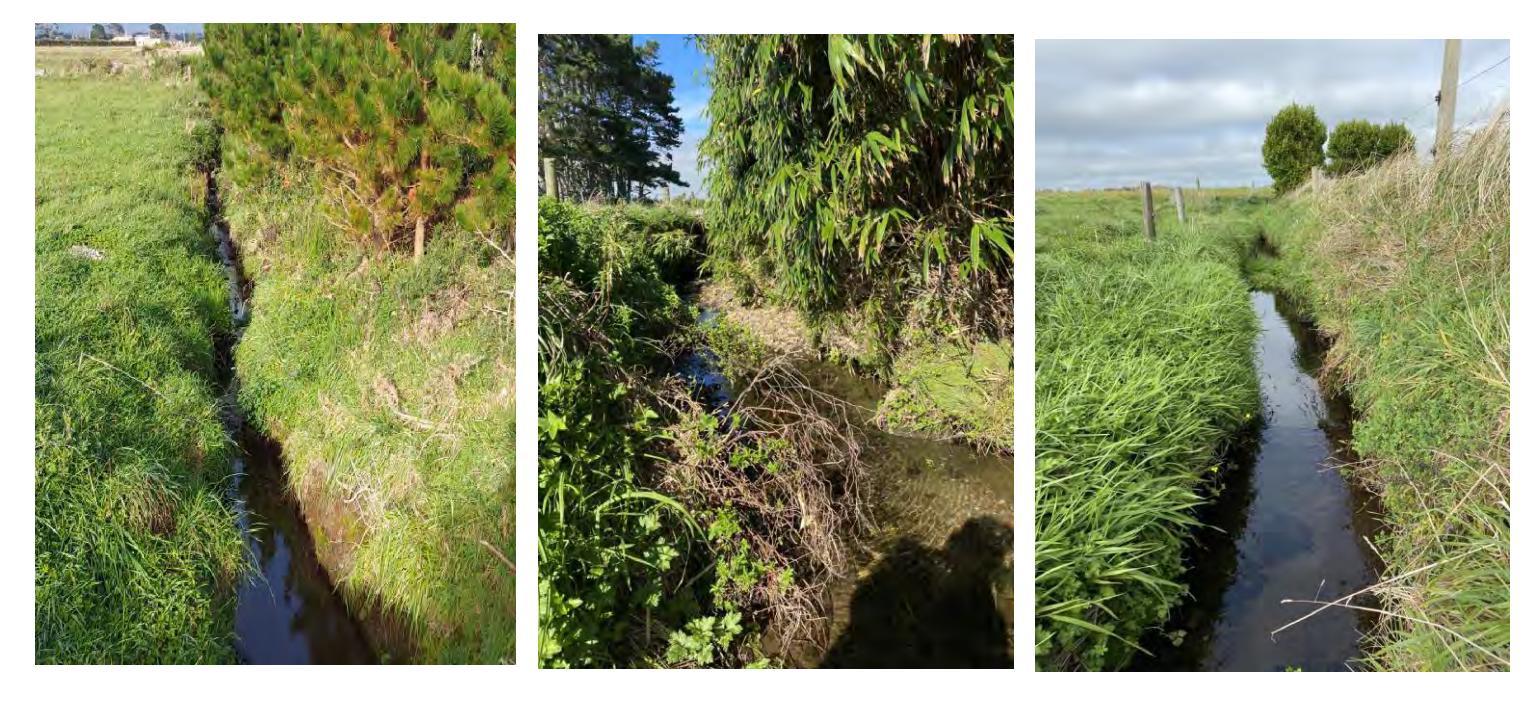
Figure 15: Unnamed permanent streams - Watercourse 1, 2, and 3 (left to right) (photos taken on 29/03/2022).

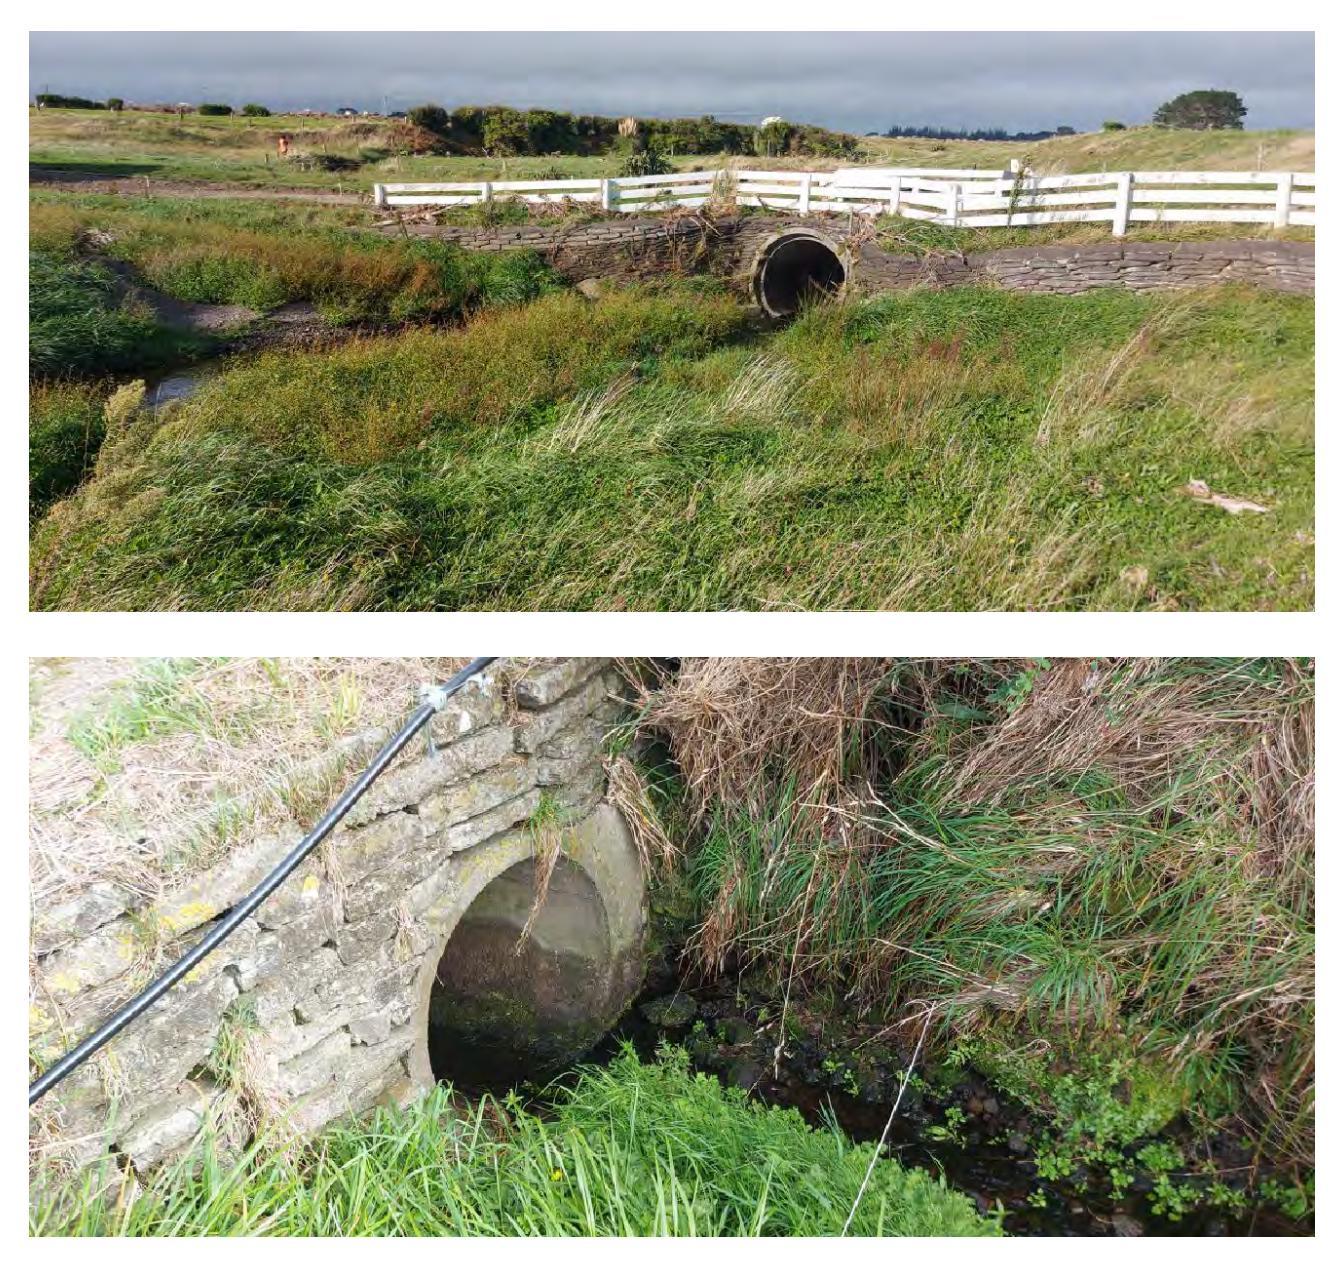
Figure 16: Culverts observed within unnamed permanent streams on the south site (photos taken 29/03/2022).

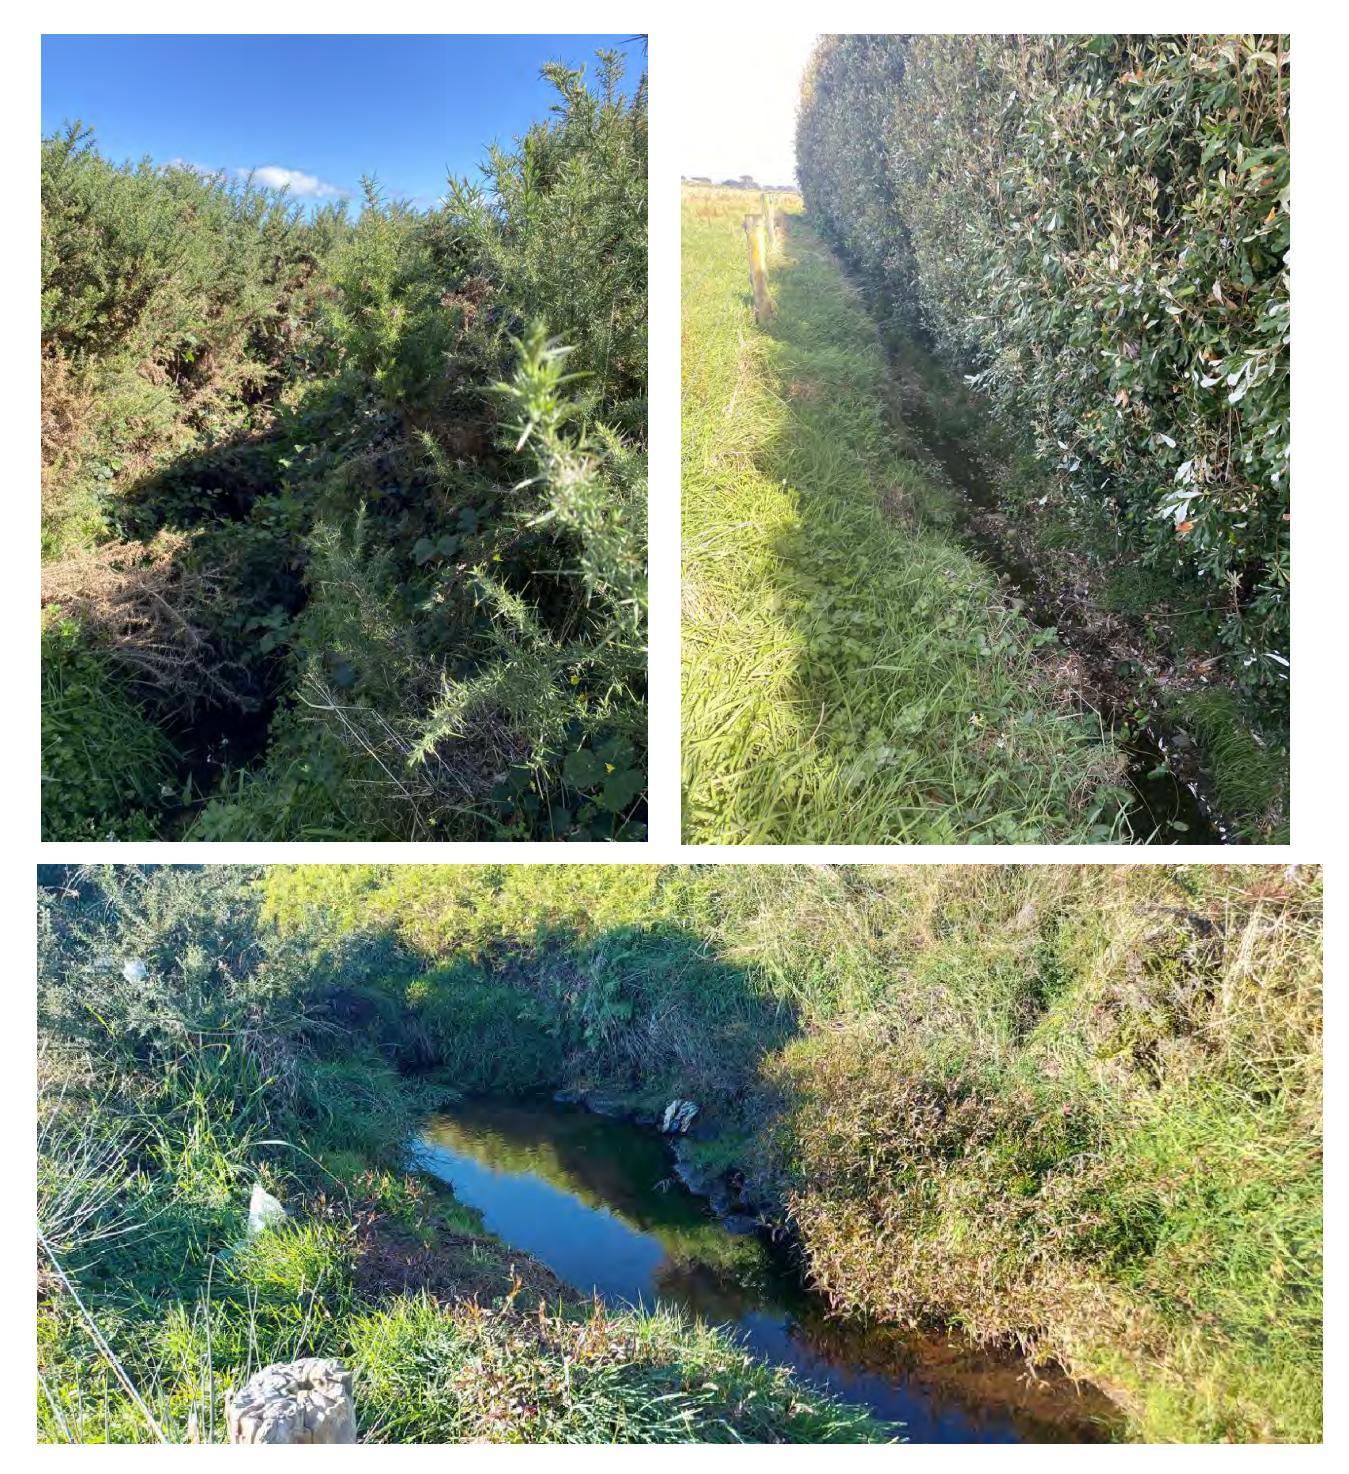
Figure 17: Intermittent streams identified within the two properties (photos taken on 29-30/03/2022).

As such, the overall ecological value of the intermittent streams is assessed as Low (Table 5).

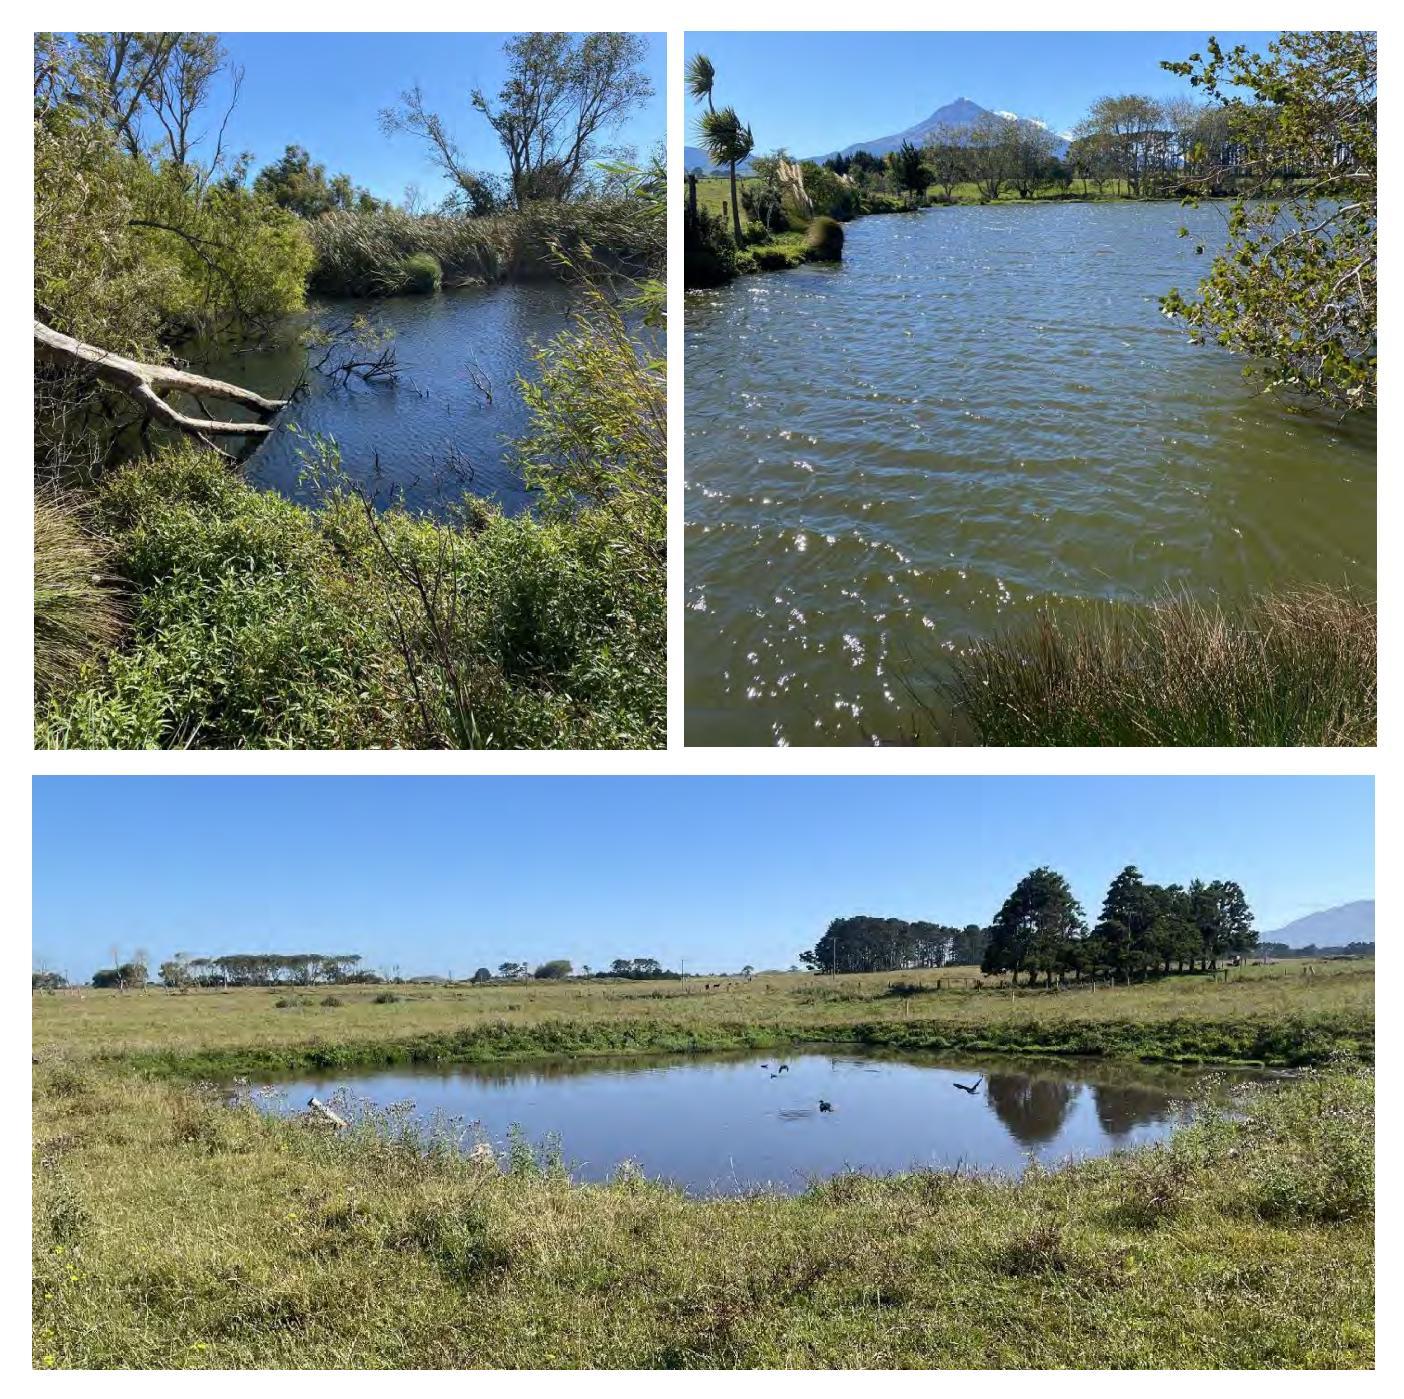
Figure 18: Ponds within the north property. Northern ponds (top left and right) with typical hydrophytic species observed and pond opposite to the cow shed (bottom).

The southern ponds are dominated by including raupō, *Juncus* sp., *Persicaria hydropiper* and *Carex* sp. (Figure 18). Avifauna observed near and within these ponds included mallard duck (*Anas platyrhynchos*).

The ponds are artifically constructed structures and have limited to no shading and likely low water quality due to continous stock access and sediment runoff. Additionally, there is limited connectivity of the ponds to nearby watercourses, therefore are unlikely to provide habitat for native species. As such, the overall ecological value of the Southern ponds are **Low**.

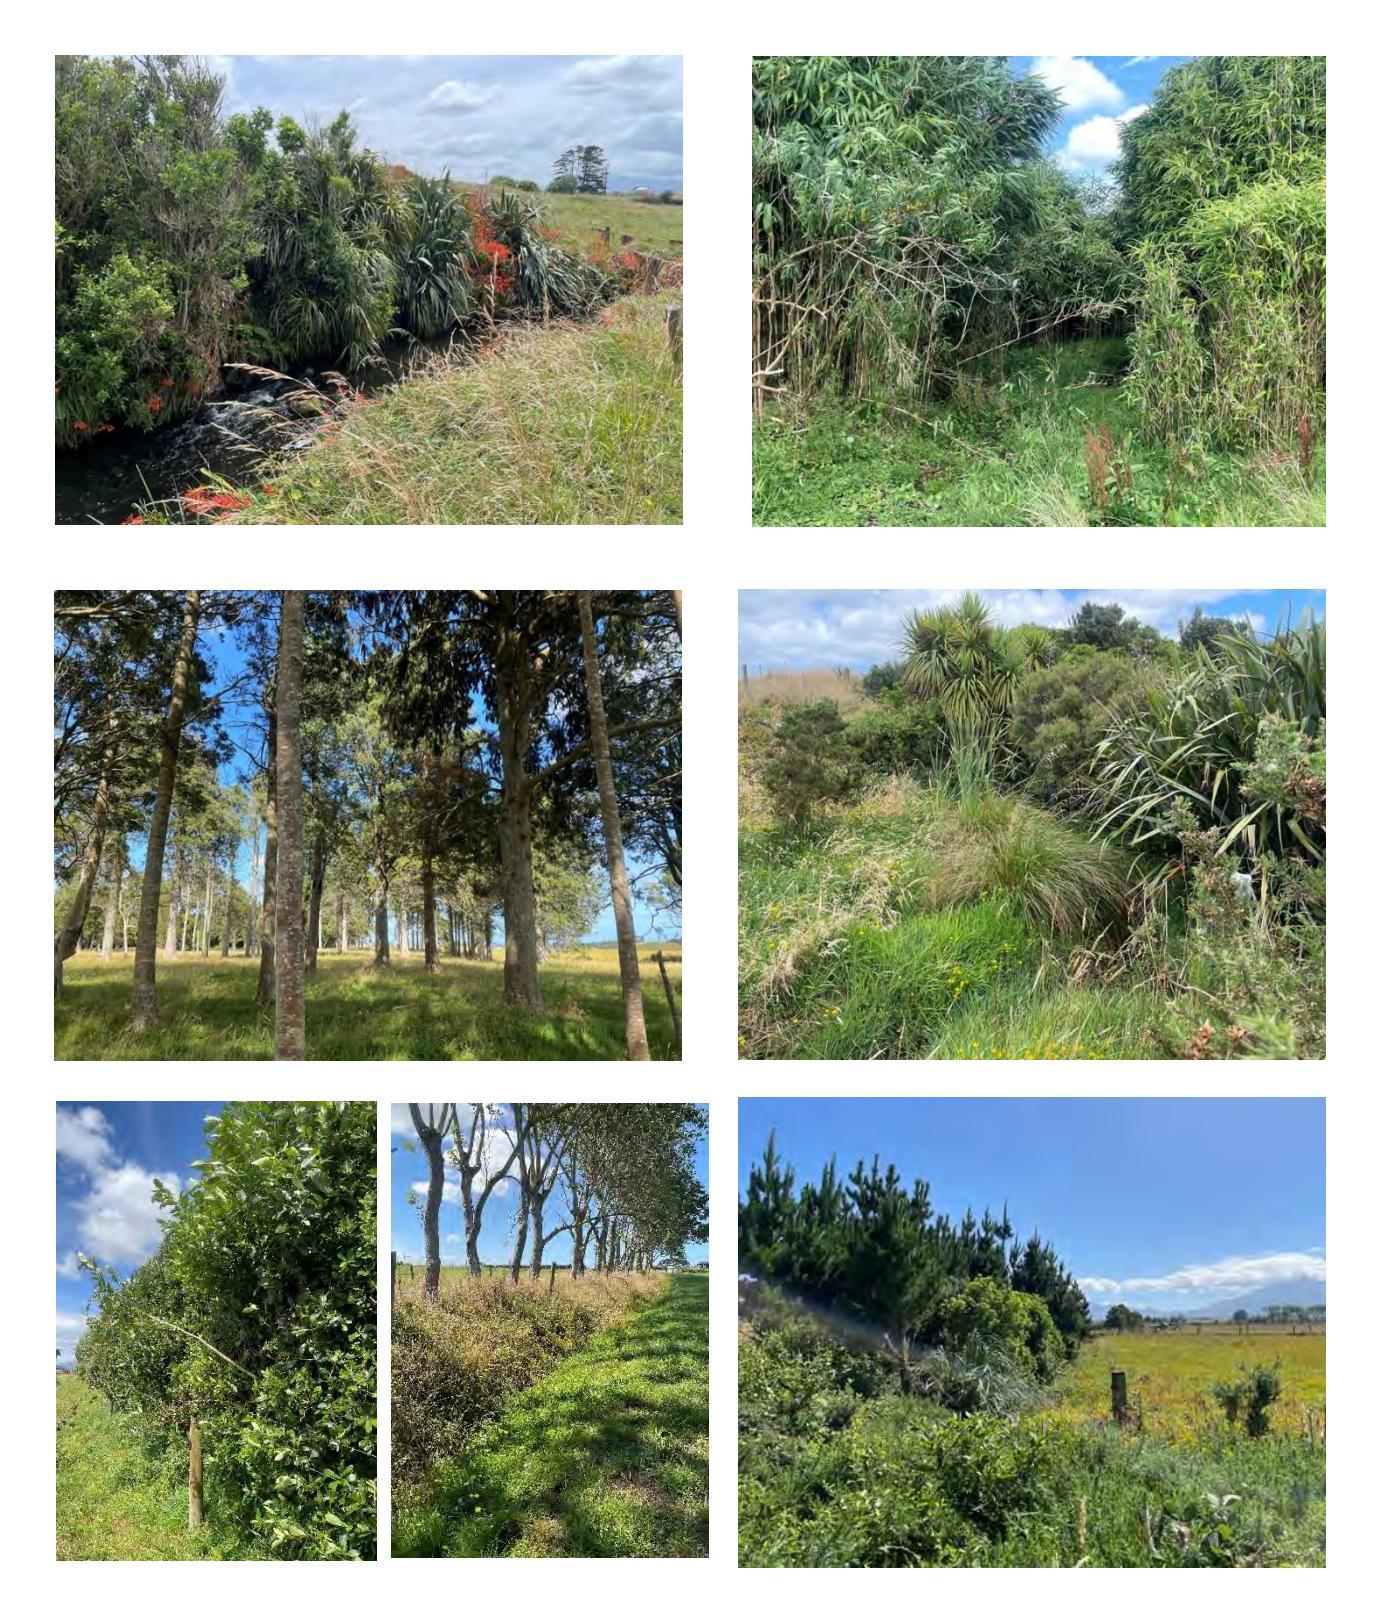
Figure 19: Typical vegetation found onsite – general mix of exotics and natives.

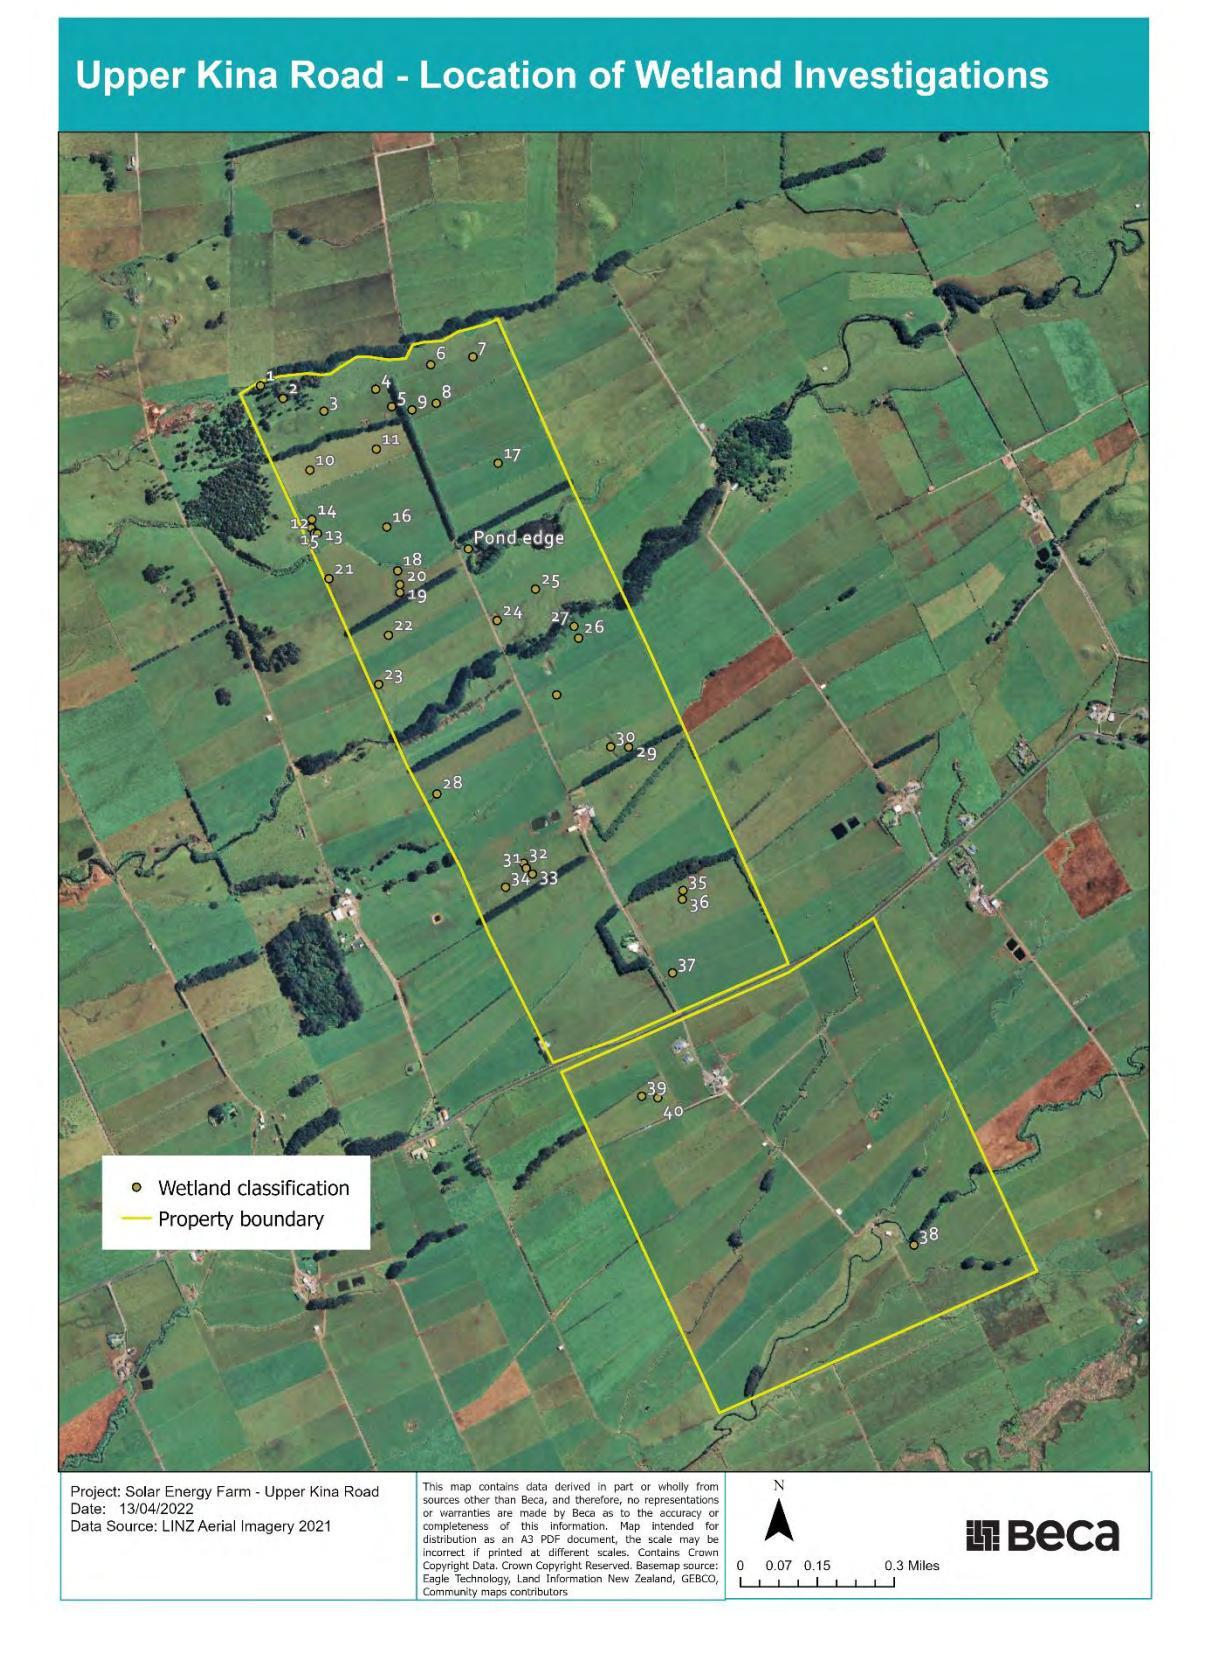
Figure 2.1. Location of wetland delineations within north and south sites.
