Memorandum

Whangarei 35 Walton Street Whangarei 0110 +649 358 2526	Auckland Hamilton Tauranga Wellington PO Box 91250 PO Box 1094 PO Box 13373 PO Box 11340 Auckland 1142 Hamilton 3240 Tauranga 3141 Wellington 6142 +649 358 2526 +647 960 0006 +647 571 5511 +644 385 9315							
Nelson 51 Halifax Street Nelson 7010 +643 548 8551	Christchurch Level 1Queenstown PO Box 1028Dunedin 49 Water Street141 Cambridge Terrace Christchurch 8013Queenstown 9348 +643 441 1670Dunedin 9016 +643 470 0460PO Box 110 Christchurch 8140 +643 366 8891Christchurch 8140 +643 366 8891Christchurch 8140 +643 366 8891							
Attention:	Catherine Stuart							
Company:	Southern Parallel Sports Campus							
Date:	8 November 2022							
From:	Tanya Blakely, Jessica Schofield							
Message Ref:	Re: SPSC Ecological Constraints and Opportunities							
Proiect No:	BM220807A

Boffa Miskell Limited (BML) has been engaged by Southern Parallel Sports Campus (SPSC) to prepare a high-level ecological assessment for the proposed Southern Parallel Sports and Equestrian Centre to inform the application for a fast-track consent.

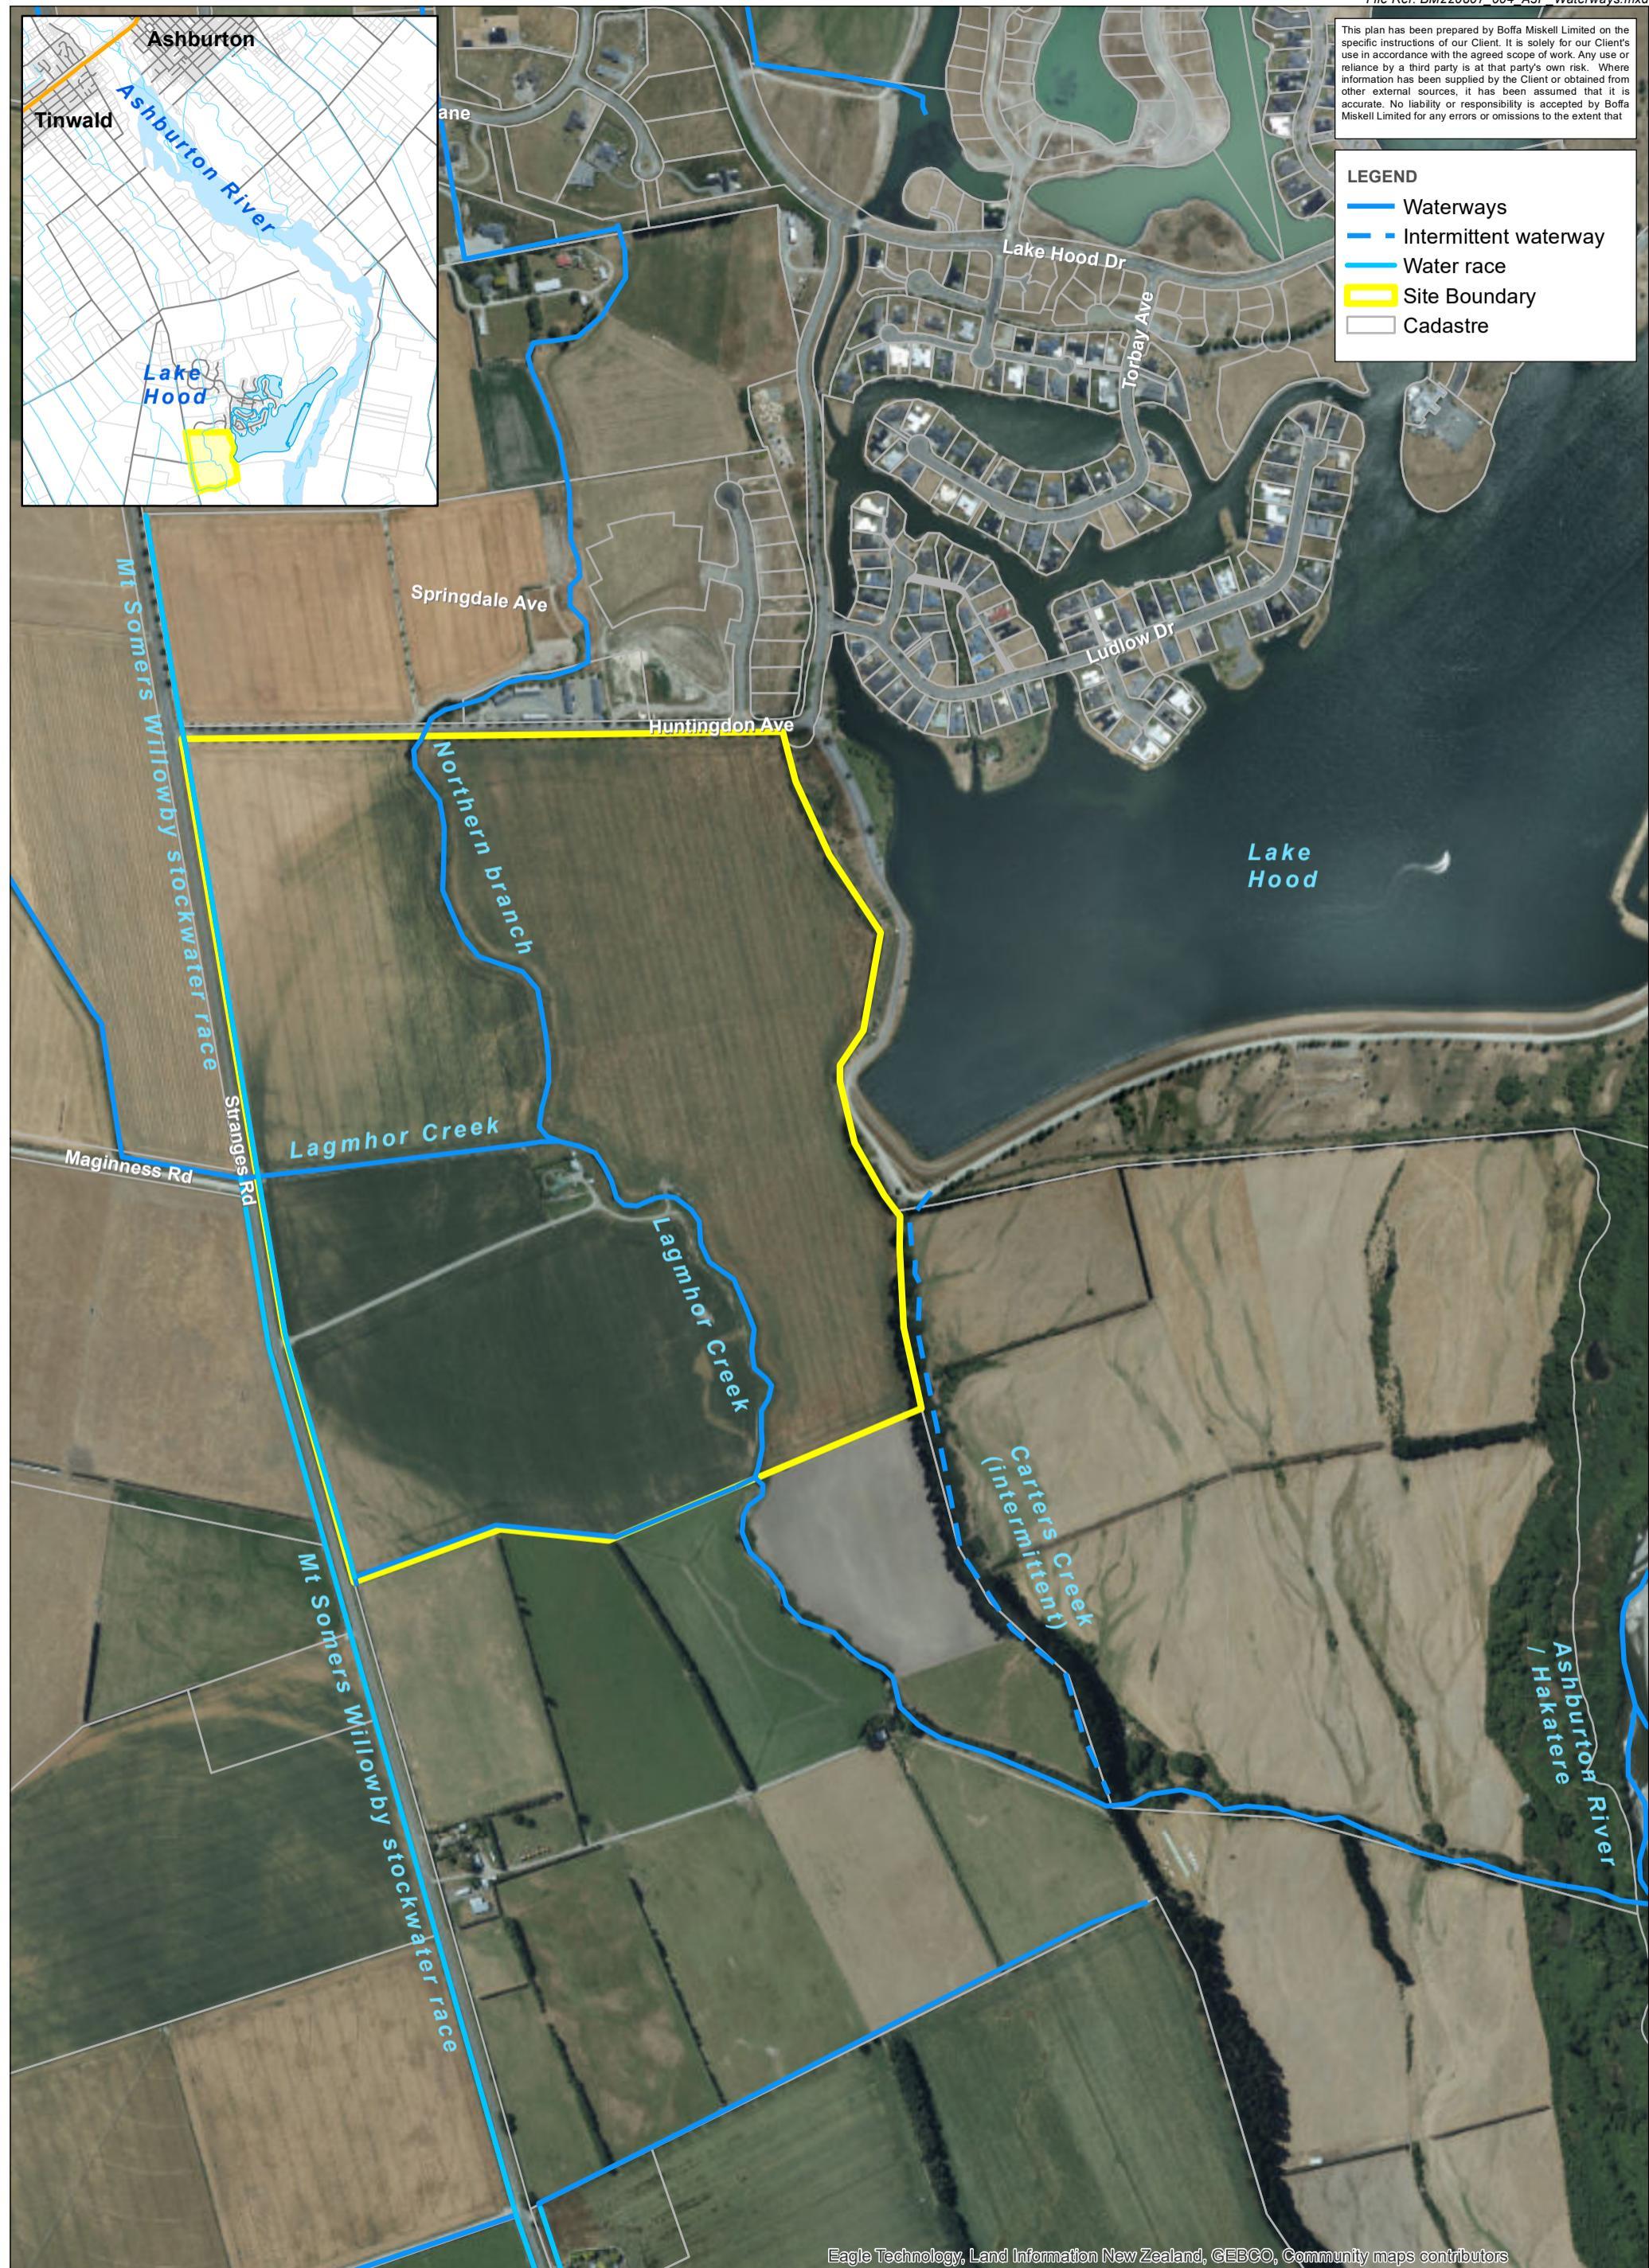
Figure 1

0 200 m	SOUTHERN PARALLEL SPORTS CAMPUS
1:7,000 @ A3	Waterways
Data Sources:	Date: 04 November 2022 Revision: 0
Cadastre sourced from LINZ data service	Plan prepared for Southern Parallel Sports Campus by Boffa Miskell Limited
Projection: NZGD 2000 New Zealand Transverse Mercator	Project Manager: katie.chilton@boffamiskell.co.nz Drawn: BMc Checked: JSc
	Data Sources: Cadastre sourced from LINZ data service Projection: NZGD 2000 New Zealand Transverse Mercator

There are multiple connected waterways within the Site (refer Figure 1). Lagmhor Creek⁶ enters the site from the western boundary and is a perennial watercourse that brings the majority of flow. The watercourse that enters the Site from the north (hereafter referred to as the "northern branch"), joins Lagmhor Creek within the Site. Lagmhor Creek joins Carters Creek downstream of the Site, before flowing to Ashburton River. Mt Somers Willowby water race runs along the western boundary of the site, parallel to the road⁷. Refer to Appendix 1 for images of the watercourses.

A section of this waterway, within the Site, has been straightened and appears to be heavily maintained with frequent clearing of macrophytes. However, downstream of the residential property (see Figure 1), the stream form is more natural (it gently meanders) and less obviously managed for drainage / flood water conveyance, with variable flow habitats, fast run and riffle habitats and small pools present. There were two culverts observed in this downstream section of the waterway, which may become perched in low flows and when water velocity within the channel increases during flood events (Figure 5). Similarly, upstream of Stranges Road (and upstream of the Site), the waterway appears to be less regularly maintained and it has more shading (from exotic weeds), with cobbles present in the channel.

The northern branch (Figure 1) is wide, with the cross section along most of its length approximately 5 m wide (or greater). This watercourse is also classified as a natural, spring-fed – plains waterway, but, like Lagmhor Creek, it has been highly modified for flood conveyance and drainage. The northern branch appears to have been dug out or periodically managed to control sediment and freshwater plant growth. The waterway may be intermittent, where surface flow may be absent during times of prolonged dry weather. However, it's unlikely to be classified as ephemeral as there was surface water present, with slow flow four days after rainfall (with the most recent substantial rainfall event 3 months prior). This would need to be confirmed by observing the watercourse during different seasons.

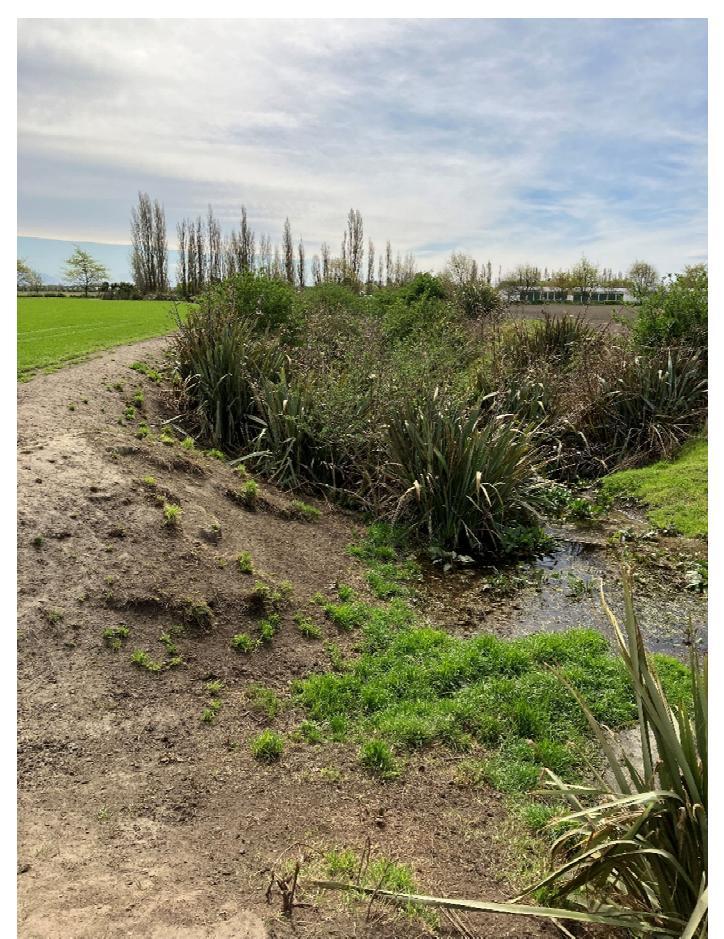
Figure 2: Vegetation within the gully area along the northern branch of the unnamed tributary of Carters Creek. Image taken during site visit on the 4th of October 2022.

The terrestrial vegetation present at the site is almost entirely improved pasture (exotic grasses and a range of exotic pasture weeds), shelterbelts of exotic species, and some weeds such as gorse (*Ulex europaeus*), scotch broom (*Cytisus scoparius*) and crack willow (*Salix fragilis*) along waterways. There is a small number of possibly self-established silver tussock (*Poa cita*) along the western boundary, and kohuhu (*Pittosporum tenuifolium*) along the northern boundary. The gully that encloses the northern branch that enters Lagmhor Creek has some remnants of indigenous vegetation, including harakeke / flax (*Phormium tenax*), tī kōuka / cabbage tree (*Cordyline australis*), bracken fern (*Pteridium esculentum*) and a small number of plants of an indigenous sedge (*Carex* sp.) (Figure 2).

Vegetation is visible in the gully in aerial photographs from as early as 1941 (Local Government Geospatial Alliance, n.d.), so it is possible that this vegetation represents remnant or naturally regenerating vegetation that is representative of what would have historically been found in the Low Plains Ecological District. As there is very little remaining indigenous vegetation in the Low Plains Ecological District and the majority of the Canterbury Plains is classified as an 'Acutely Threatened' land environment (Walker et al., 2007), this vegetation would be considered significant under the Environment Canterbury (2013) Regional Policy Statement (RPS) Appendix 3 significance criteria. This vegetation is proposed to be retained and enhanced as part of an improved ecological corridor.

The vegetation present in the gully (northern branch) may represent remnant or naturally regenerating vegetation that is representative of what would have historically been found in the Low Plains ED. While this vegetation is of low value (due to its condition), it meets the test of significance in the RPS (under rarity) (Environment Canterbury, 2013).

- Remove weeds in the gully riparian area of the northern branch, keeping any indigenous species (i.e., harakeke and tī kōuka). The removal of willows is recommended, via cut and paste or drill and fill techniques, which would allow for roots to be left in situ to avoid affecting bank stability.

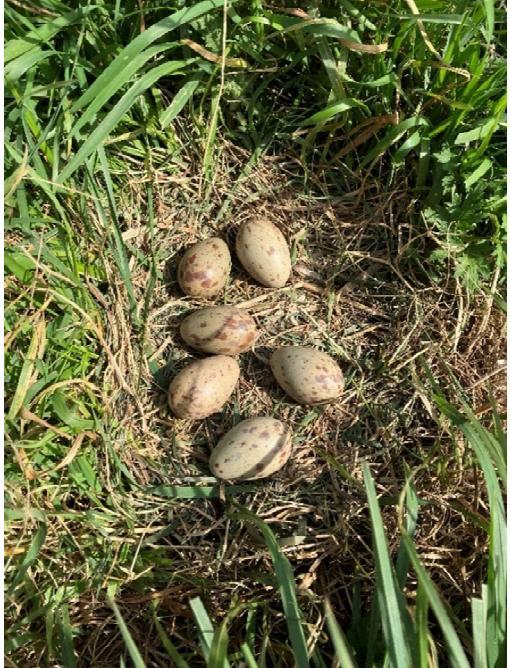
Figure 3: Pūkeko eggs observed during site visit on the 4th of October 2022.

Of particular note, during the site visit / walkover New Zealand pied oystercatcher (*Haematopus finschi*, At Risk – Declining) and black-fronted tern (*Chlidonias albostriatus*, Threatened – Nationally Endangered) were observed feeding within the paddocks on site (Appendix 2). At the confluence of the western and northern branches of the tributary to Carters Creek, a pūkeko (*Porphyrio melanotus melanotus*, Not Threatened) nest was observed (Figure 3).

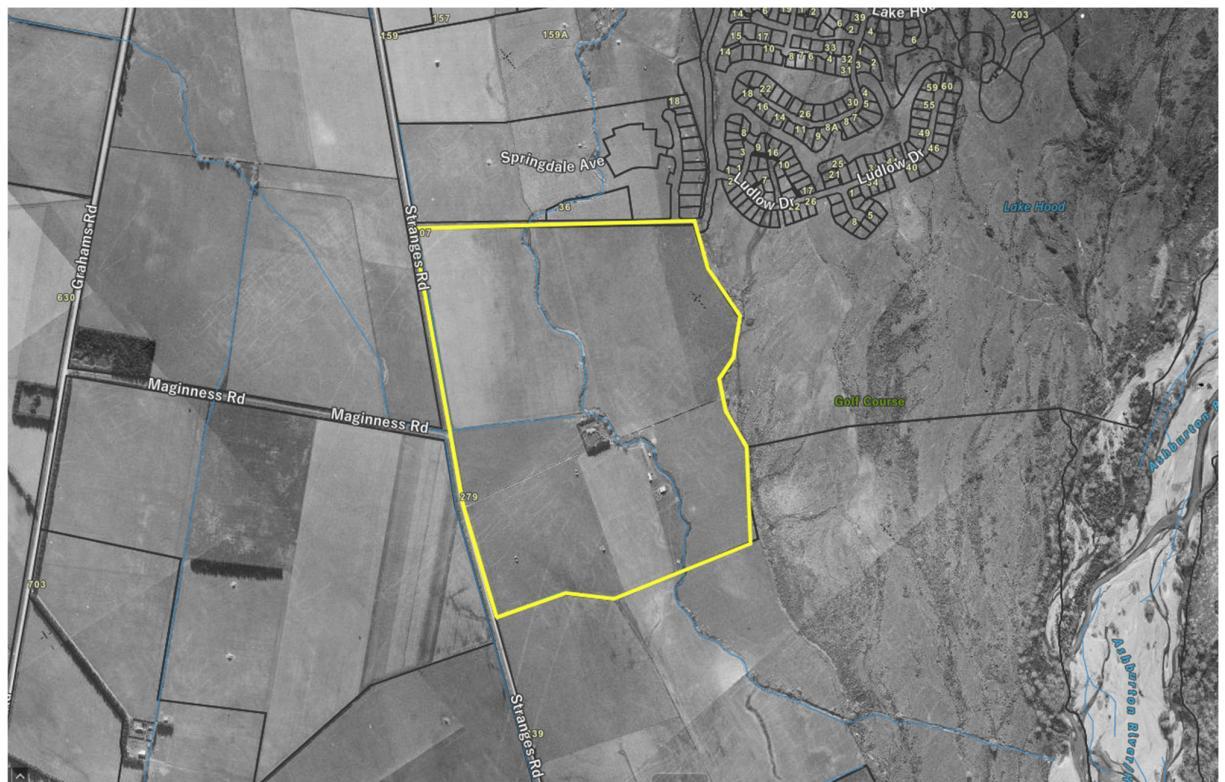
Figure 4: Environment Canterbury Maps Historic Aerial Imagery 1940-1944 with LINZ river layer overlaid. Site extent indicated by yellow line.

Based on our interrogation of historic aerial imagery, Lagmhor Creek and the northern branch are present in similar extent and locality to present day location (Figure 4). Upstream of the Site, historic aerials show Lagmhor Creek had a meandering channel, which has been straightened for agricultural and flood conveyance purposes. In this historic imagery, the braid plain of the Ashburton River extends further than present day to the Site's eastern most boundary.

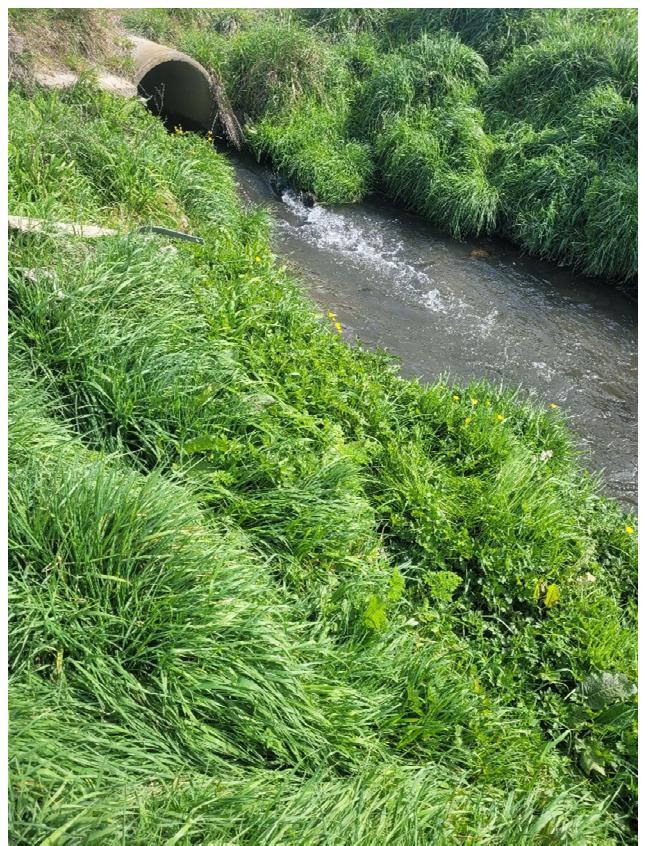
Figure 5: Culvert below confluence of the branches of unnamed tributary to Carters Creek.

Within the section that flows west-east there were five culvert crossings (for a pivot irrigator) each with an approximately 700 mm diameter pipe. These were spaced c.50 m apart and may restrict the flow (and potentially fish passage) at times. The crossing closest to Stranges Road has a pipe of approx. 5 m in length, providing for a vehicle / farm crossing.

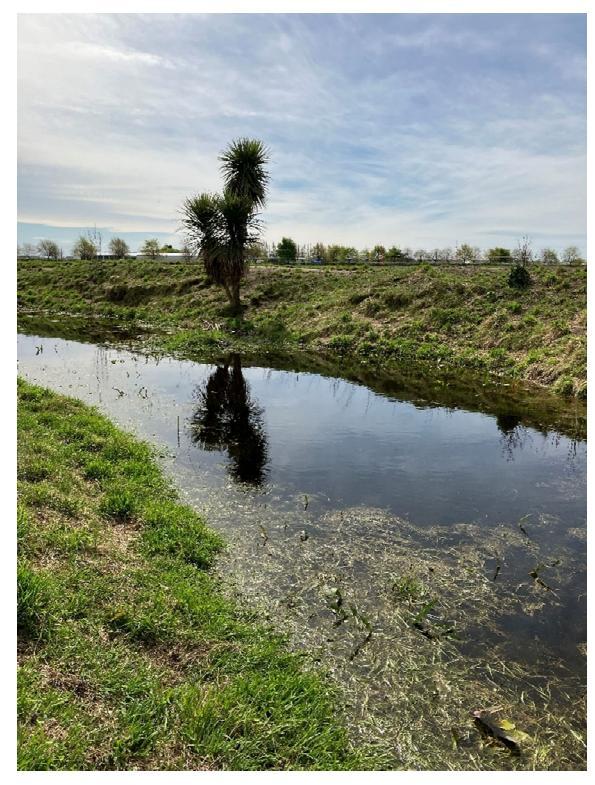
Northern branch of unnamed tributary of Carters Creek

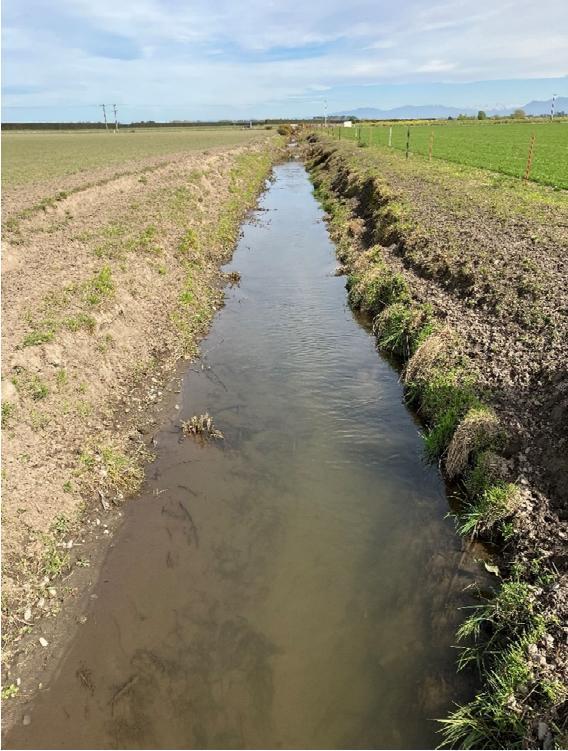
Straightened section of the western branch of unnamed tributary of Carters Creek

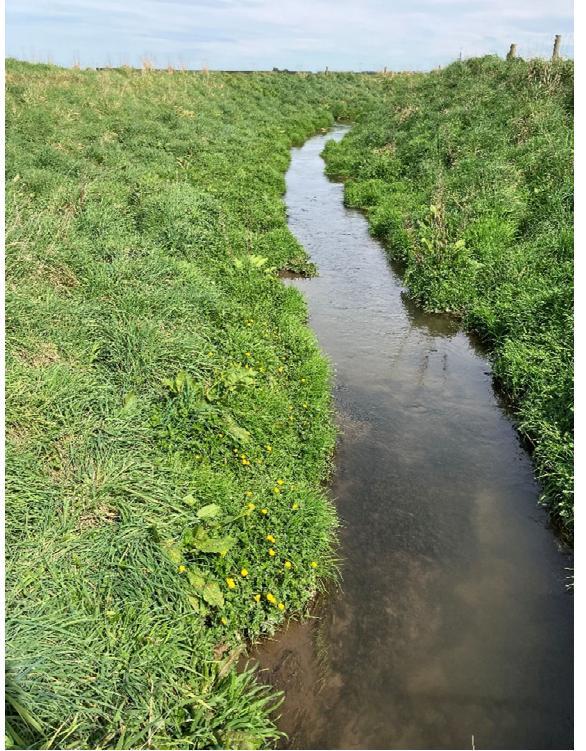
Unnamed tributary of Carters Creek downstream of the residential dwelling and below the confluence of the northern and western branches

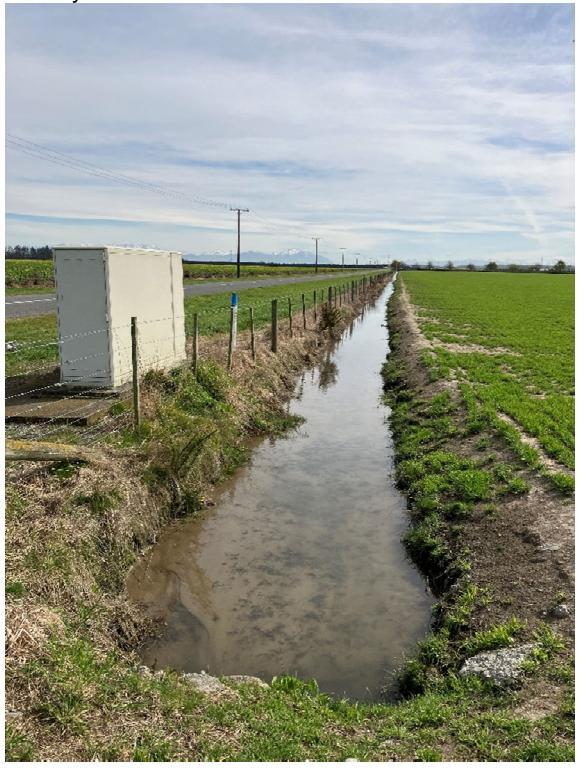
Mt Somers Willowby water race, which runs inside the Site along the western boundary

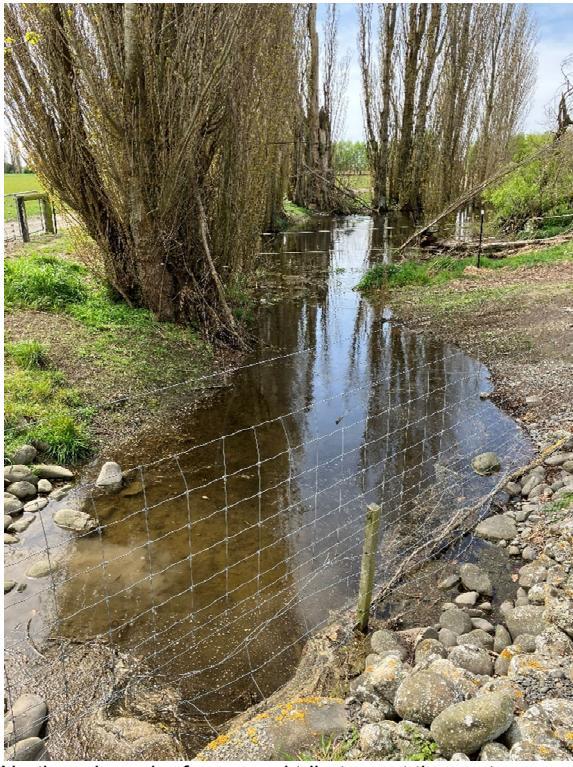
Northern branch of unnamed tributary, at the upstream extent of the Site near Huntingdon Avenue

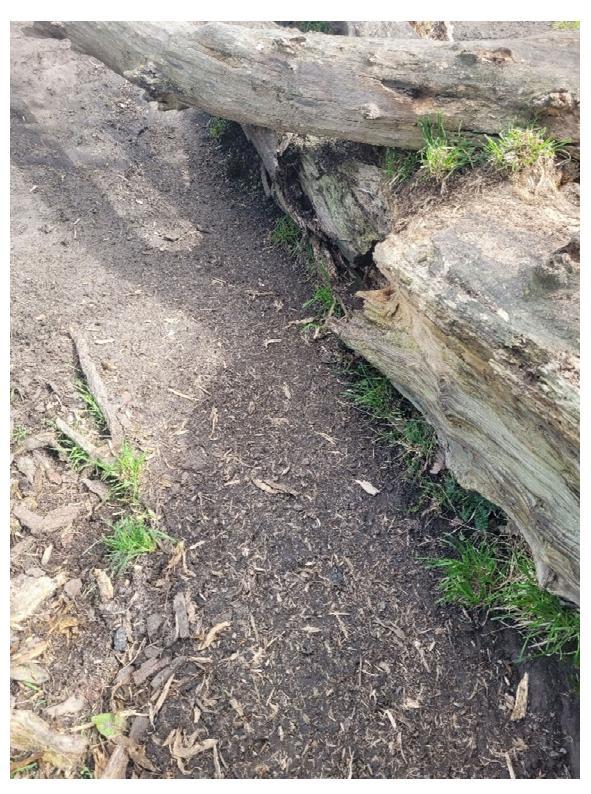
Woody debris near Huntingdon Avenue

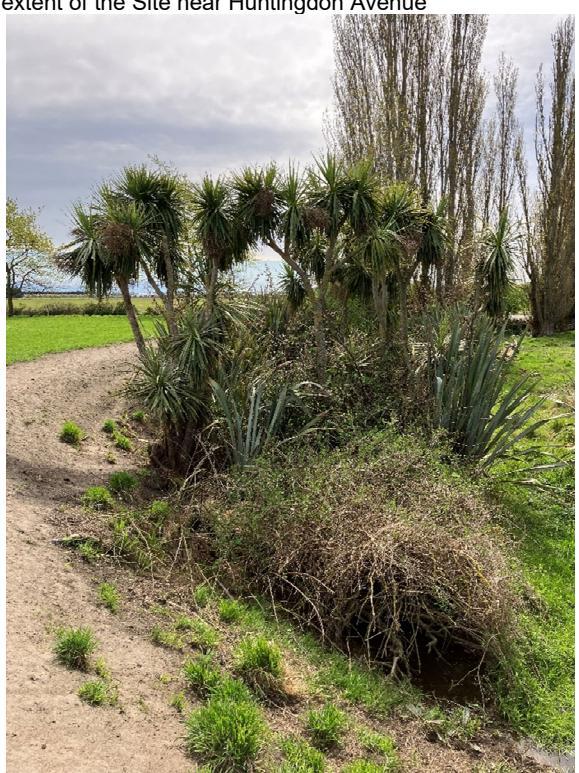
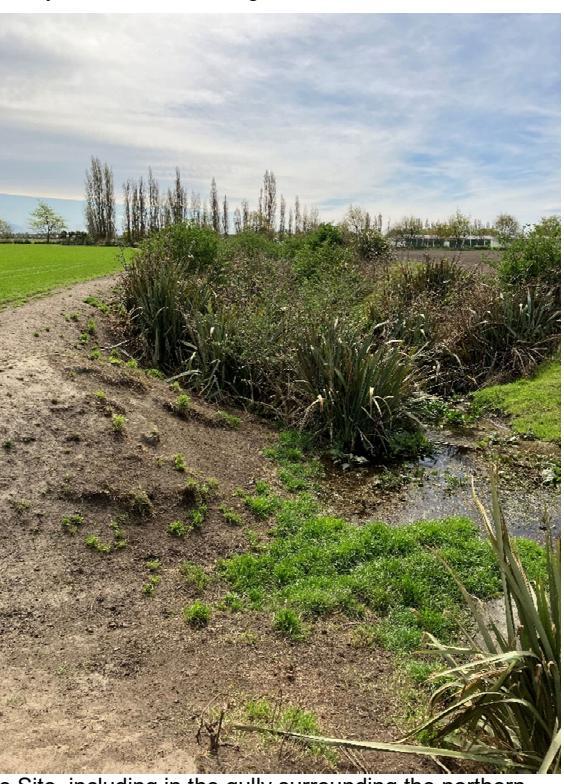
Tī kōuka / cabbage trees and harakeke / flax present wihtin the Site, including in the gully surrounding the northern branch, which may represent remnant or naturally regenerating vegetation historically present in the Ecological District

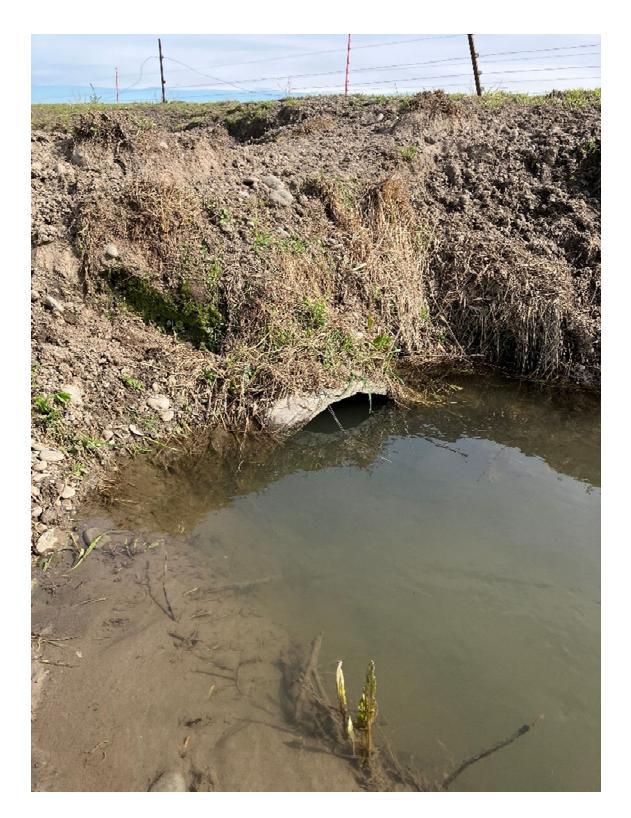
One of the culvert crossings on the western branch

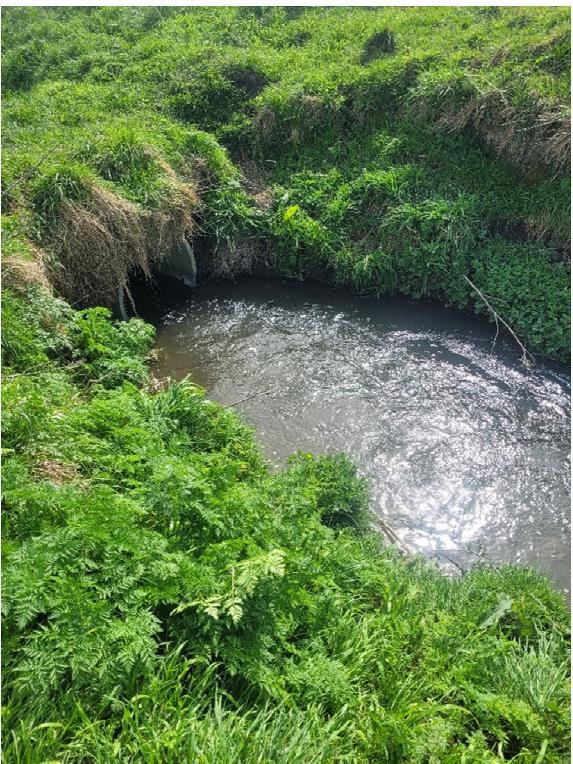
A culvert crossing in the unnamed tributary to Carters Creek, downstream of the confluence of the northern and western branches
