# **Arboricultural report**

- **To:** Nick Mattison, Project Planner, Civix s 9(2)(a)
- From: Andrew Barrell, Consultant Arborist Tree 3 Ltd s 9(2)(a)
- Date: 01 June 2021
- Re: 6-10 The Strand, 21 Hurstmere Road, and 33-45 Hurstmere Road, Takapuna Notable Tree

Development constraints assessment

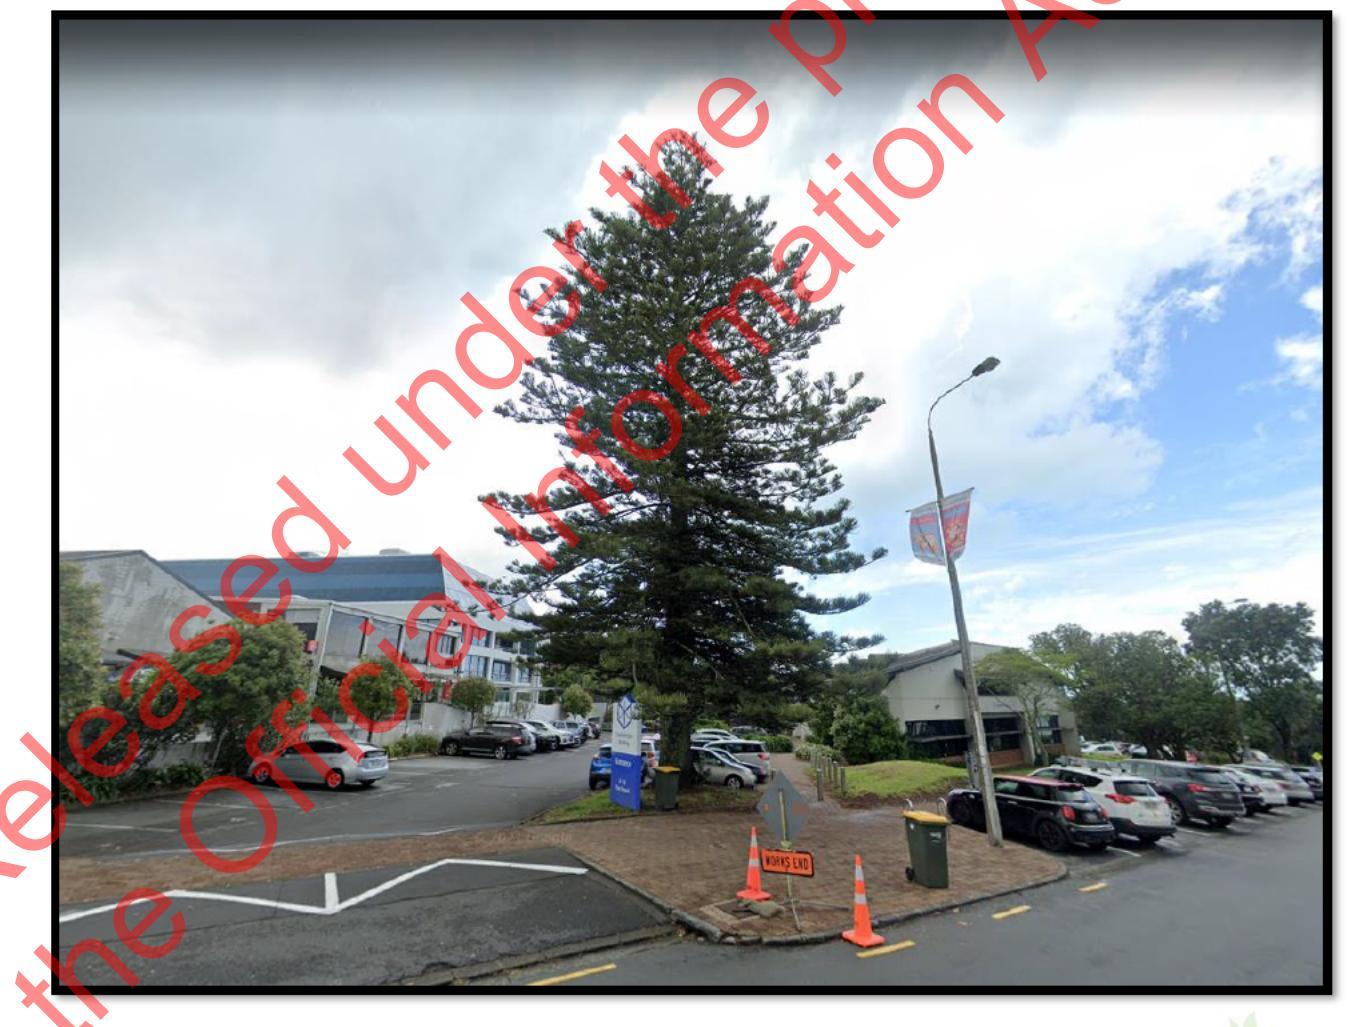
10) Figure 2 below is an image of the tree (courtesy of Google Streetview) which shows the tree and its immediate surrounds. This image shows that the majority of the TPZ is covered with a combination of tarmac, footpaths and pavers with a relatively small percentage covered with grass/bare earth.

- 15) **Root zone disruption**. The tree appears to be in reasonably good health in spite of most of the TPZ being covered with tarmac and footpaths. Assuming the proposal compromised the abovementioned 25% of TPZ area, if the TPZ were to be ameliorated so that it provided a more root-friendly environment it is conceivable that this scale of root zone disturbance could be adequately tolerated and mitigated with the possibility that there would be an overall improvement in the growing environment. This would ideally be achieved by removal of all foreign objects from within the TPZ area (tarmac, kerbing, footpaths etc.) and applying a layer of aged wood chip mulch to the exposed area to a depth of 75-100mm which would be maintained for at least three years post-construction.

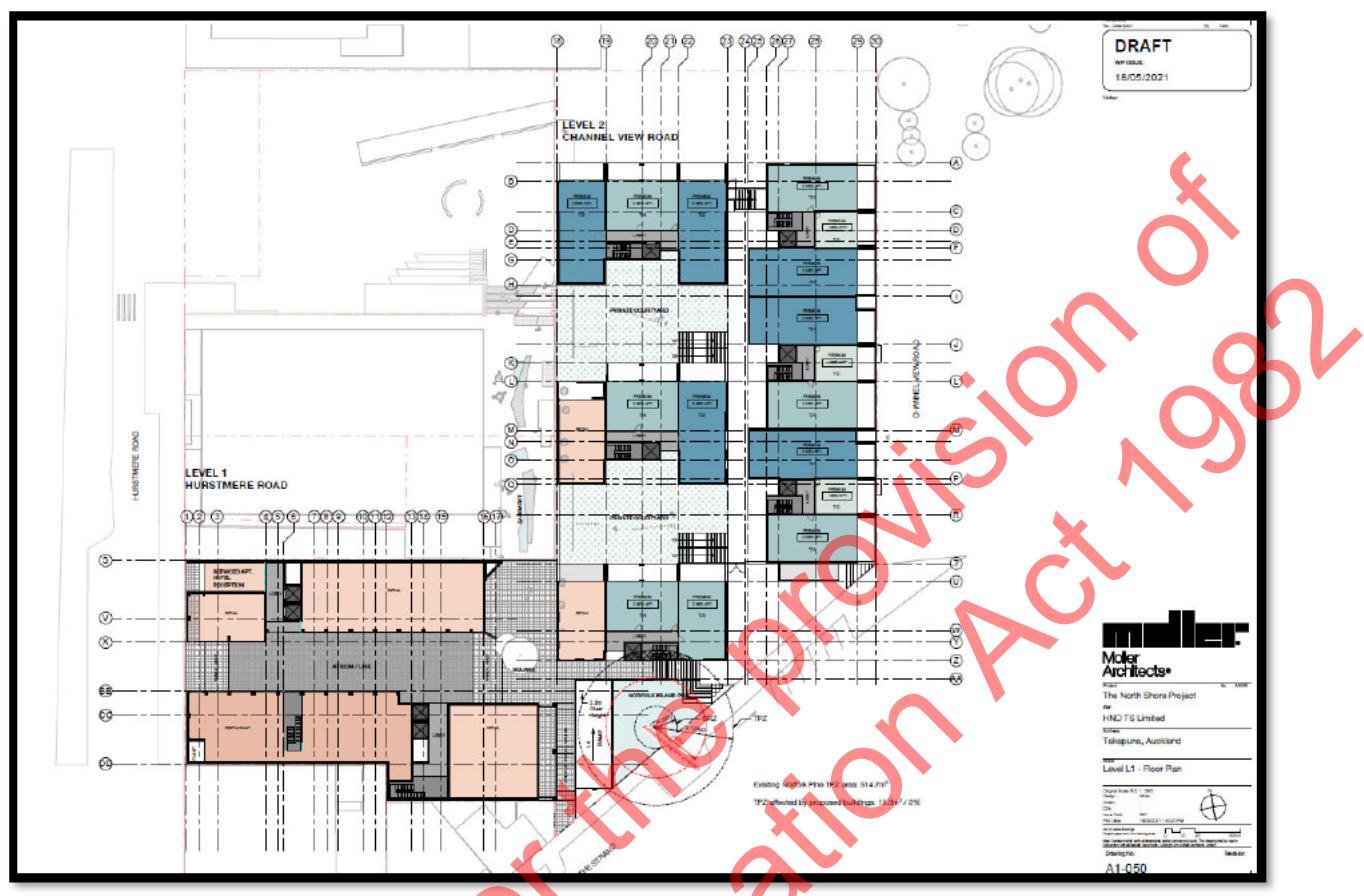
Figure 3 – Current proposed site layout in relation to the Notable tree.

11) Figure 3 below shows the current layout as of 18 May 2021. Figure 4 shows an enlarged section which clarifies the extent of proposed works in close proximity to the tree. These figures indicate that 3% of the TPZ is affected by the building which presumably relates to the encroachment to the north of the tree. Note: in this situation the TPZ is approximately the same as the AUP definition of the PRZ.

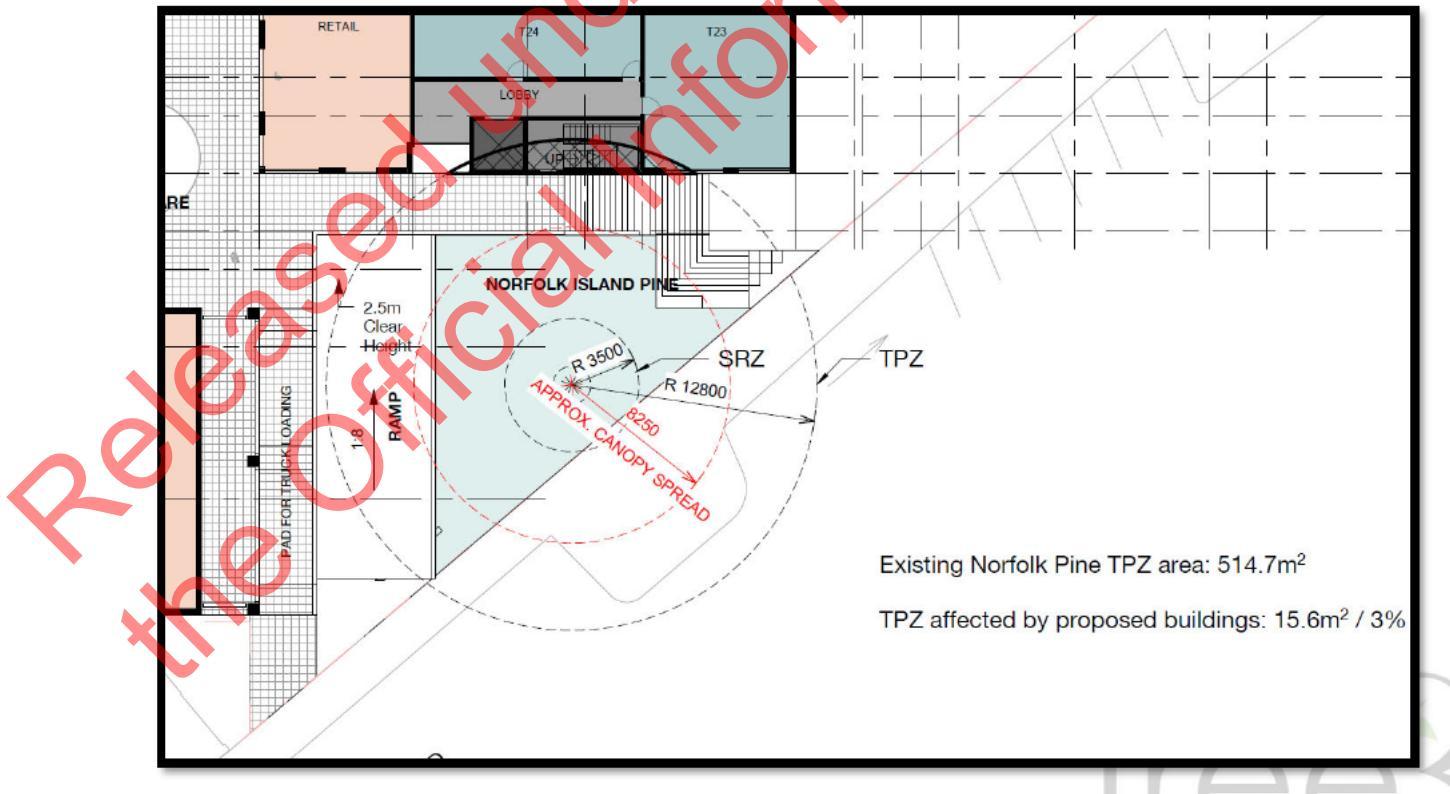
Figure 4 - Enlarged version of above plan showing proposed works in relation to the Notable tree.

- 19) *Canopy disruption*. Extrapolation from the image in Figure 4 indicates that the closest encroachment towards the canopy of the tree occurs to the north. In this area the building is at least 2m from the outer edge of the canopy. This only implicates a very small section of the canopy and, for the remaining canopy footprint beyond this area, the building footprints are located at least 5m or more from the canopy.

- 20) The most significant canopy encroachment is obviously the area with 2m clearance between the canopy and nearest building. In this situation there is adequate room to enable scaffolding to be used without causing a significant impact on adjacent limbs. Minor tip trimming may occur if necessary (which would only likely amount to no more than 1m off the end of the closest limbs) and many limbs can simply be pushed aside and temporarily shielded by plywood cladding on the scaffolding to prevent interference with work activities (see additional comments below about maintenance pruning). The remaining areas around the periphery of the canopy have adequate space to enable construction-related activities to occur with no conflict with branches.

- 21) With regards to managing ongoing conflicts between growing limbs and adjacent buildings, there will be a requirement in future to carry out minor maintenance pruning on the relatively small northern section of canopy where it comes close to the building. This may entail some tip reduction of lateral limbs by approximately 1-2m. This would provide adequate clearance from the building for conceivably several years before any ongoing pruning would be required.

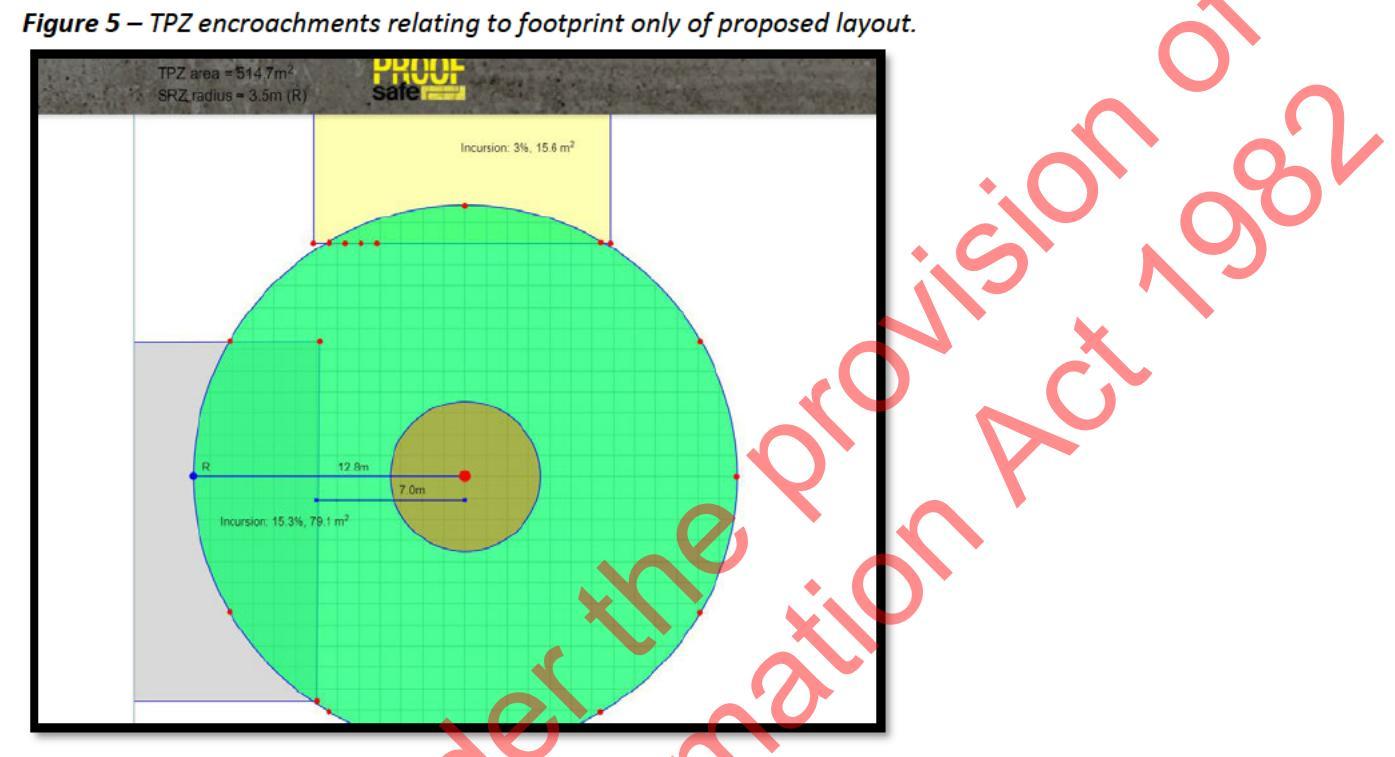
13) Figures 5 and 6 below show graphical representations of the extent of TPZ affected by the footprint of the building and ramp – Figure 5 shows the actual footprint and Figure 6 shows the footprint with an additional buffer zone of 1m to accommodate overcut/construction activity. These images and calculations are taken from the Proofsafe website (<u>https://proofsafe.com.au/tpz\_incursion\_calculator.html</u>) and serve to provide approximations of the extent of encroachments.

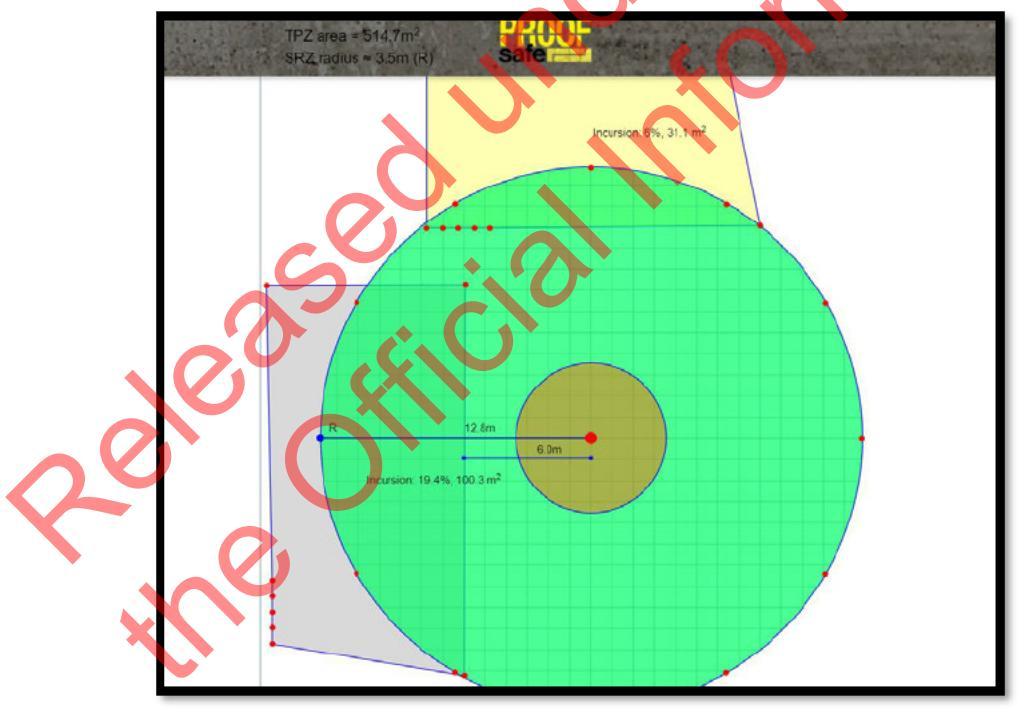
Figure 6 – TPZ encroachments relating to footprint of proposed layout plus 1m buffer zone.

14) Figure 6 represents a more realistic estimate of TPZ area that will be affected by the proposed layout. According to this image the ramp will implicate 19.4% of the TPZ and the building to the north will implicate another 6% which results in 25.4% (or 131.4m<sup>2</sup>) of TPZ affected by the proposed layout. There are no SRZ encroachments.

- 17) So, whilst the industry standard (AS4970) indicate that anything affecting over 10% of the TPZ requires compensation elsewhere contiguous with the TPZ, this is unlikely to be achievable in what is a very constrained location however, amelioration and improvement of existing root zone area could provide similar benefits i.e. an improvement in the overall rooting environment of the tree. As such the extent of root zone compromised by this current design is of a scale that will be able to be adequately mitigated by reinstatement of the maximum area of TPZ to mulched surface/fully permeable (as opposed to the current status which has only a very small percentage as fully permeable).
