Neil Construction Ltd PO Box 8751 Symonds Street Auckland 1150 Ref: LtR-0782/Mar15/Rev1

RE: DUE DILIGENCE INVESTIGATION OF 101 & 105-107 TOTARA ROAD AND 9 MCKEAN ROAD, WHENUAPAI.

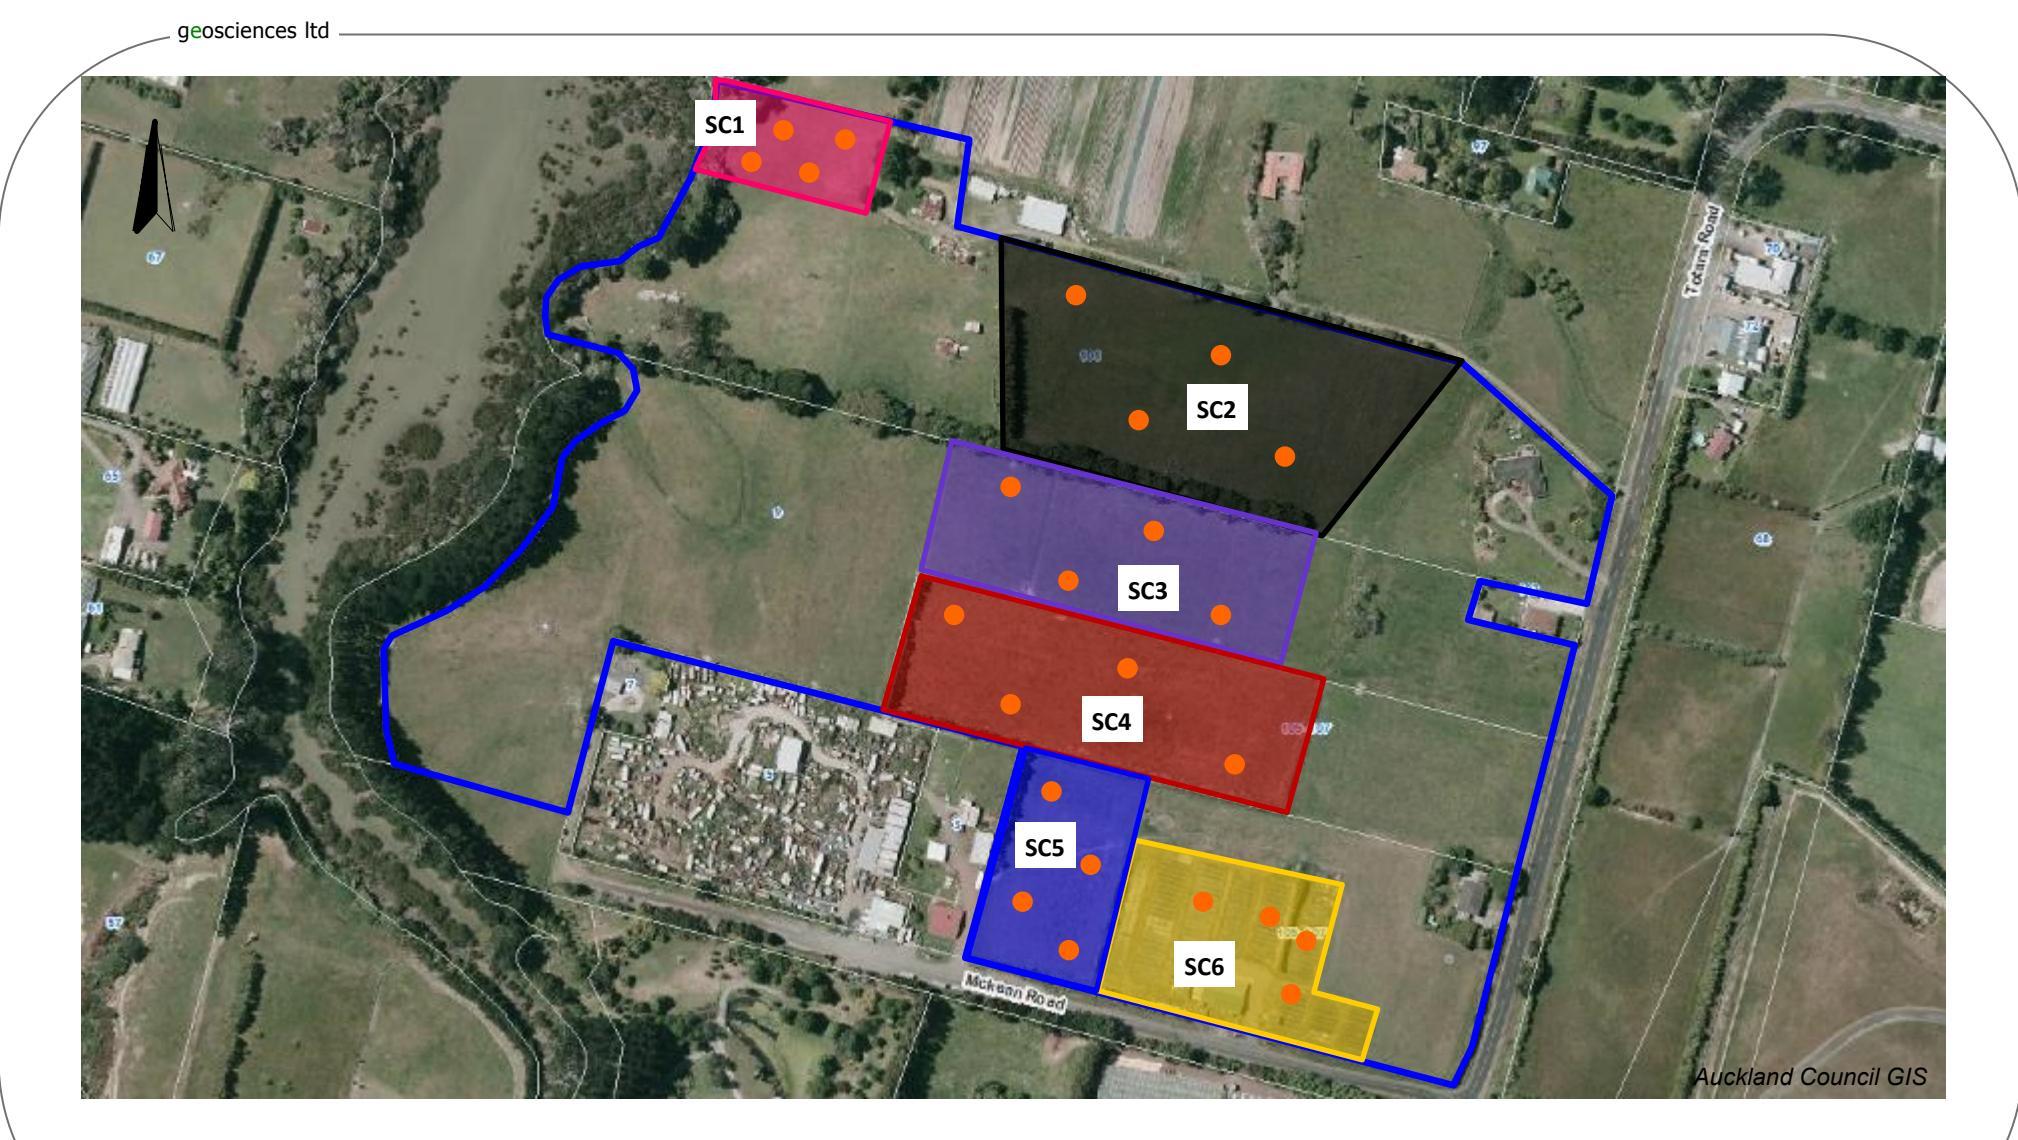
FIGURE 2. SOIL SAMPLING LOCATIONS

The sampling protocol followed was in accordance with the Contaminated Land Management Guidelines (CLMG) No. 5 -*"Site Investigation and Analysis of* Soils". The soil sample locations are shown in Figure 2, and site photographs are attached in Appendix C.

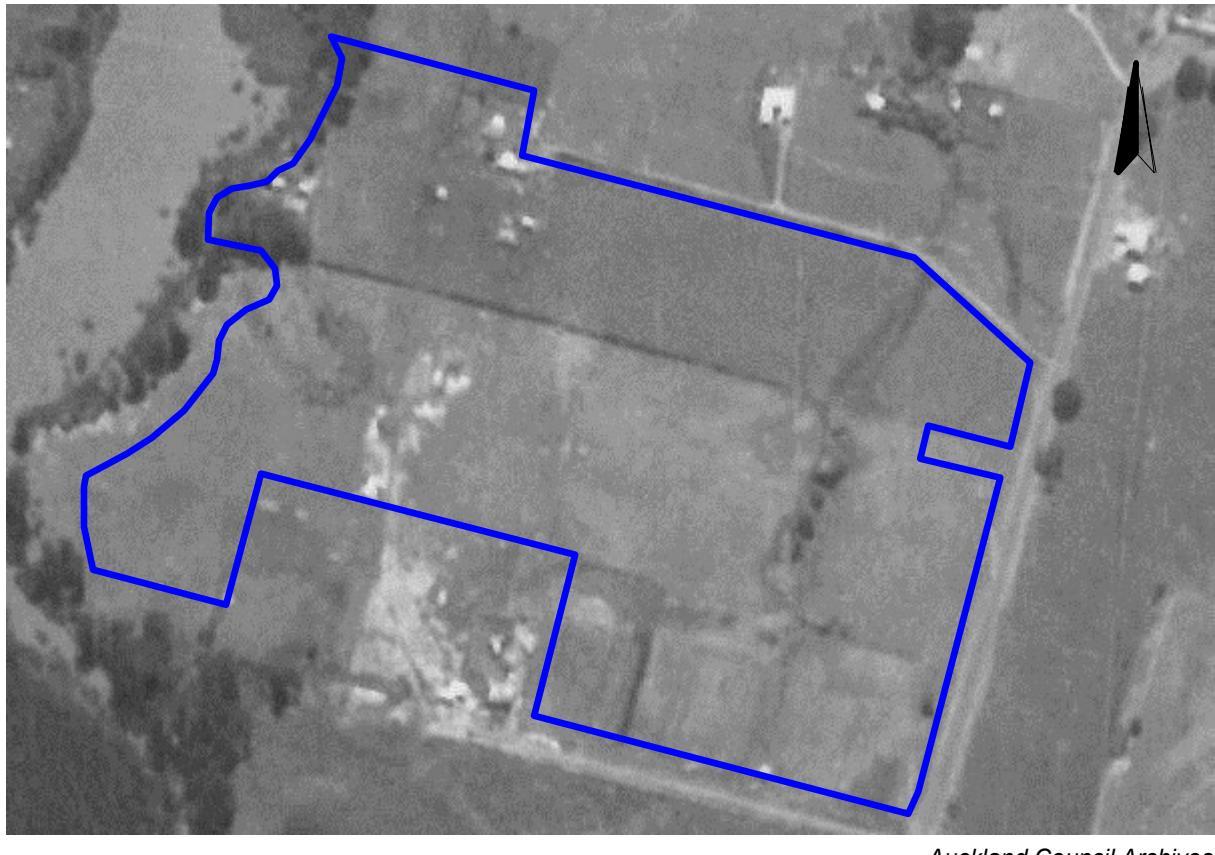
1968 Aerial Photograph

- **1968** This is the earliest photograph available for the site and shows that the majority of the site is apparently covered in pasture. The eastern boundary is bordered by Totara Road, while the southern boundary by McKean Road. Six unidentified structures are located in the northern corner of the site. In the southeastern corner, the aerial photograph shows different colouring and textures in the fields consistent with former horticultural broad acre cropping. An area of disturbance is visible in the centre west of 9 McKean Road, adjacent to a small gully bordering the western boundary.

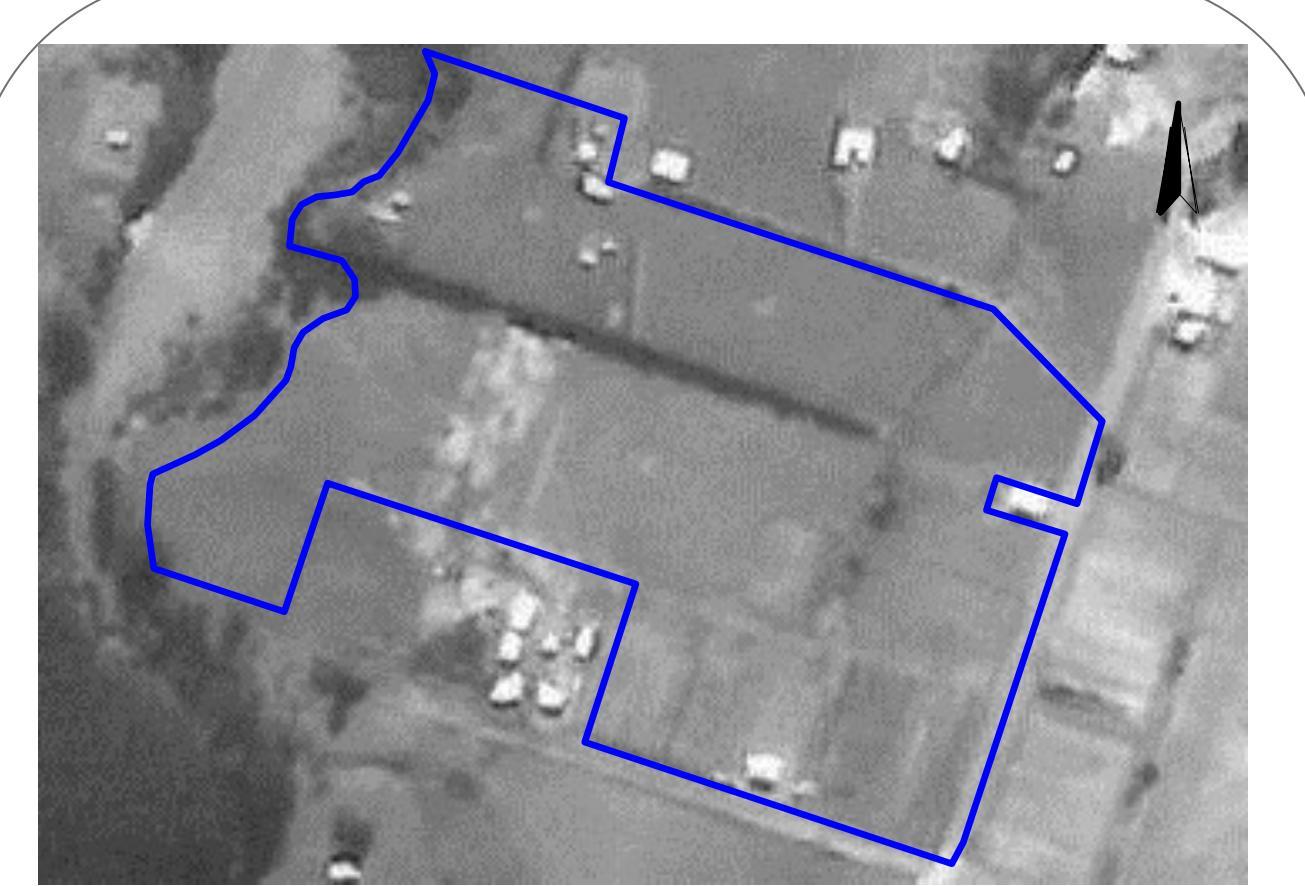
1975 Aerial Photograph

- **1975** The 1975 aerial is clearer than the previous plate making the site features discernible. Three additional unidentified structures are visible along the southern boundary of the site, however no other significant changes are observable in respect of the Totara Road Properties. Within the centre west of 9 McKean Road, the identified area of disturbance has expanded laterally. A small gully clearly runs north to south through all the properties parallel to Totara Road.

The unidentified structures mentioned in the 1975 aerial photograph, located at 101 Totara Road, has been confirmed as a residential dwelling and storage sheds for farm equipment and hay storage. There were no structures on site that could have been spray races or animal dips, and no distinct visual indications were identified that confirm the disturbance identified in the 1968 and 1975 aerial images

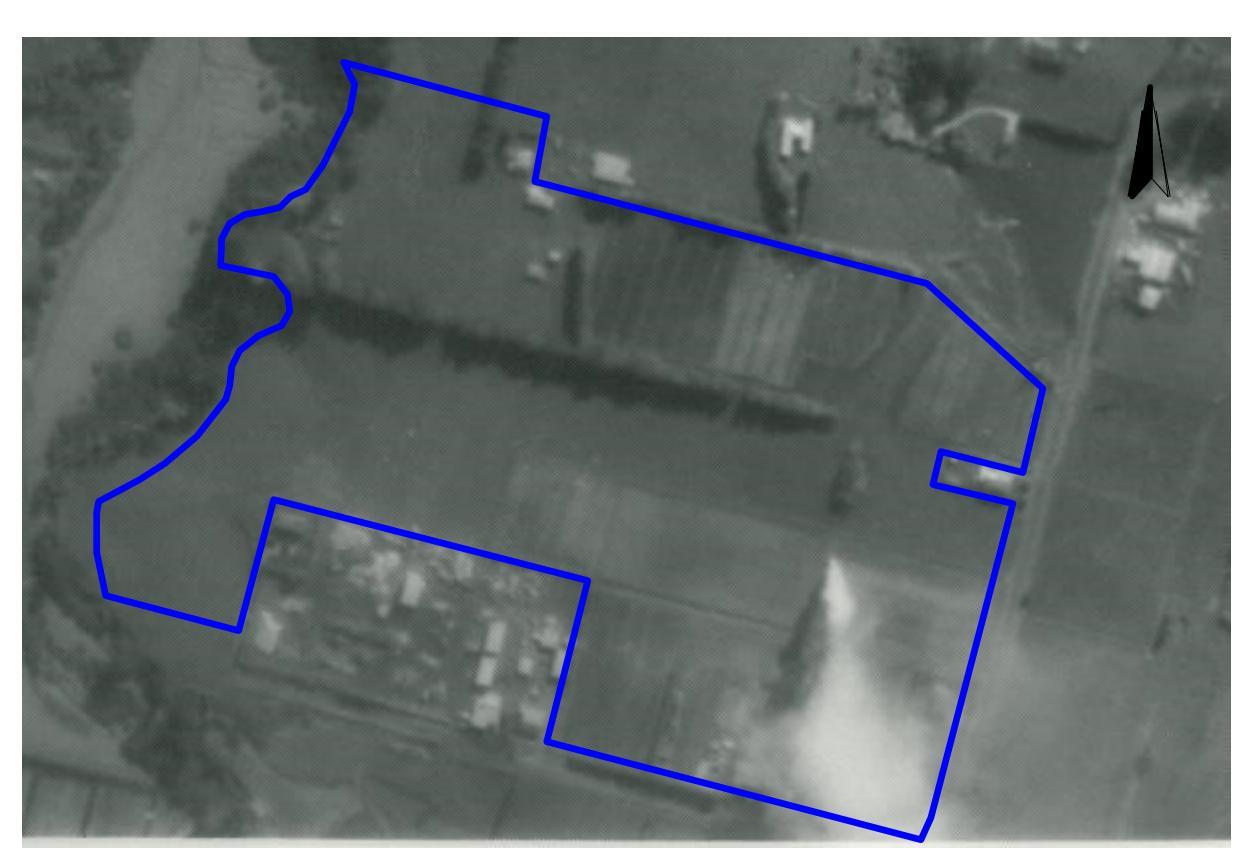
1987 Aerial Photograph

- **1987** By 1987 cropping activities are distinct in the southeastern and northeastern portions of the site, encompassing the majority of the properties. In this image, it appears that only the property at 9 McKean Road remains as pastoral land in conjunction with the northwestern corner of 101 Totara Road. A portion of the property at 105-107 Totara Road is obscured by a small fire within 9 McKean Road. Neither of the two identified

gully areas are visible at this time. Storage activities have also commenced on the adjacent McKean Road Properties, appearing to encompass addresses 3, 5 & 7.

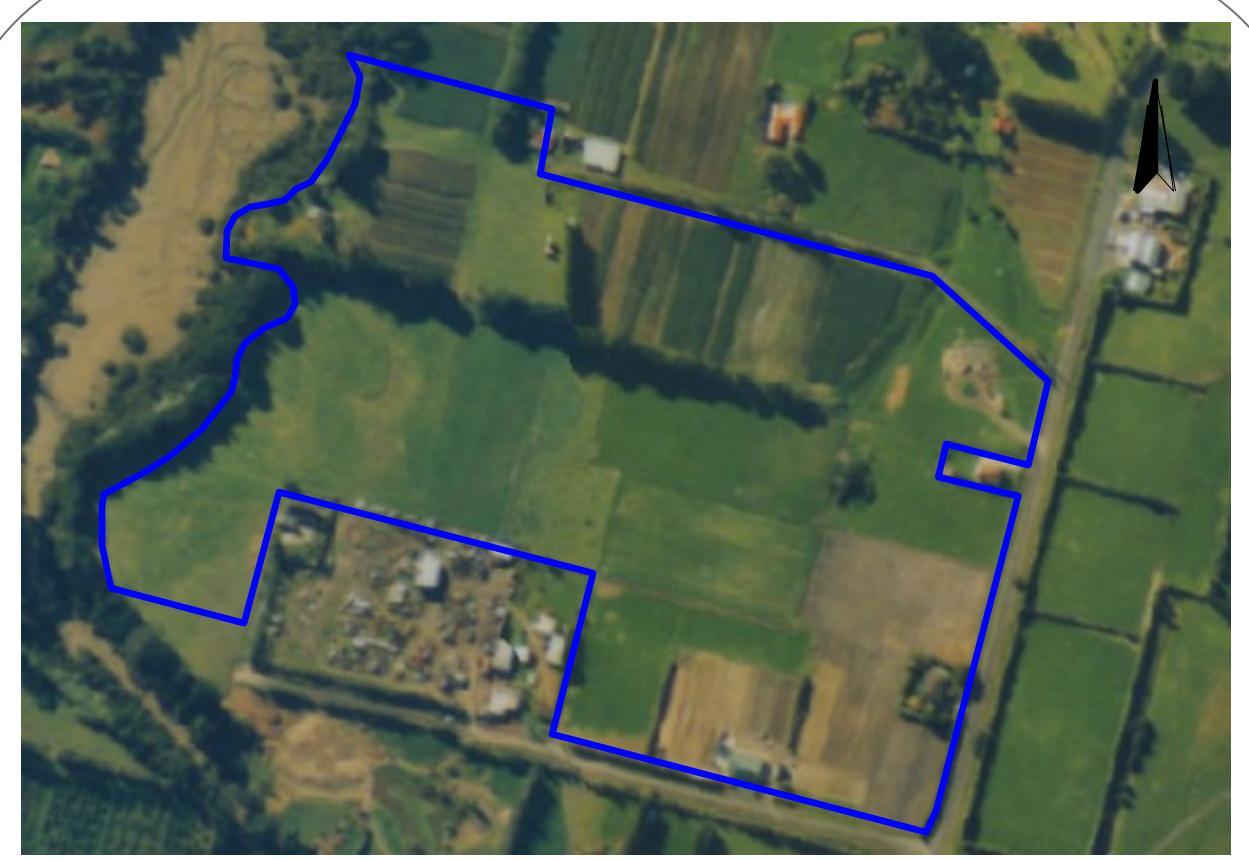
1996 Aerial Photograph

- 1996 The 1996 aerial is the first colour image available for the site and appears generally consistent with the 1987 image, but further clarifies field boundaries. Apart from the property at 9 McKean Road, the majority of the remainder of the site is under broad acre crop, or shows evidence to suggest recent cropping activity. In addition, a section of the northwestern corner of 101 Totara road has been developed into cropped land. A residential dwelling is now clearly evident on the front portion of the 105-107 Totara Road Property. The two gully systems identified historically are faintly visible in this image, although cropping activities at 105 Totara Road appear to encroach into the system. In addition, the storage activities on the adjacent McKean Road properties continue.

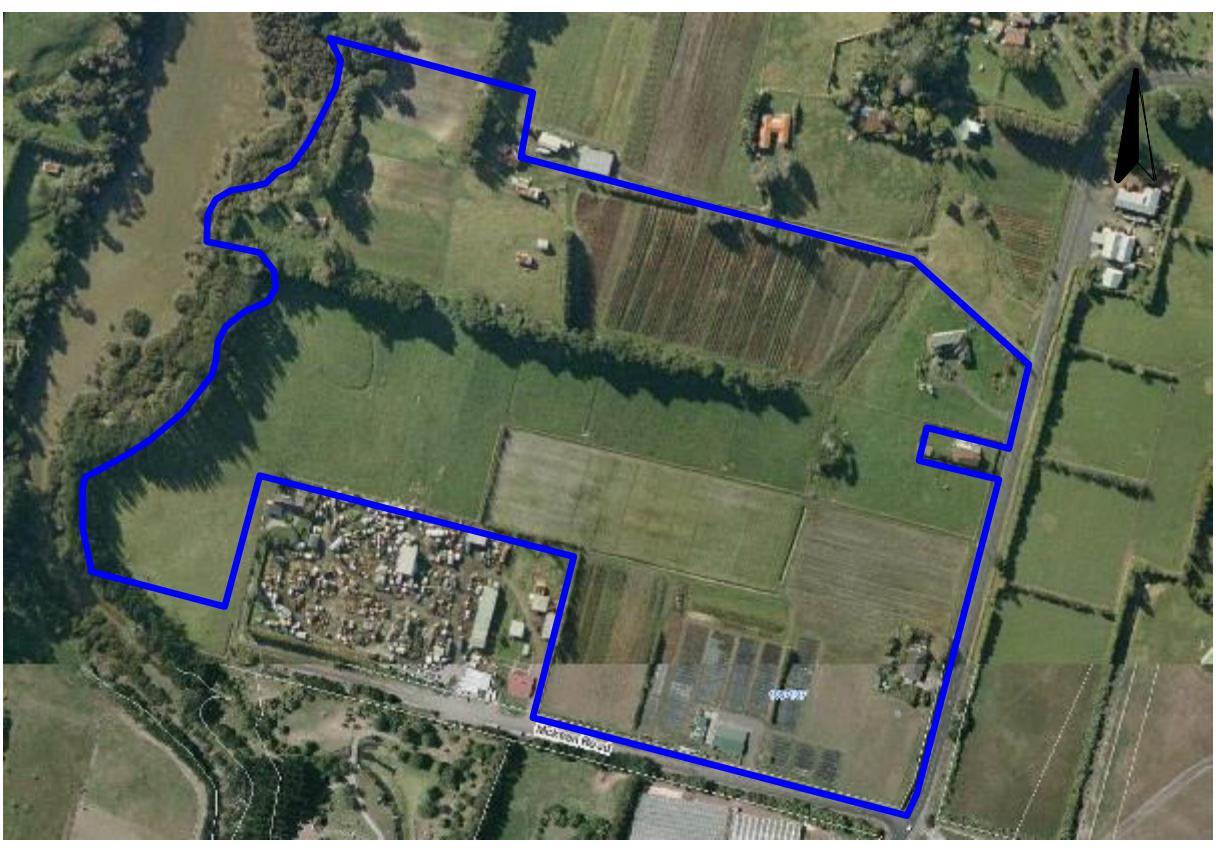
2001 Aerial Photograph

- **2001** The 2001 plate shows continued cropping activities within 101 and 105 107 Totara
- **2009** Roads, with the distinct addition of plastic ground covering within the portion of 105-107 Totara Road bordering McKean Road. Between 2001 and 2009, intermittent cropping activities remain across these portions of the site, significantly reducing in extent between 2006 and 2009. The identified gully systems have are again clearly visible in this series of images while the storage activities at the adjacent McKean Road site have intensified.

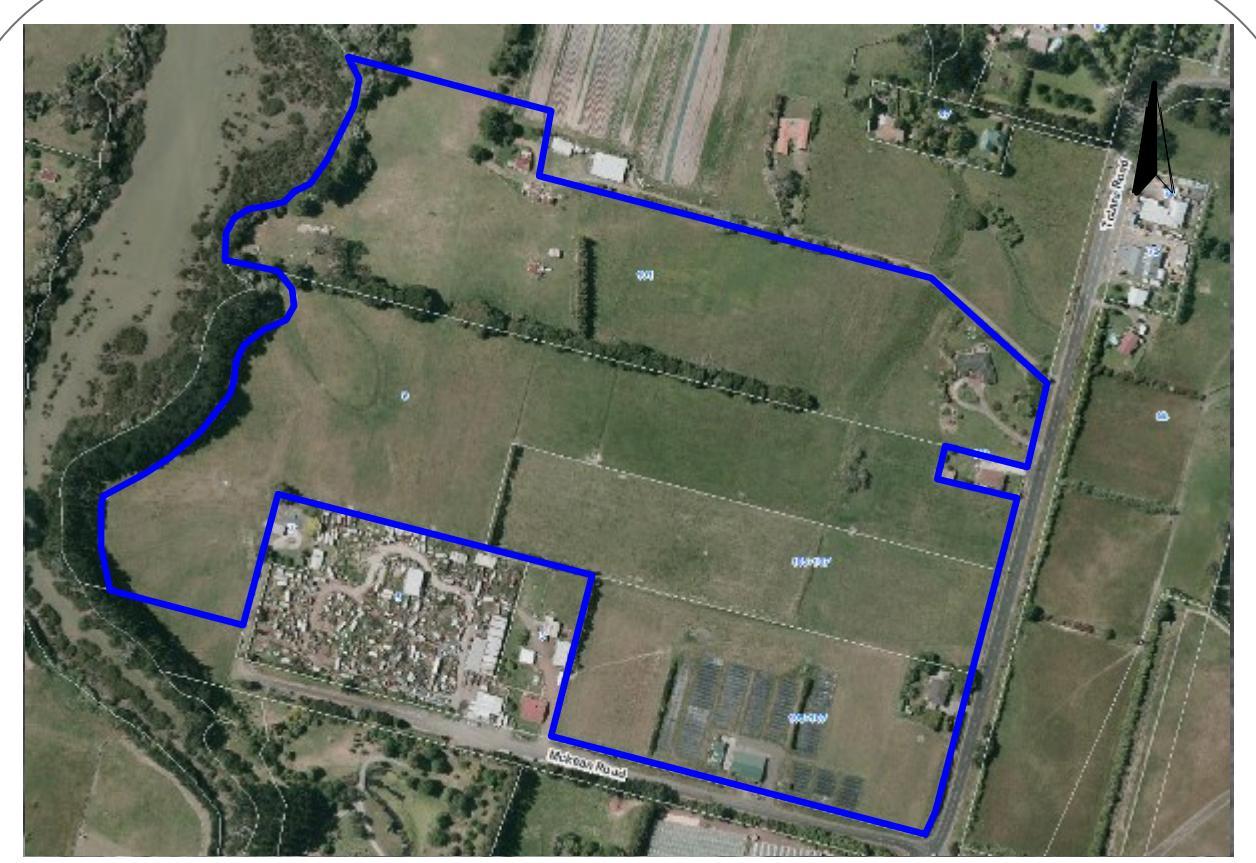
2010 Aerial Photograph

- **2010** By 2010, it appears that all cropping activities have ceased except for the nursery
- 2015 operation along the southern boundary of 105-107 Totara Road where it borders McKean Road. The most recent 2015 aerial image from Google Earth shows that the majority of the site has been returned to pasture, with the exception of a small portion of the nursery area discussed above. Storage activities at the adjacent McKean Road sites show significant coverage of the piece of land.

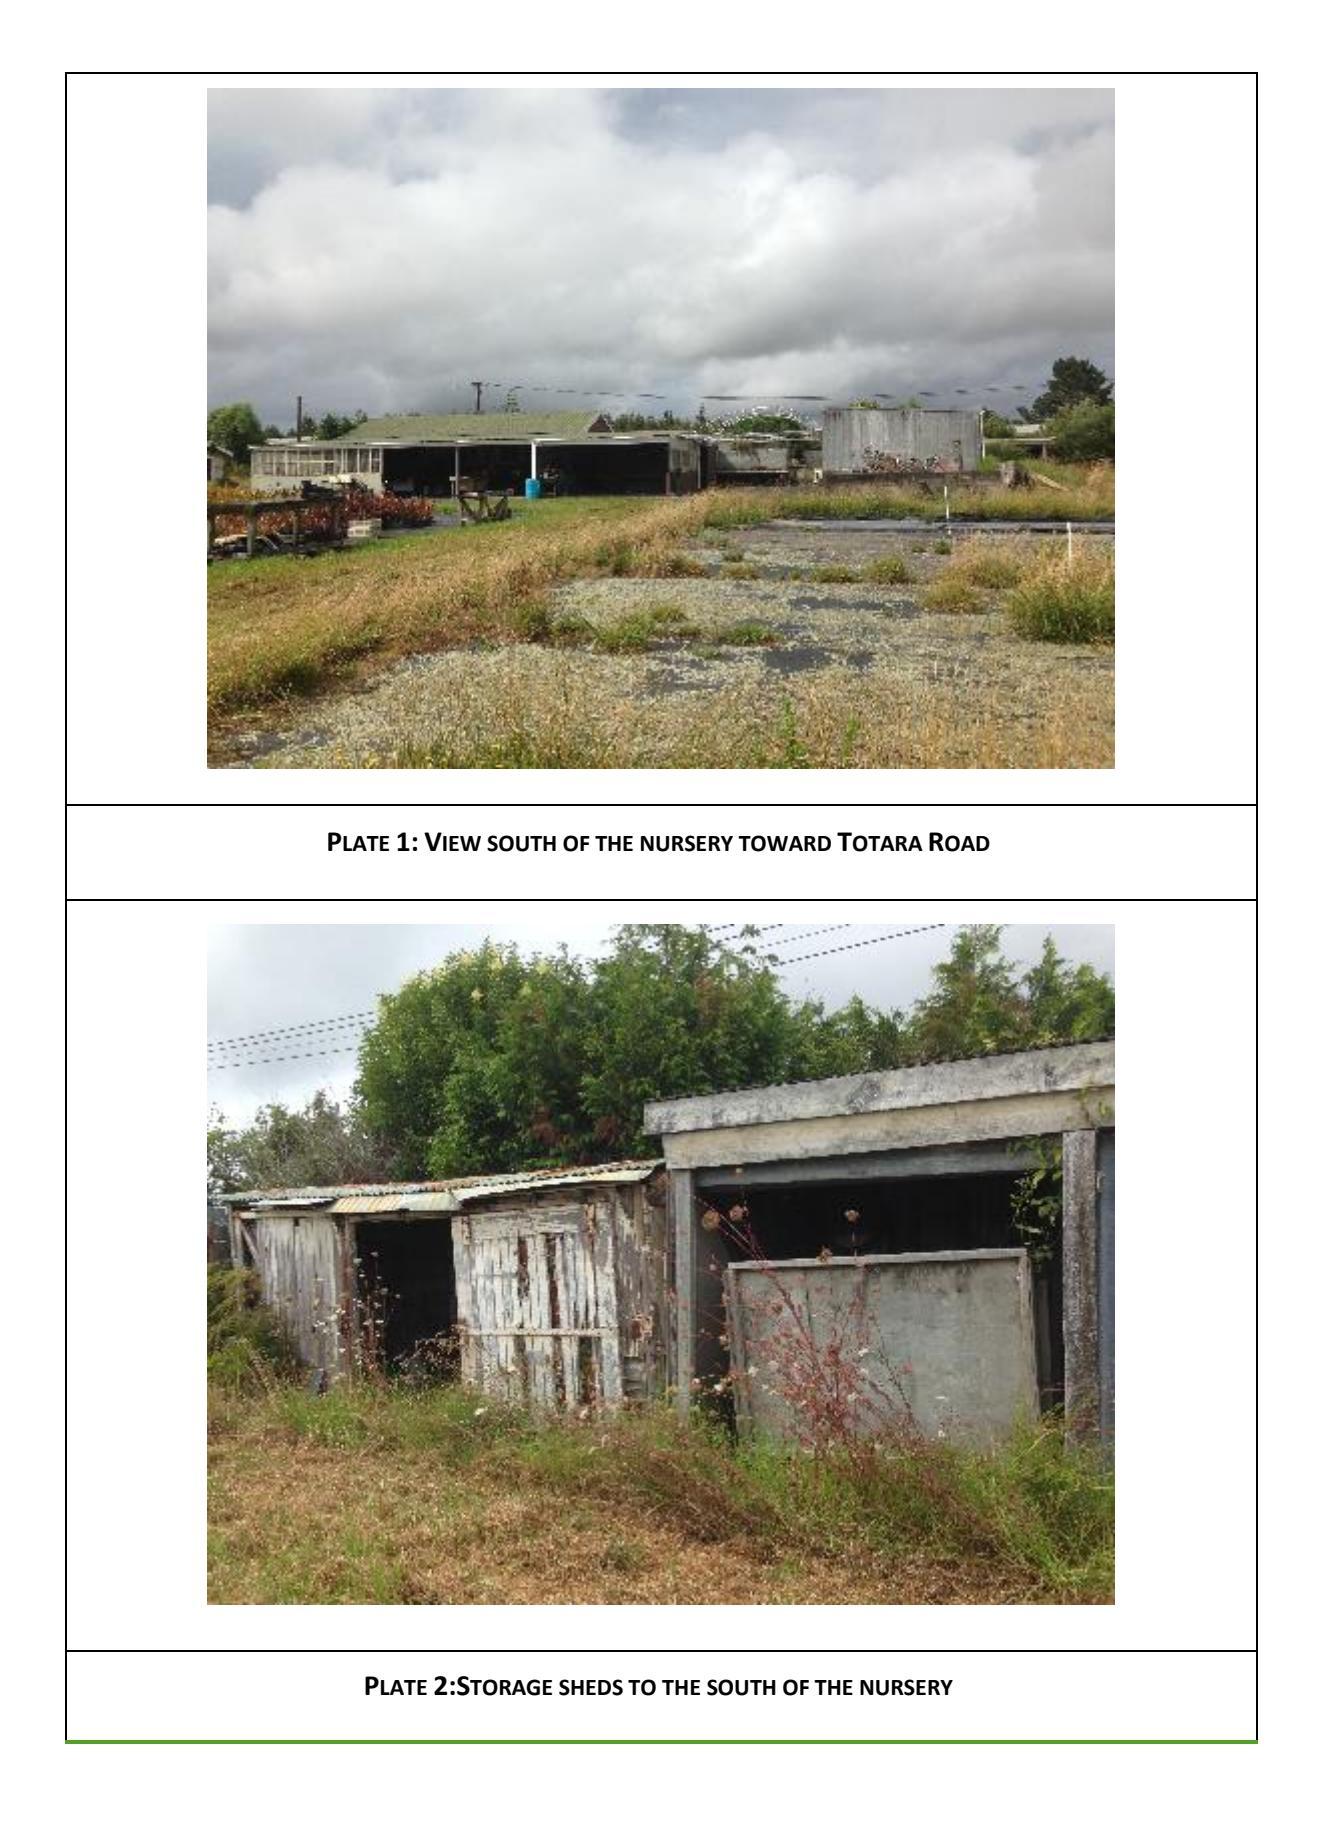
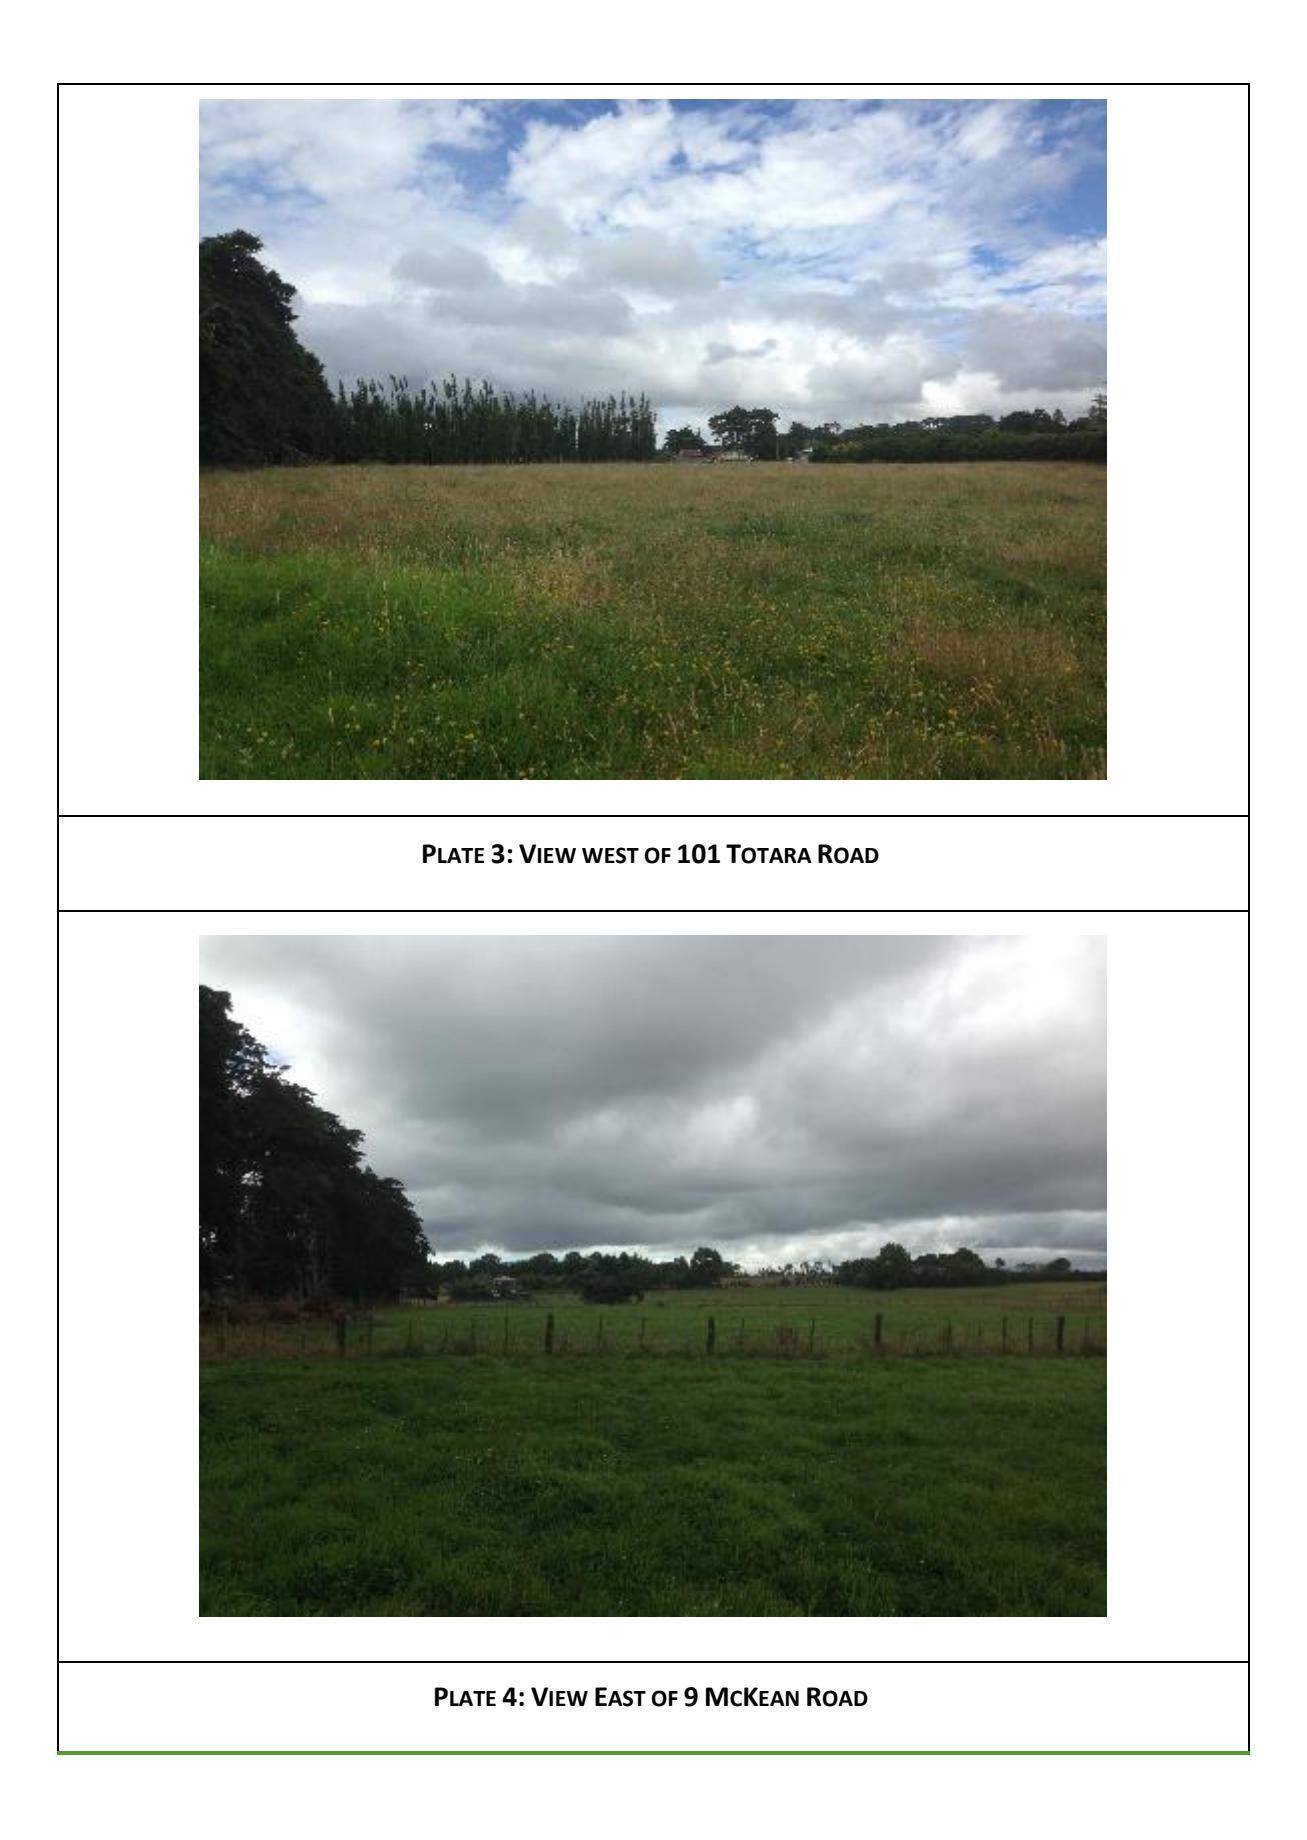
APPENDIX B SITE PHOTOGRAPHS

At the time of the inspection, the site is in the same general configuration as shown in the 2010 to 2015 aerial photographs. That is, the majority of the site is pastoral land, except for a small nursery area on 105-107 Totara Road. At the time inspection, the nursery did not appear to be in use with the area largely overgrown with miscellaneous pasture grasses and weeds, with only a few flax plants remaining within the central rows. Portions of this area remain covered by black plastic weed matting.

Two storage sheds were identified to the south of the nursery, one of which contained a number of pesticide and insecticide containers including Vapor Gard / Wilt Pruf (a terpenic polymer to prevent desiccation), Attack (an organophospahte broad-spectrum insecticide), Asulox selective weedkiller (an acid herbicide), Imidan insecticide (an organophosphate insecticide) and Preeglone Extra (a non-selective herbicide).
