Document Ref: AKL2016_0303AB Rev 1

RE: PRELIMINARY GEOTECHNICAL REPORT FOR WHENUAPAI WATERFRONT BLOCK, MCKEAN & TOTARA ROADS, WHENUAPAI

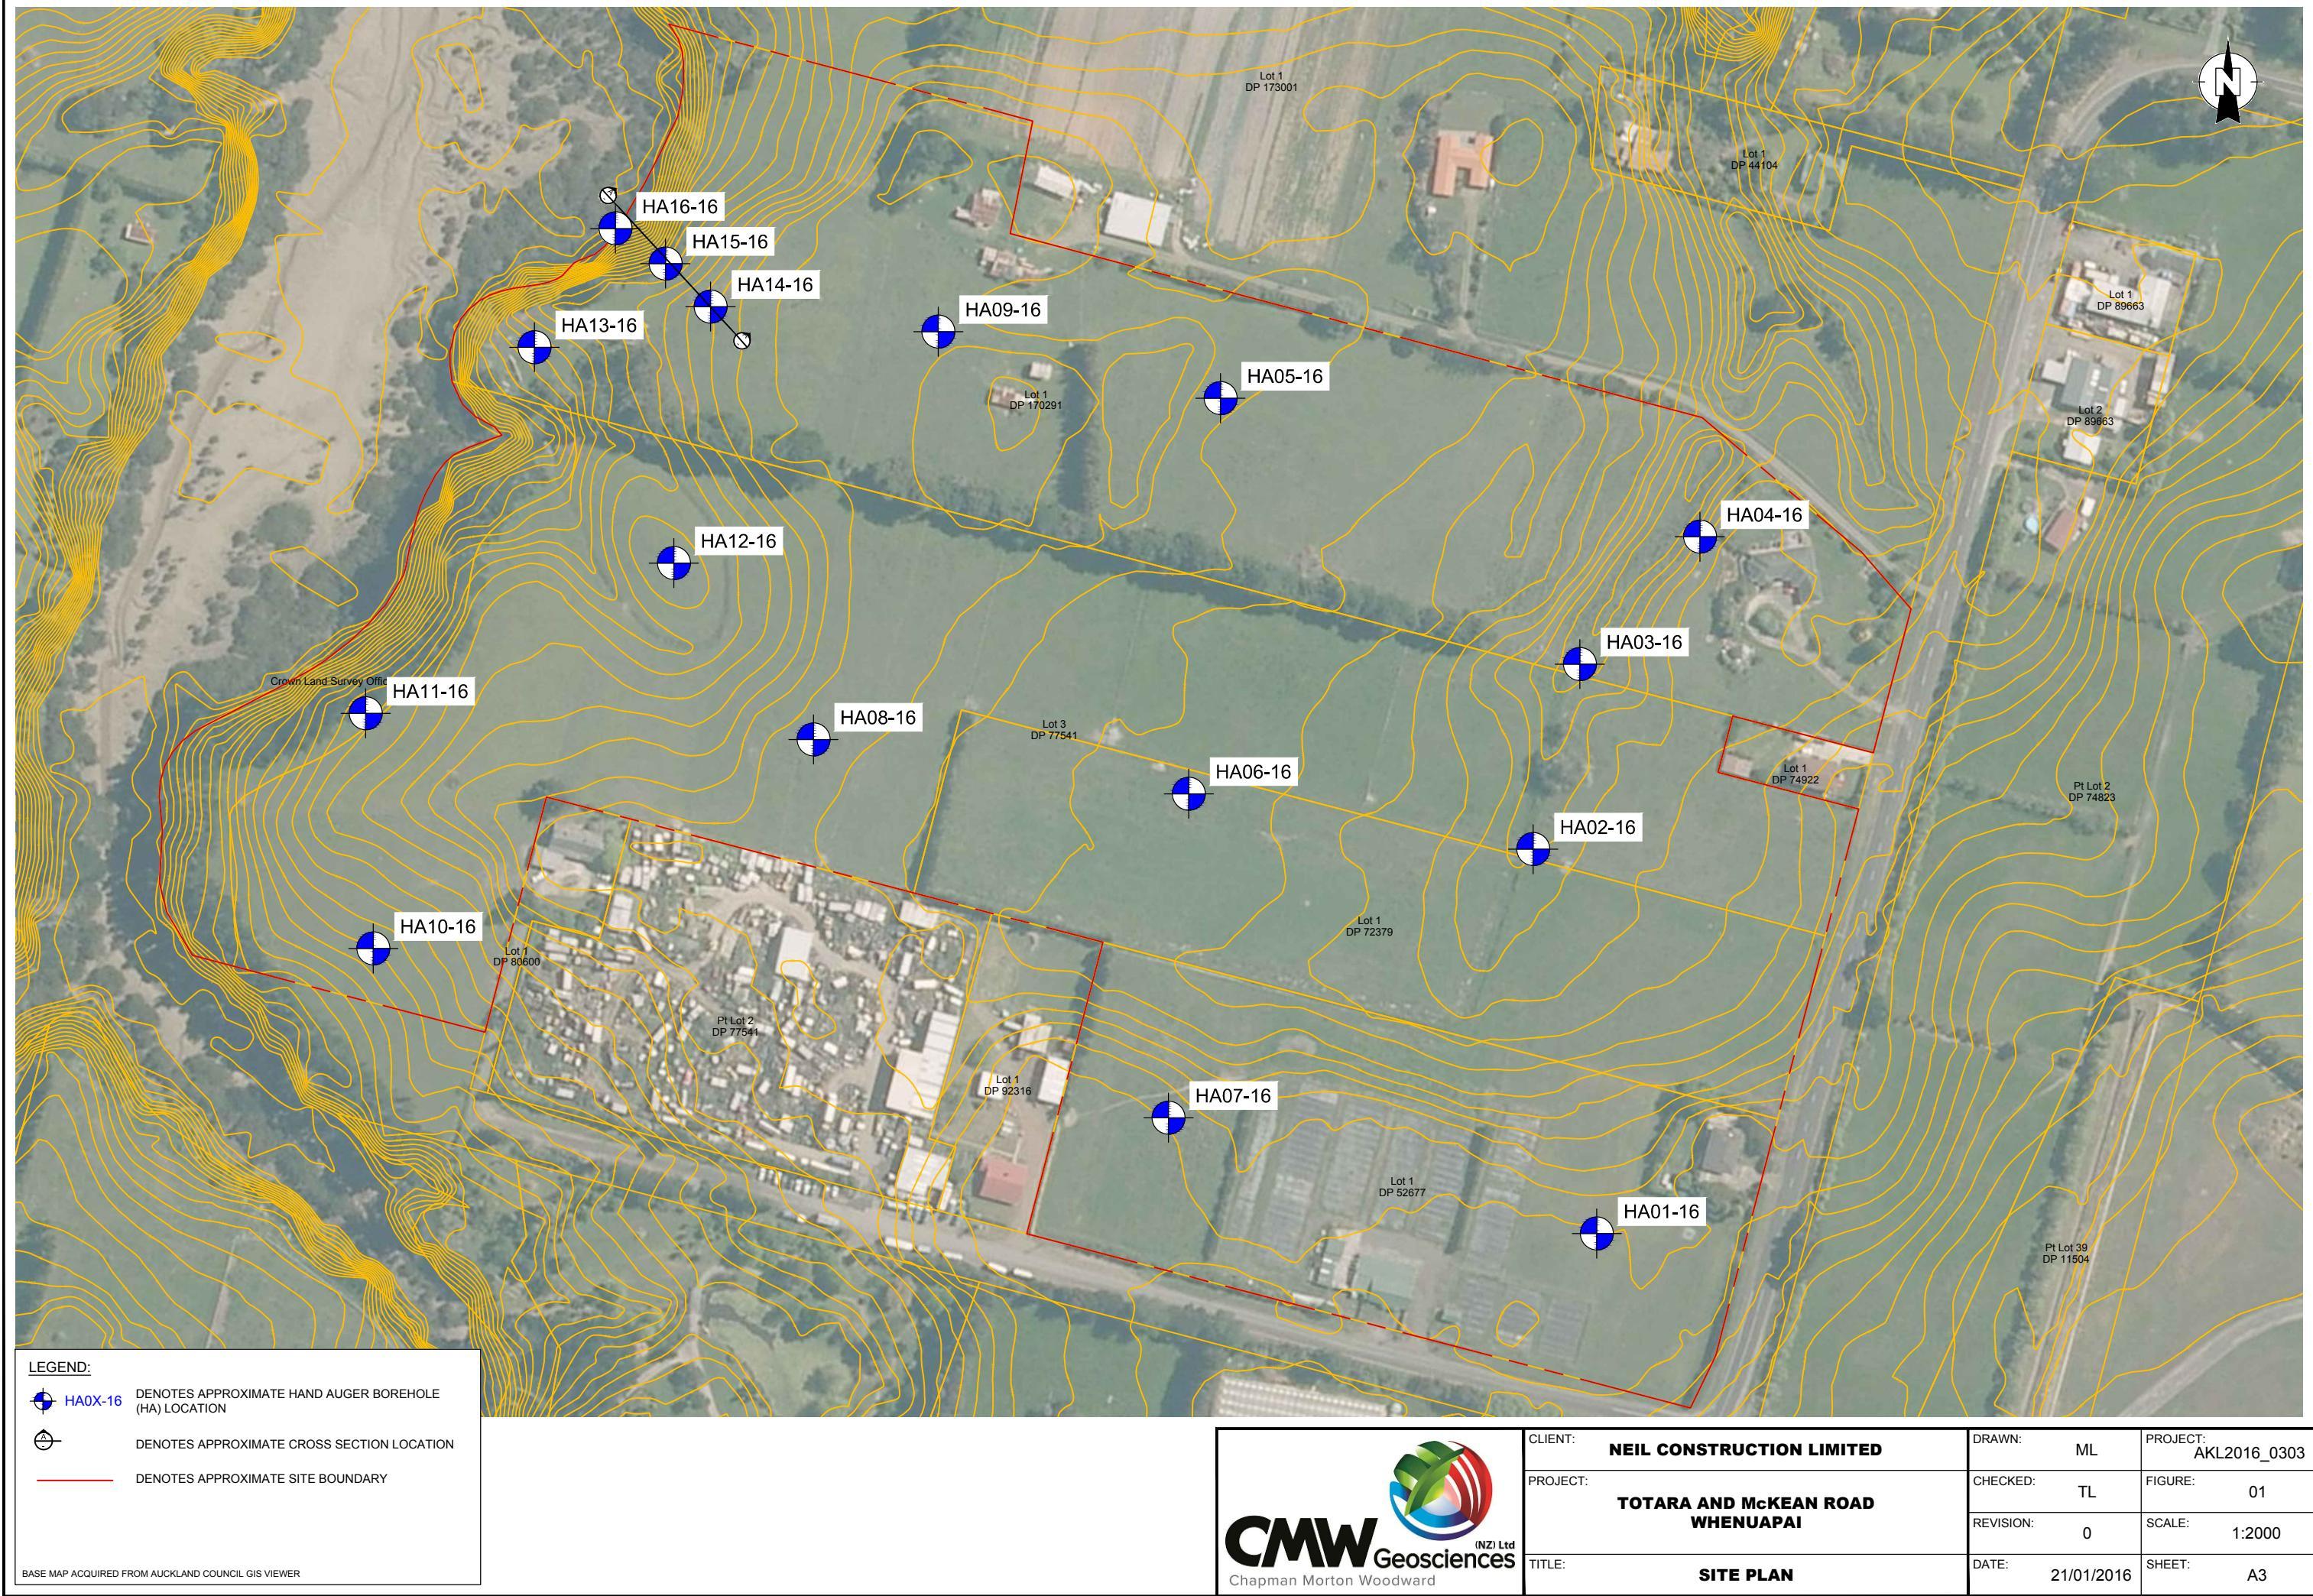
DRAWN:	ML	PROJECT: A	KL2016_0303
EAN ROAD	CHECKED:	TL	FIGURE:	01
AI	REVISION:	0	SCALE:	1:2000
N	DATE:	21/01/2016	SHEET:	A3

Full borehole records and the approximate locations of the boreholes are shown on the site plan appended to this report.

CMW have completed a stability analysis, using the proprietary computer software Slide and the Morgenstern-Price method, on the existing ground levels along the cross-section alignment shown on the appended site plan (A-A') through the bank adjacent to the estuary. The profile used to create the ground model analysed was measured on site. Soil strength parameters were given to the different unit layers by interpreting the results of the investigation and our knowledge of the soil conditions.

A cross section was also measured down slope over the coastal bank in the north east corner of the site to gain an understanding of likely set-back requirements.

Our stability analyses completed on the cross section A-A' indicated that the coastal bank has stability factors of safety less what is required by Auckland Council standards for residential sub divisions. Current and required factors of safety are shown on the stability printouts appended to this report.

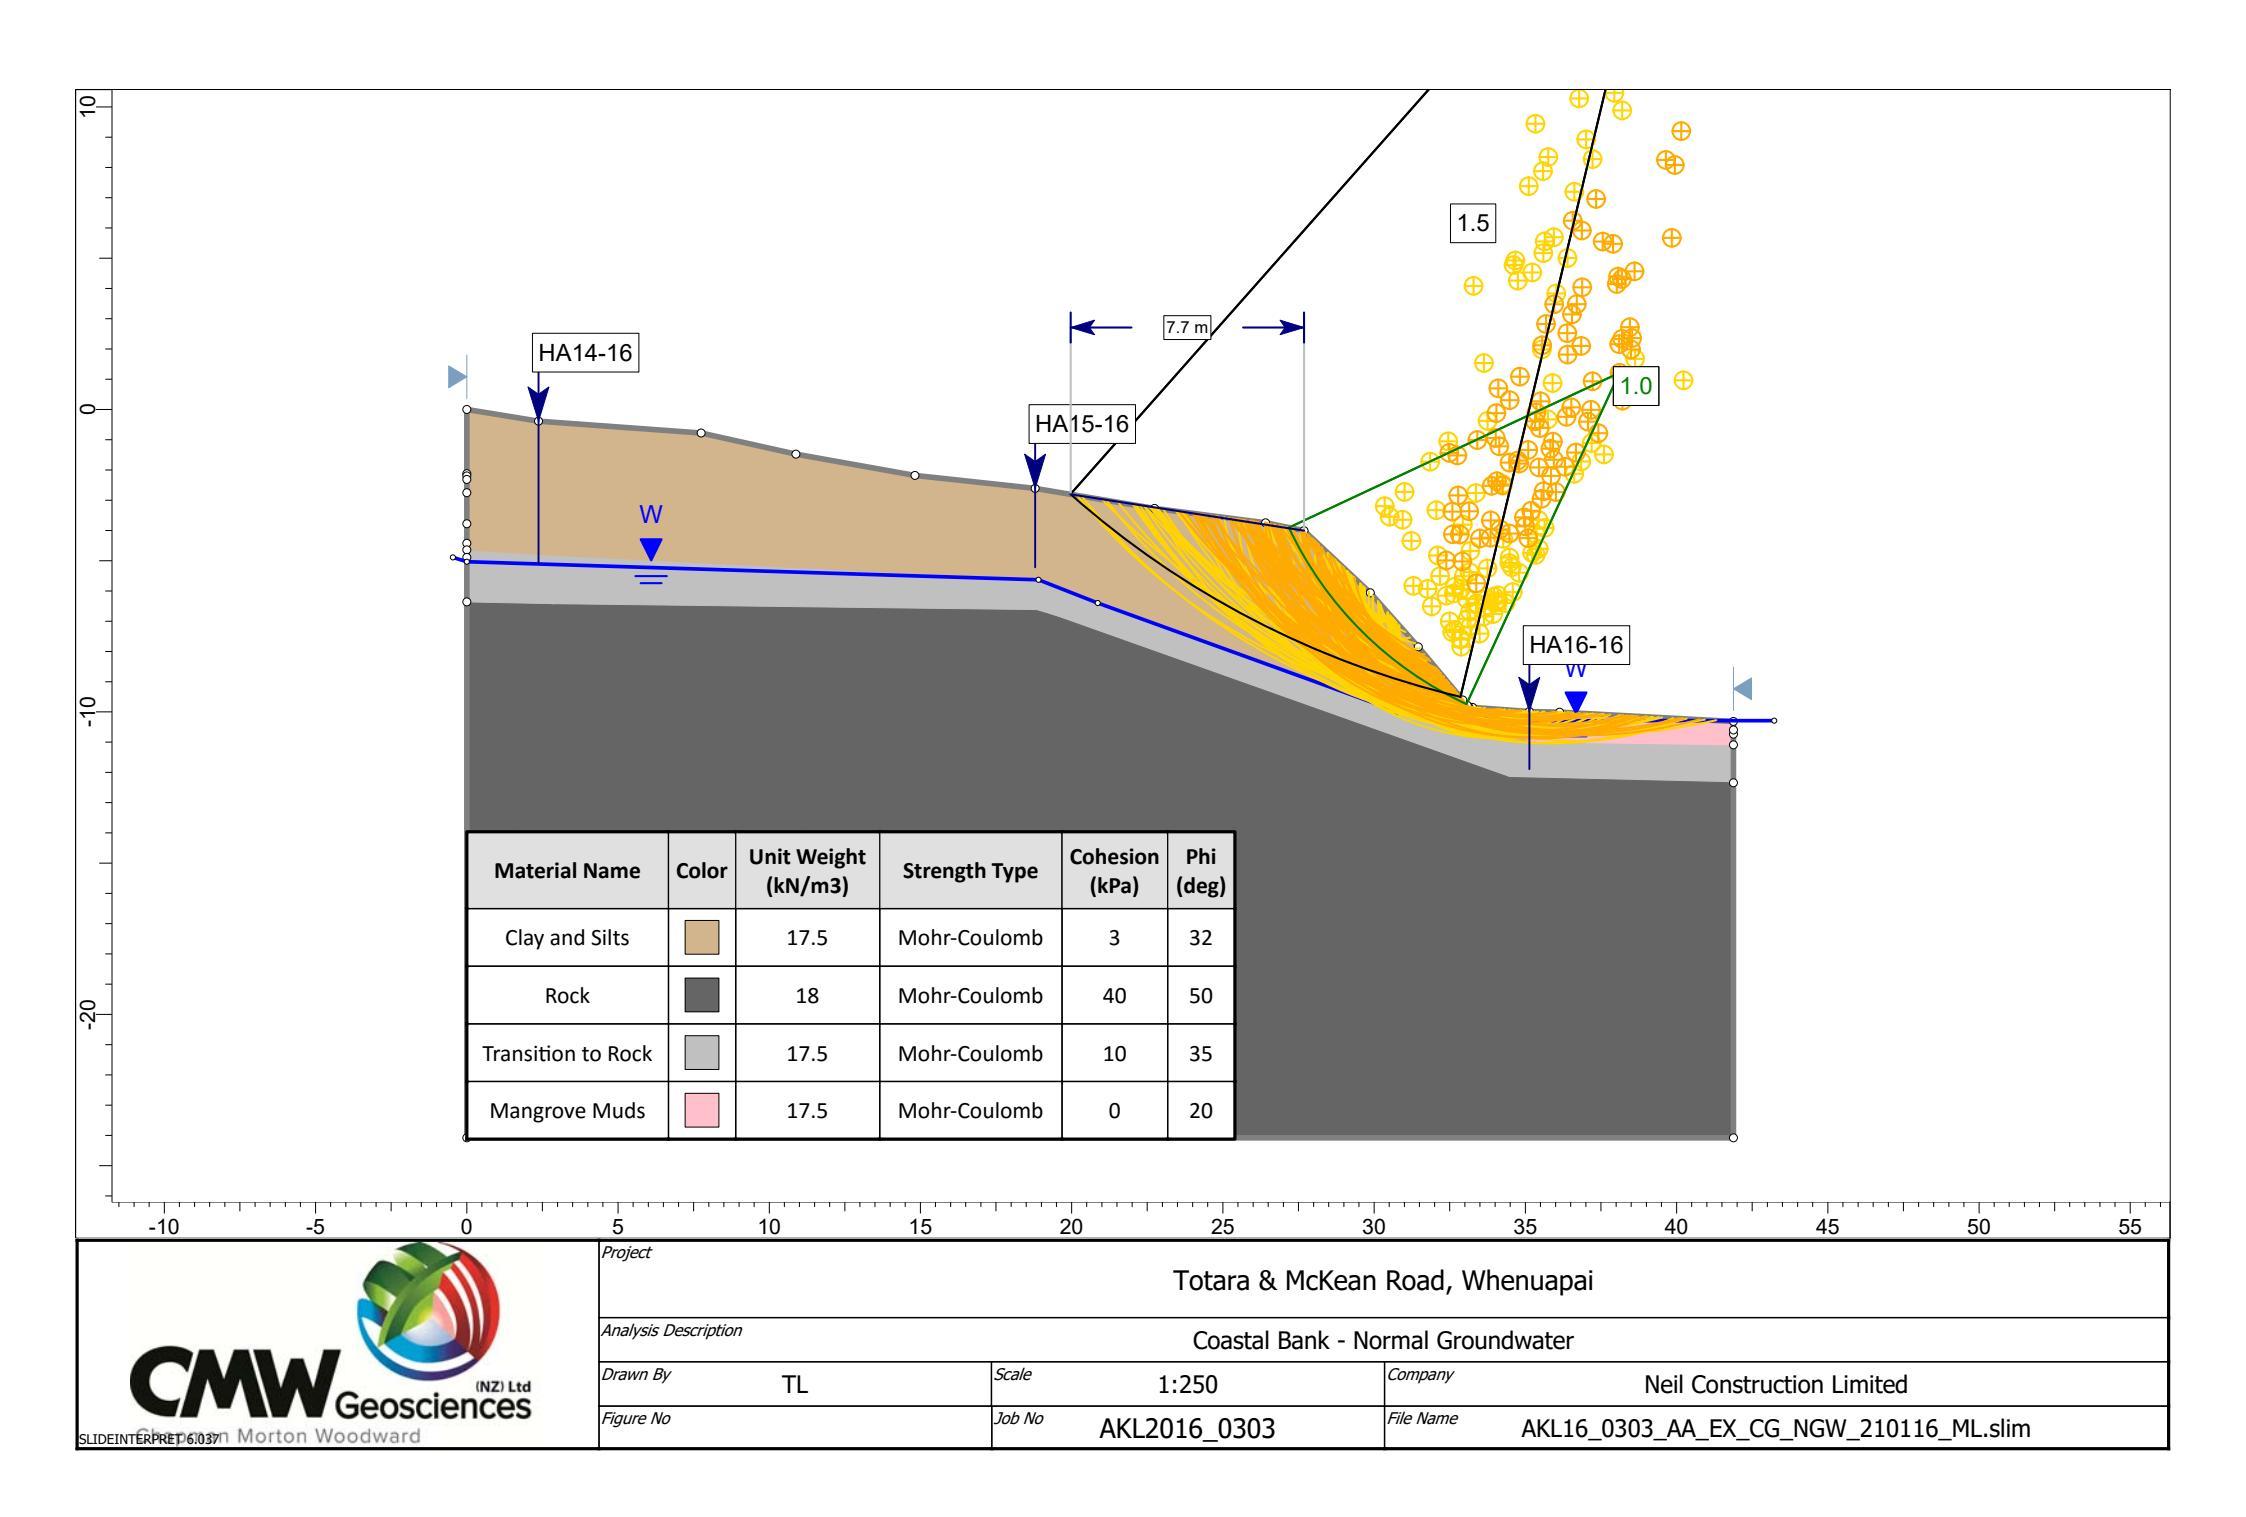
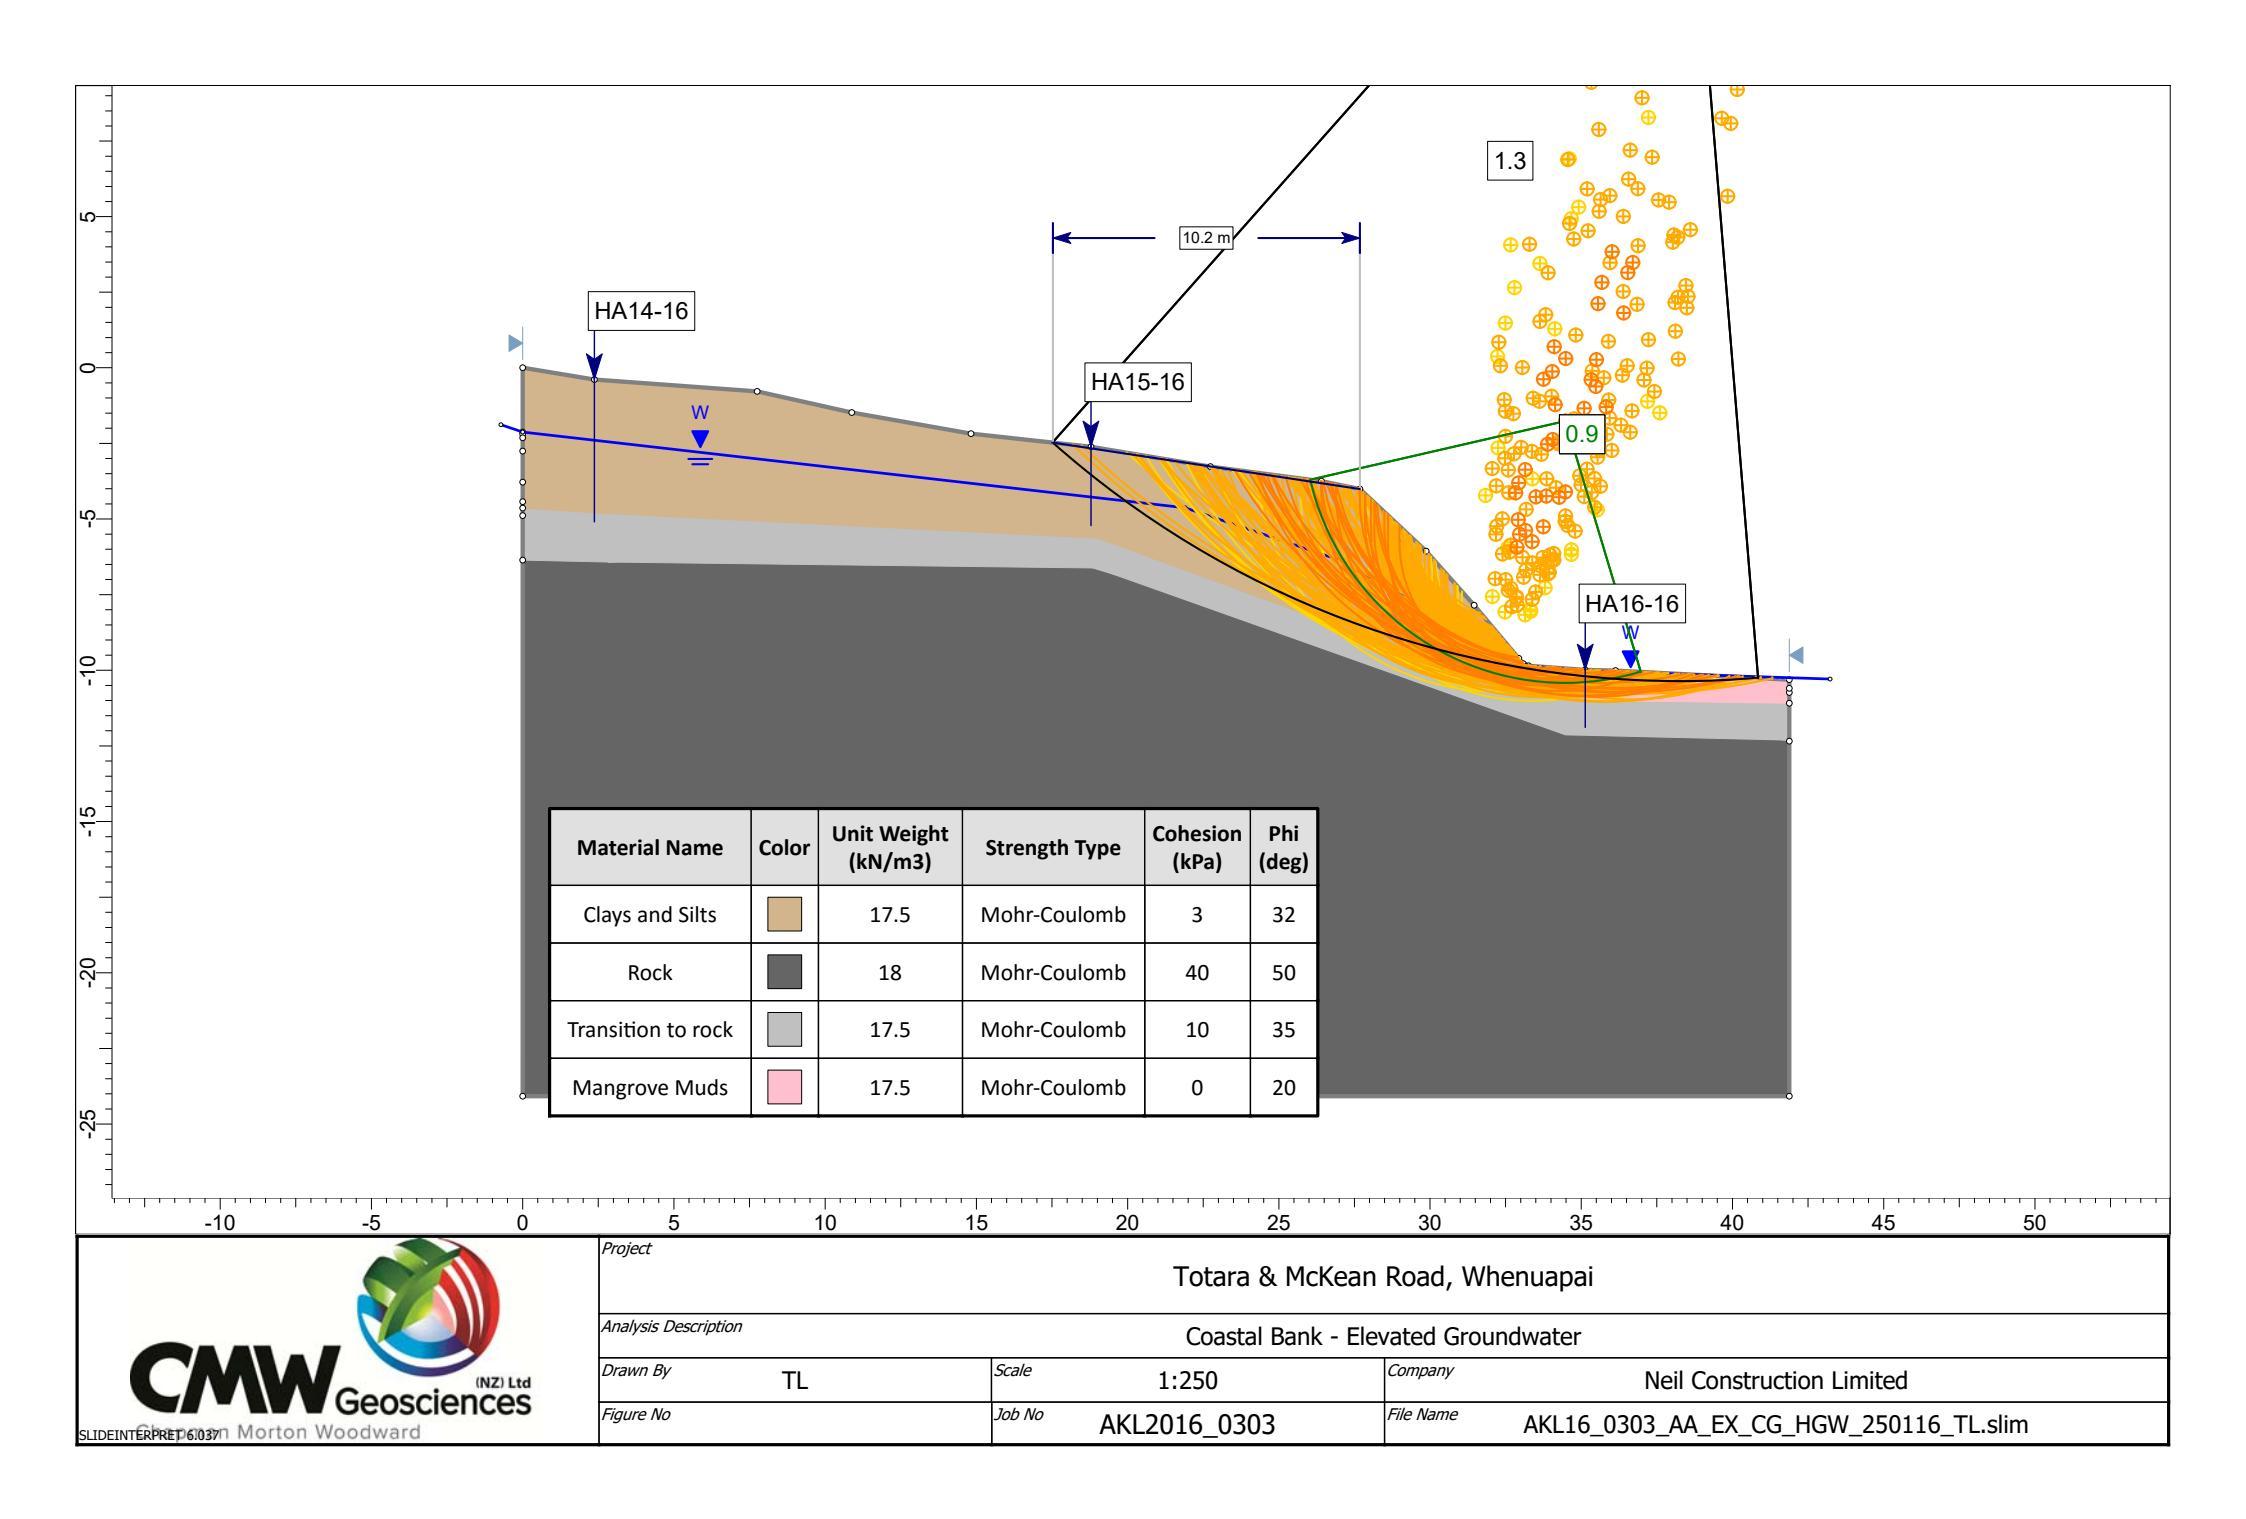
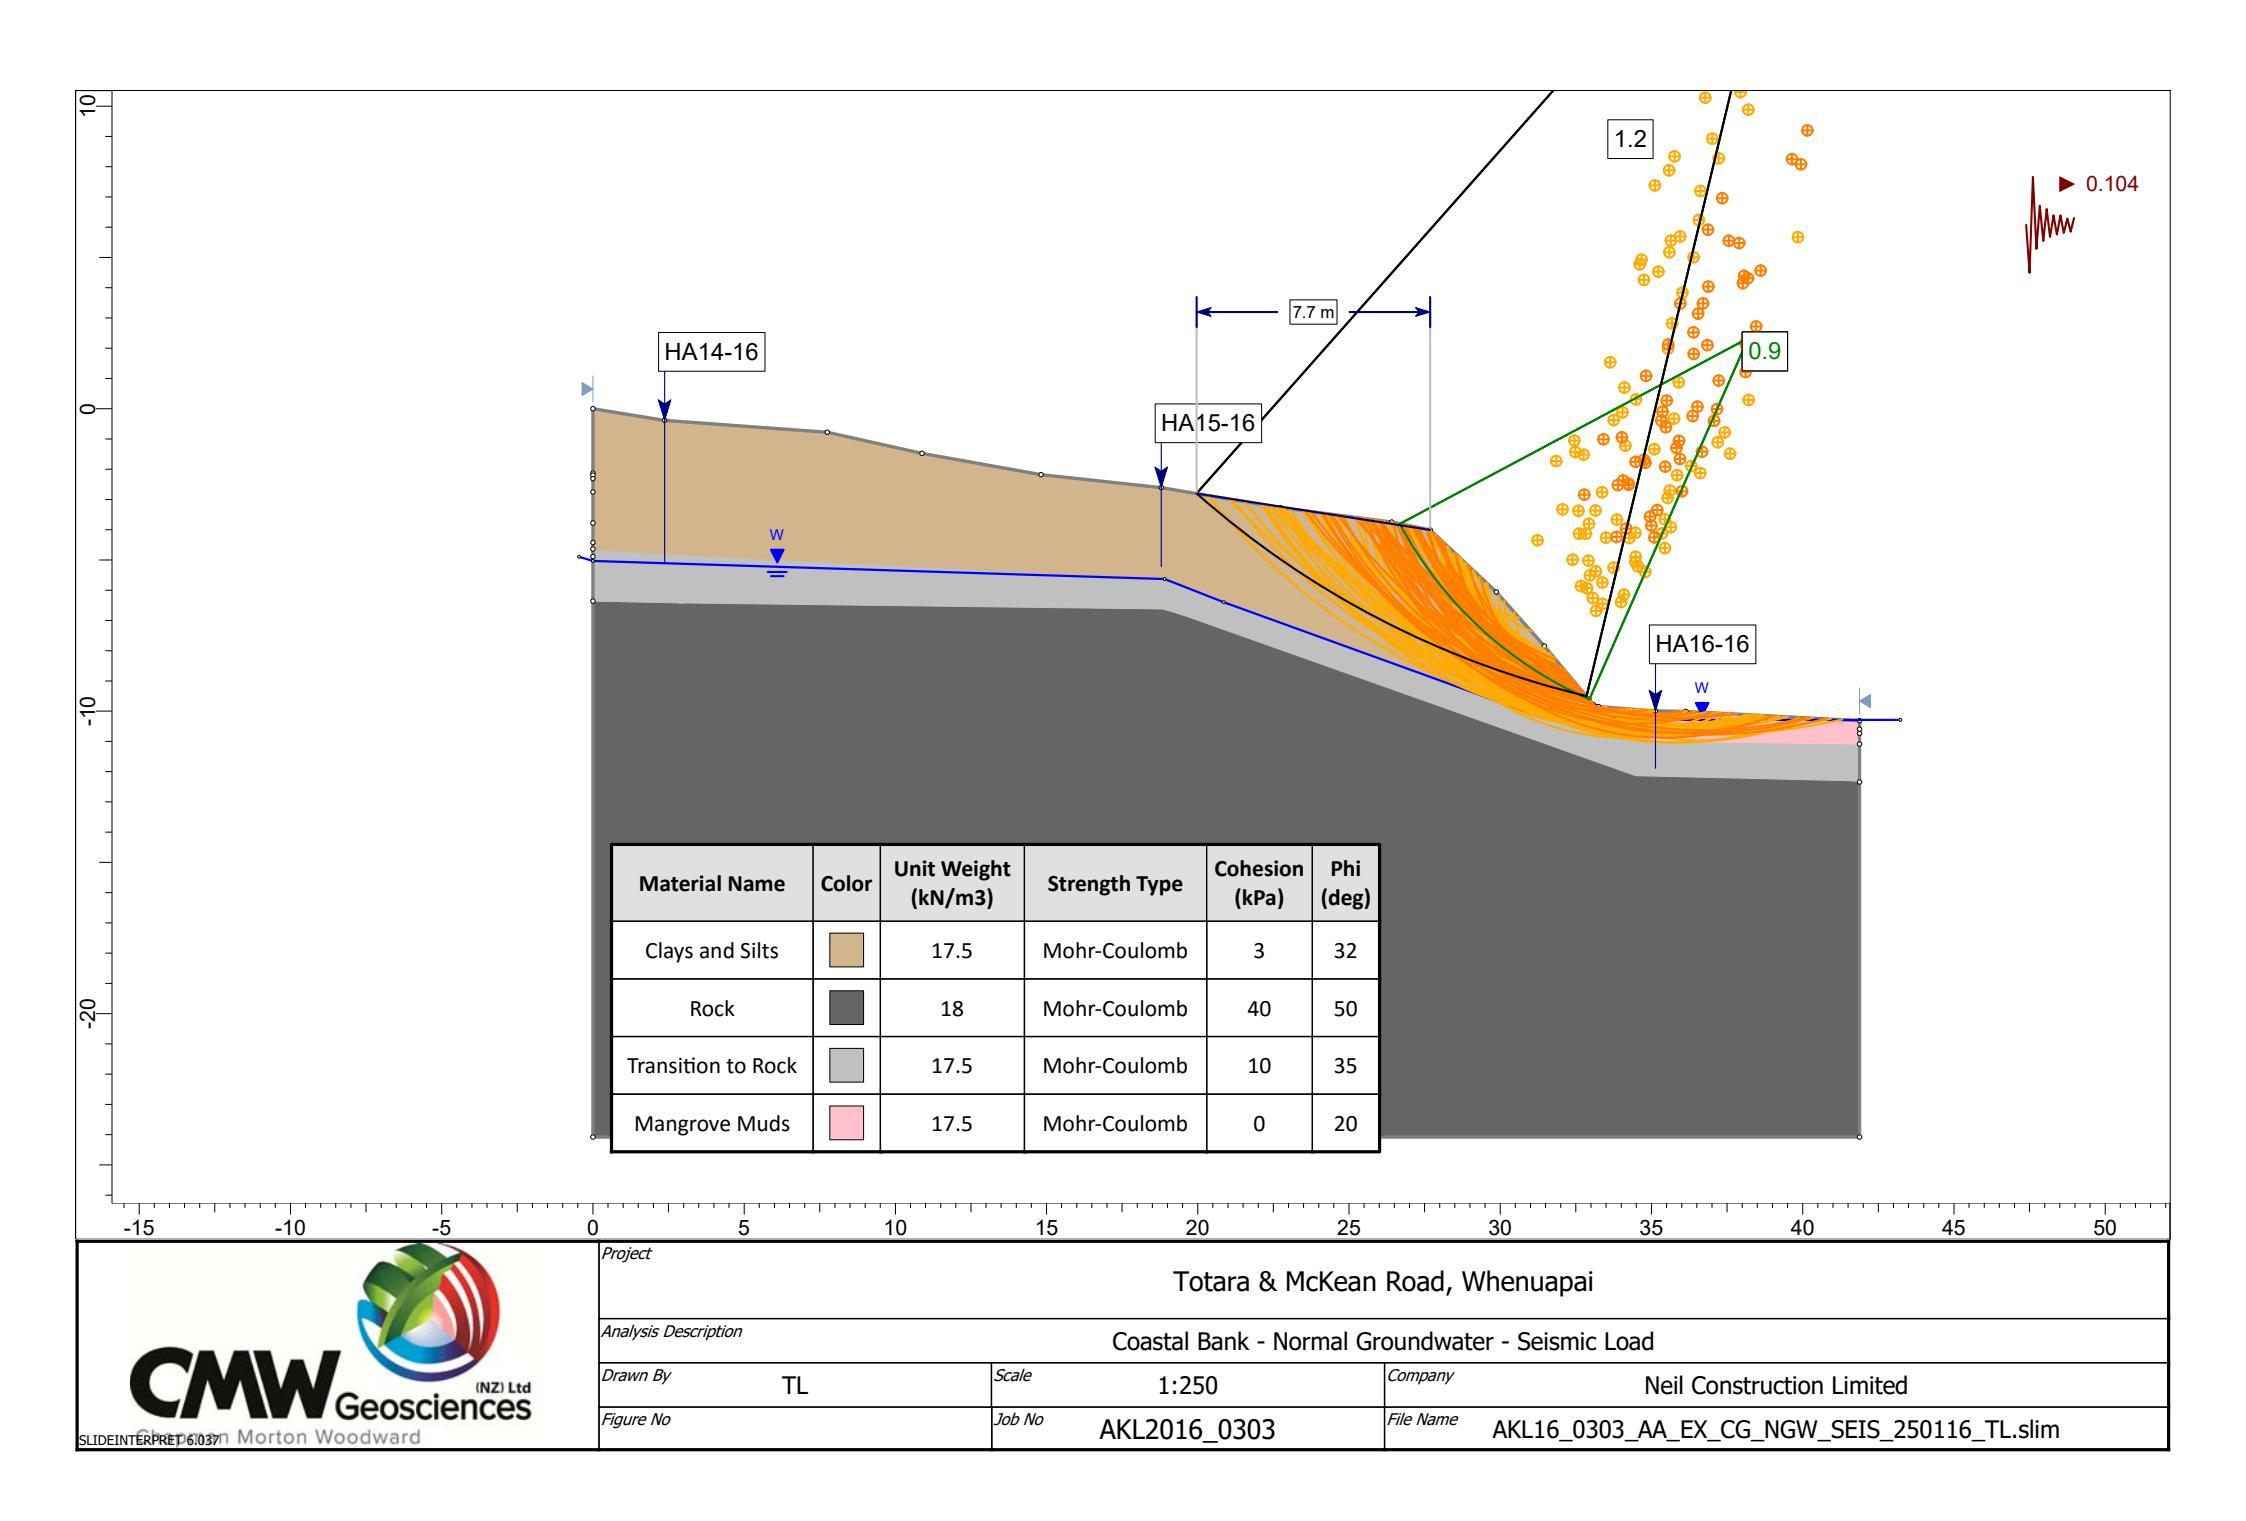
The appended stability print outs indicate that a safe set back of at least 10m (Elevated Groundwater Conditions) from the crest of the coastal bank is required to meet Auckland Council Standards. Any development proposed within this set back must be subject to further stability analysis and possible remedial works.

Auckland Council Code of Practice for Land Development and Subdivision requires a minimum Factor of Safety of 1.5 for long term slope stability under prevailing groundwater conditions, 1.3 for short term elevated groundwater conditions and 1.2 under seismic loading.
