Document Ref: AKL2019-0040AL Rev 0

RE: DUE DILIGENCE, GEOTECHNICAL INVESTIGATION REPORT 73 TRIG ROAD, WHENUAPAI

CMW Geosciences (CMW) was engaged by Neil Construction Limited as part of their due diligence process to carry out preliminary geotechnical investigation and reporting of the site at 73 Trig Road, Whenuapai, which is being considered for the construction of light industrial buildings.

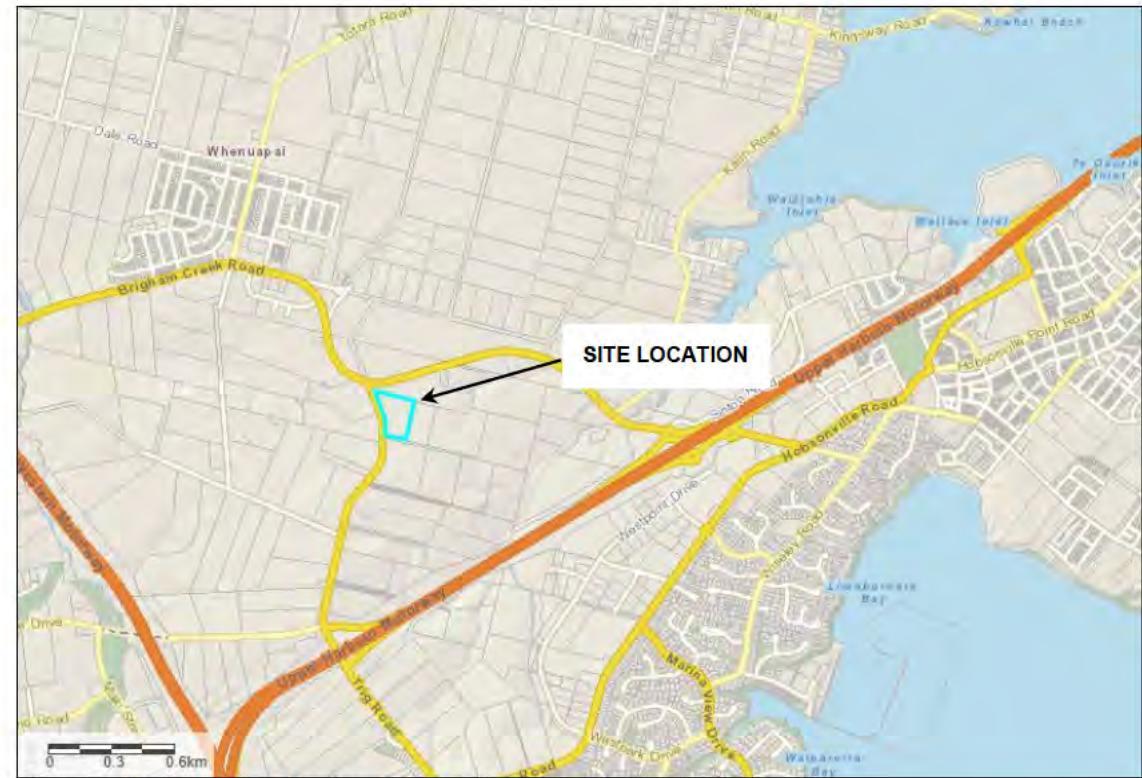
Figure 1: Site Location (Auckland Council GeoMaps)

The site is located at 73 Trig Road, Whenuapai, legally described as Lot 1 DP 117365, as illustrated in *Figure 1* below. The property has an approximate area of 2.6 hectares and is irregular in shape, being bound by Trig Road to the west, and neighbouring rural properties to the east, north and south

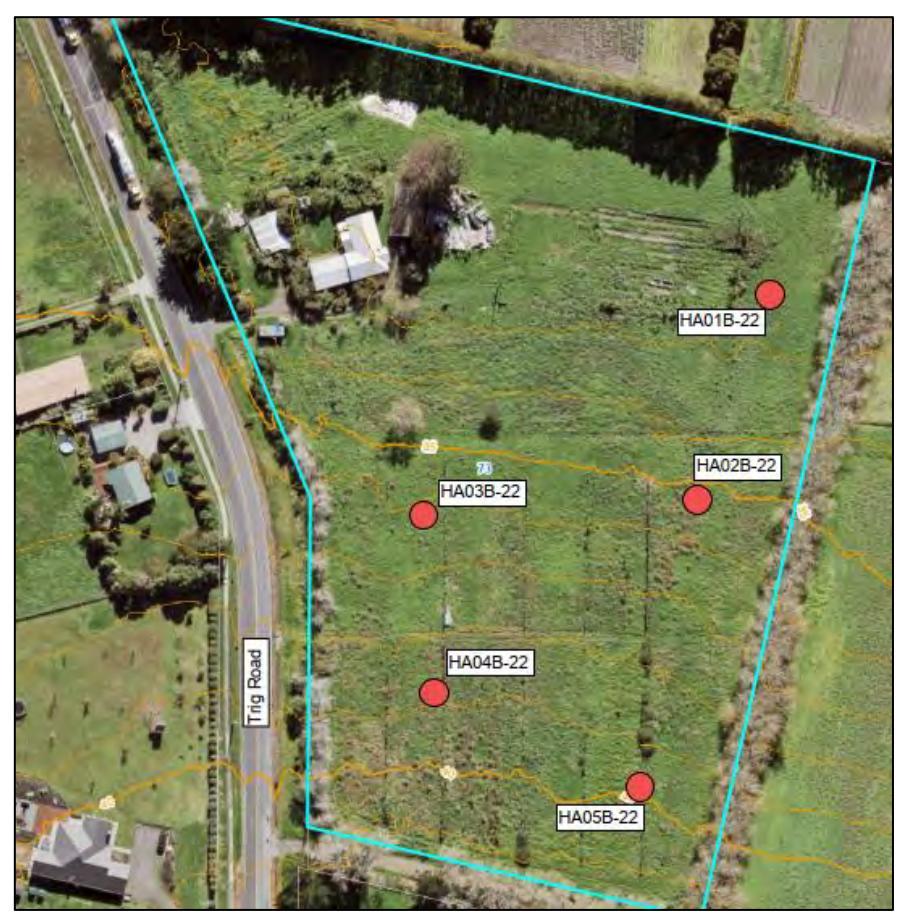
Figure 2: Site Investigation Plan (Auckland Council GIS)

The approximate locations of the respective investigation sites referred to above are shown on the Site Investigation Plan in *Figure 2* below. Test locations were measured using a handheld GPS. Elevations were inferred from the existing Auckland Council GIS contours.

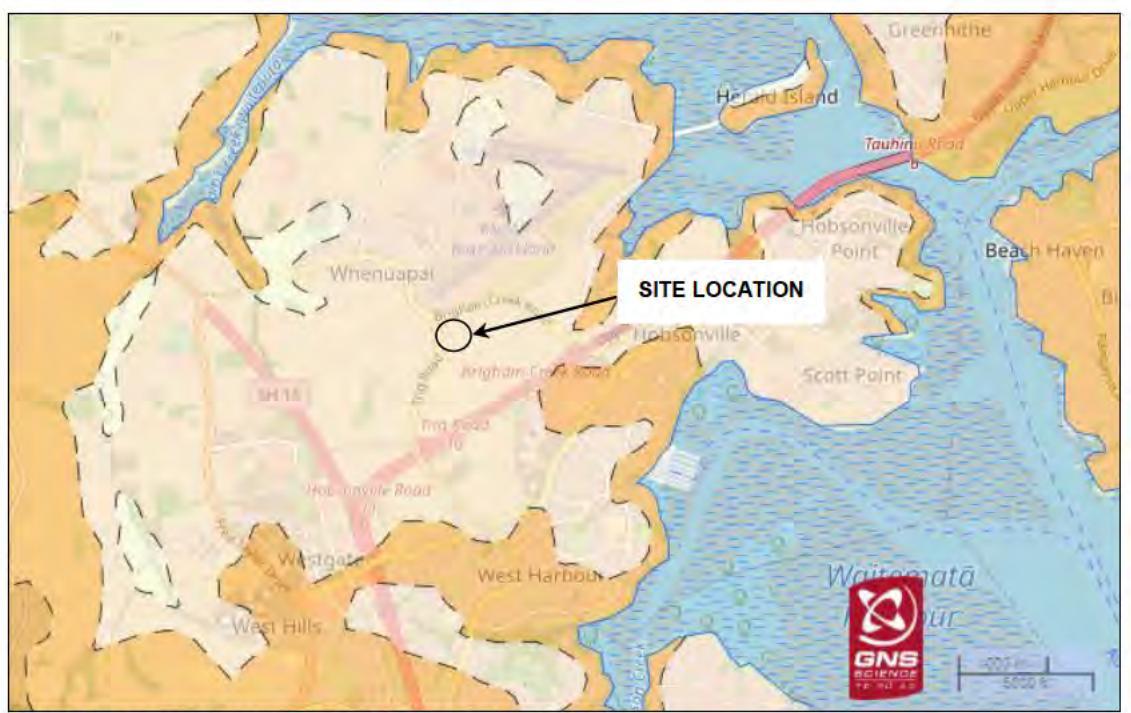
Figure 3: Regional Geology (GNS Science Geology Map)

Published geological maps² for the area depict the regional geology as comprising Late Pliocene to Mid Pleistocene alluvial deposits of the Puketoka Formation as illustrated in *Figure 3* below.

These alluvial clay and silt deposits include pumiceous mud, sand and gravel with muddy peat and lignite, rhyolitic pumice (including non-welded ignimbrite, tephra and alluvial pumice deposits) and massive micaceous sand beds. Below these upper soil layers, the deeper geological formation is reported to comprise interbedded muddy sandstones and siltstones of the East Cast Bays Formation within the Waitemata Group.
